Flood Investigation Report

Fouracres (Maghull), Sefton Lane (Maghull),
Hawksworth Drive (Formby), Water, Street (Thornton)
and Moss Lane (Lydiate)

Date of flooding: 24/09/2012

Version 1.2
November 2012

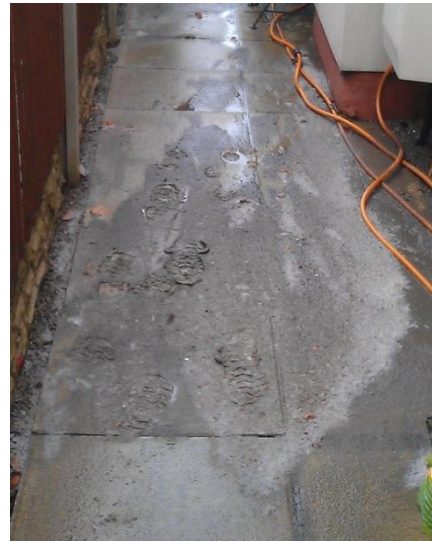
Figure 5: Foul debris residence side passage

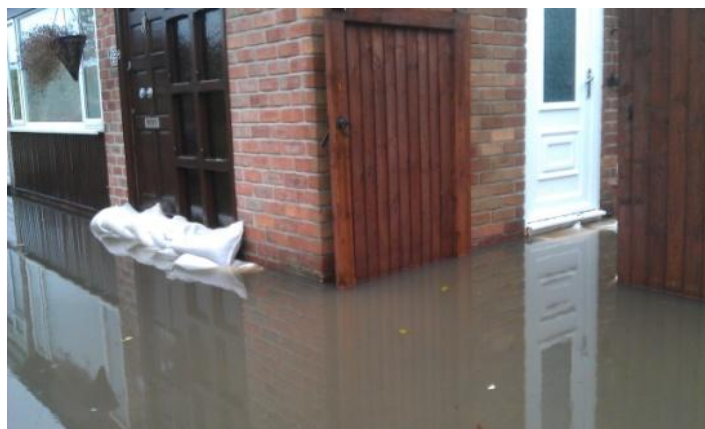
Along Fouracres itself approximately 40 properties were affected by flood water with 24 properties being internally affected. The road itself was not affected by the flood water as it is higher than the properties.

Figure 6: Illustrating the level of flooding around houses in Fouracres

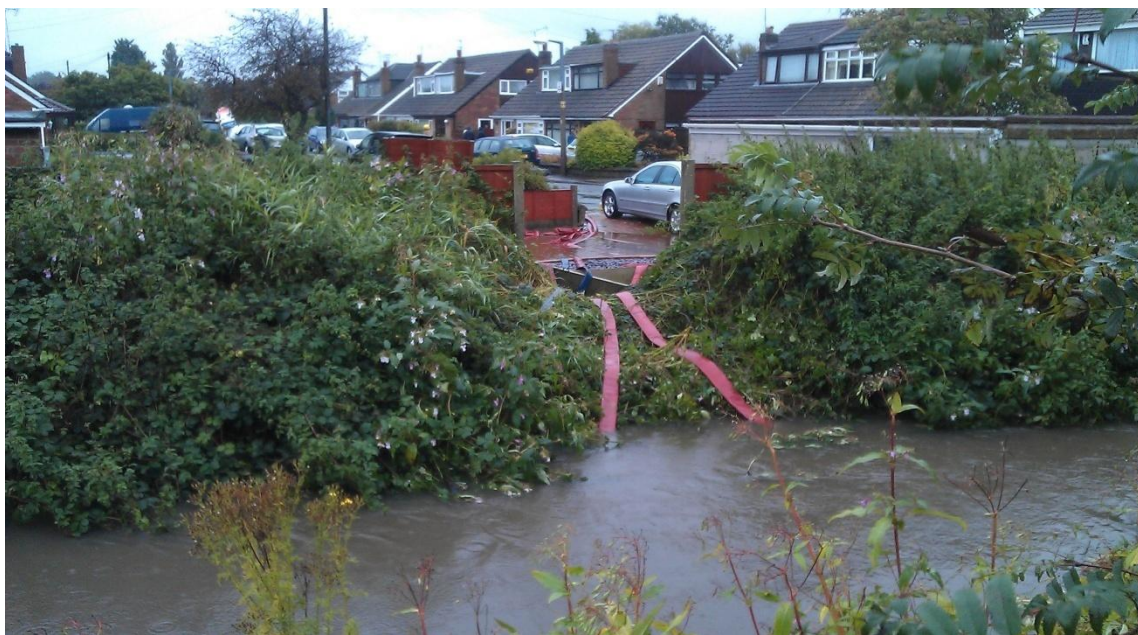
There was a suggestion that the cause of the flooding was that Dover's Brook had breached its bank, subsequent inspection by the Environment Agency has found no evidence of a breach or overtopping on either Dover's or Whinny Brook. As can be seen in the picture below of Whinny Brook (looking towards the head of Fouracres), the levels in the Brook were high but did not reach its full the capacity.

Figure 7: Illustrating the height of water in Whinny Brook (looking towards Fouracres)

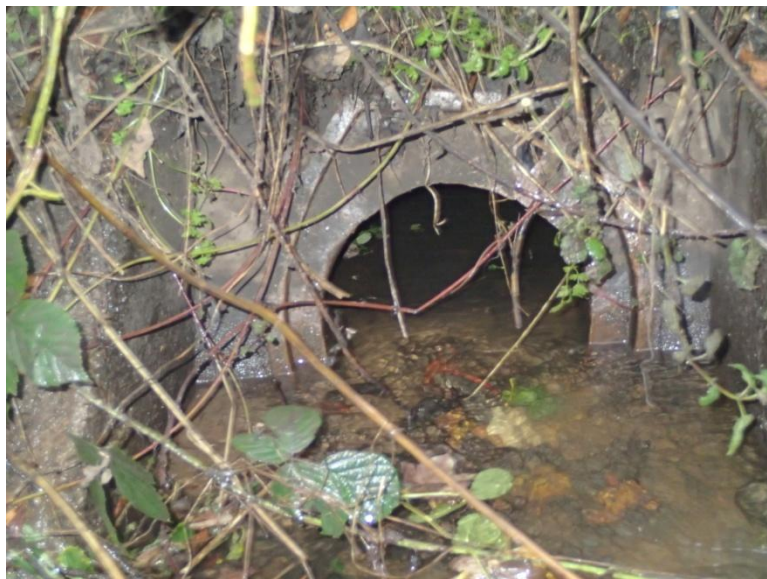
United Utilities did not find a blockage on the surface water sewer system either. However, it was found that neither of the 2 outfalls which discharged into Dover's and Whinny Brook had a flap/non return valve on them. They have undertaken to carry out further investigations on the system to better understand it and check for cross-connections.

Below is a picture of the outfall from Fouracres into Whinny Brook which was taken during a period of low flow, the outfall is still partially submerged.

Figure 8: Outfall from Fouracres into Whinny Brook, taken 06/11/2012

Number	Recommendation	Lead Risk Management Authority
1	Investigate the merit of installing flap valves/non return systems on the outfalls into Whinny Brook and Dover's Brook.	United Utilities
2	Co-ordination of maintenance priorities and works between the Risk Management Authorities	Environment Agency
3	Work with landowners with riparian duties to reduce the impact of debris and blockages.	Environment Agency
4	The Council should work more closely with the Canal and River Trust in order to understand the role and potential contribution of their systems to flood risk	Sefton MBC
5	The Council, Environment Agency and United Utilities need to review how they share intelligence and co-ordinate responsibilities	Sefton MBC
6	The risk management authorities should review other locations where this mechanism for flooding might be an issue	United Utilities

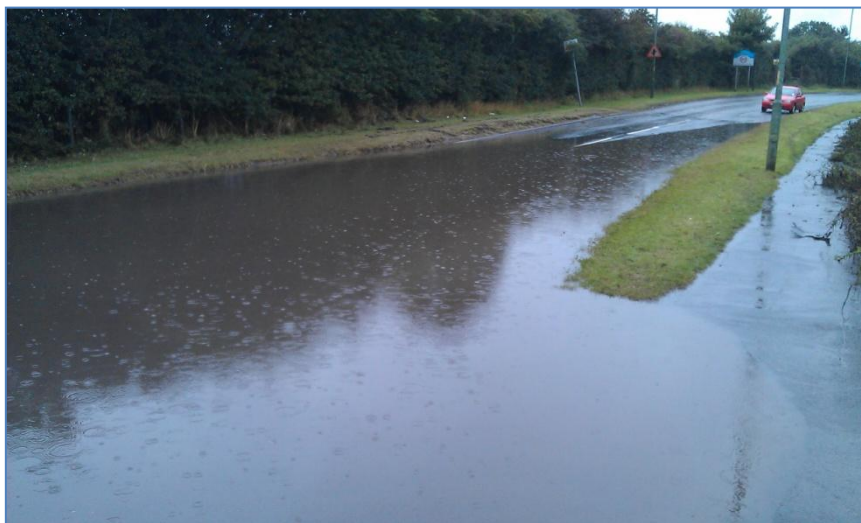
The first source (*A, figure 11*), was from the surface water system not being able to discharge into Dover's Brook or the River Alt due to high river levels.

The first area of flooding, travelling from Sefton village towards Maghull, was a 60m stretch between the village and the bridge over the River Alt. Rainwater had come off the field on the north side and pooled in the dip and inundated the road to approximately 15cms deep.

Figure 11: Bridges Lane, area A, taken 25/09/2012

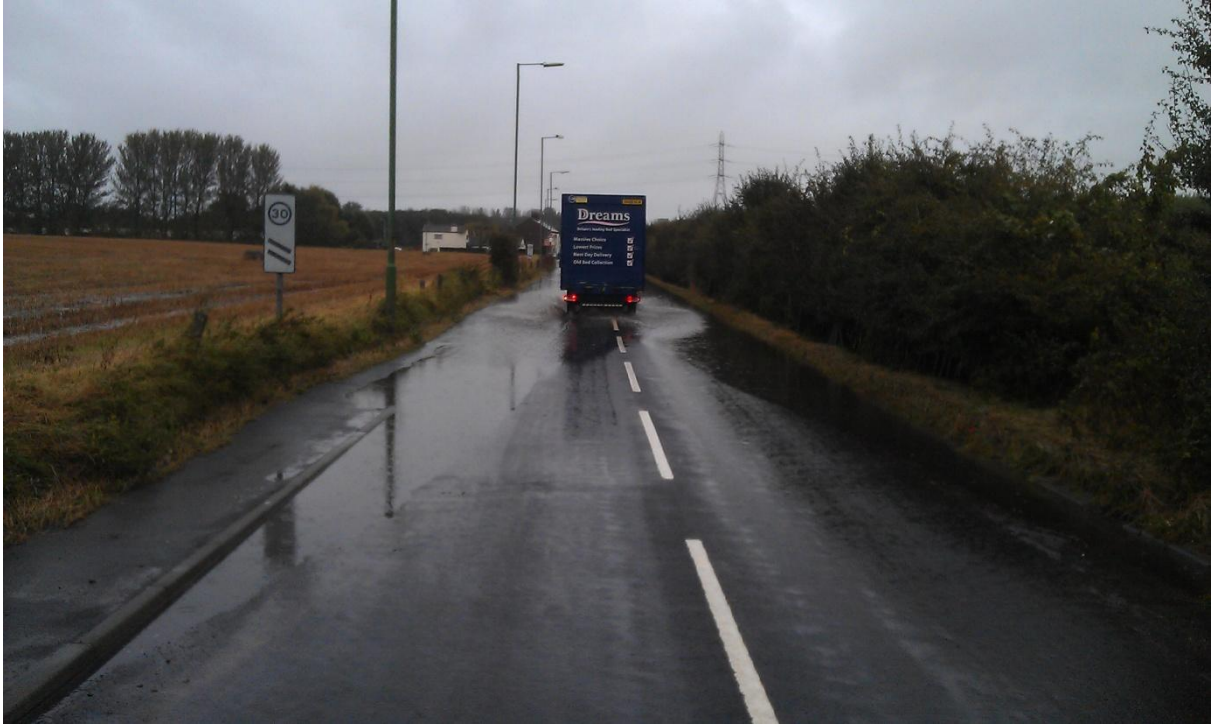
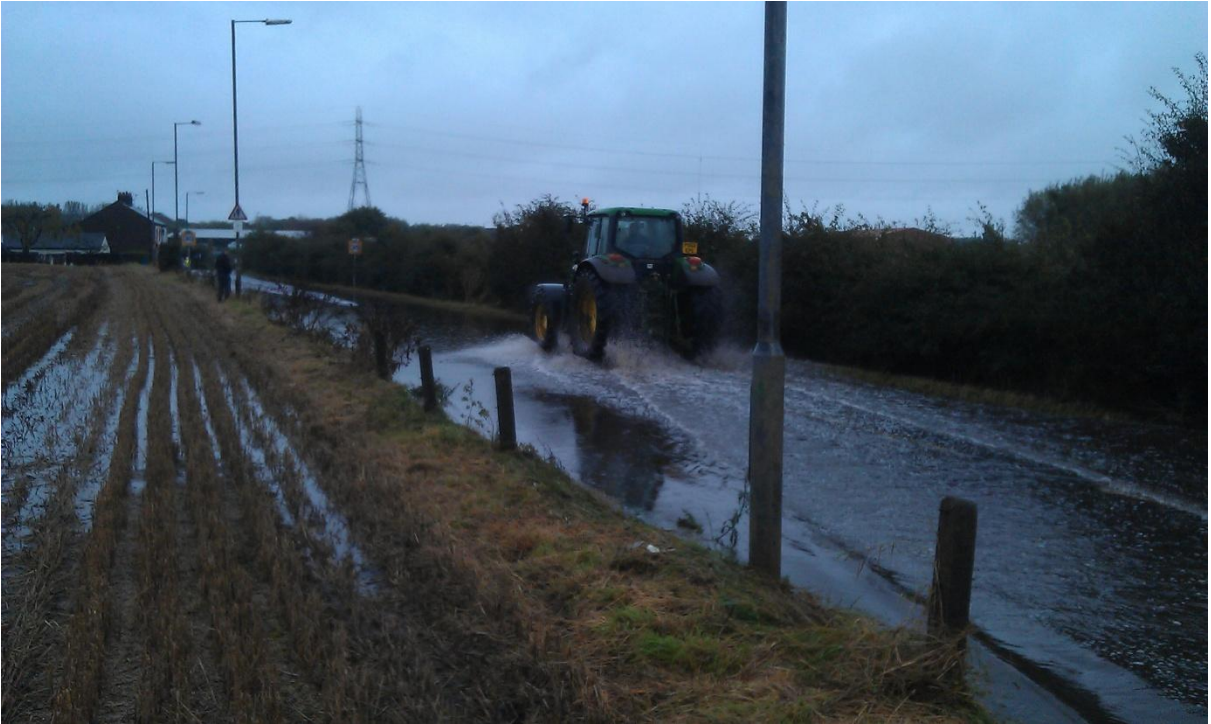
The second stretch (B, Figure 13 and figure 14), of highway flooding was between the bridges over the River Alt and Dover's Brook to a depth of approximately 15 cms.

Figure 13: Bridges Lane, area B, taken 25/09/2012

Figure 14: Bridges Lane, area B, taken 25/09/2012

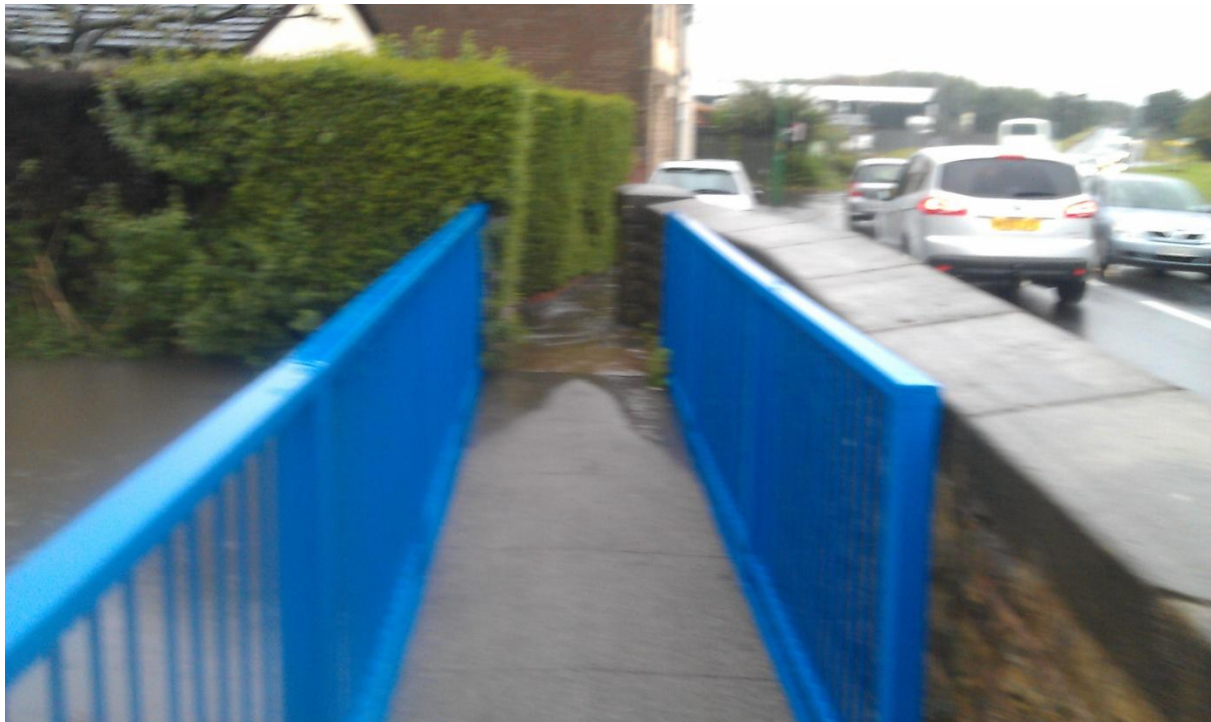
However, the major source of flooding was from Dover’s Brook overtopping the embankment at a low spot close to Dover’s Bridge, as can be seen in the photograph below (Figure 15). The water flowed along the footpath into the highway and joined up with the surface water flooding, forming a pool across the road, approximately 12cm deep. Some water flowed along the road towards the waste recycling centre and pooled at the entrance, and some water flowed around the backs of the properties on Sefton Lane damaging outbuildings, a caravan and ingressed into at least 1 property.

Figure 15: Dover’s Brook flooding into Sefton Lane, taken 24/09/2012

The other source of flooding was again caused by high river levels in Dover’s Brook. The water level rose to a sufficient height that it was able to overtop the flood embankment at a low point close to the footbridge.

Number	Recommendation	Lead Risk Management Authority
1	Investigate installing flap valves/non return systems on the outfalls that discharge into Dover's Brook and the River Alt.	Sefton MBC
2	Environment Agency should engage in further discussions with the riparian owner at Dover's Bridge about raising the embankment, to raise the low point	Environment Agency

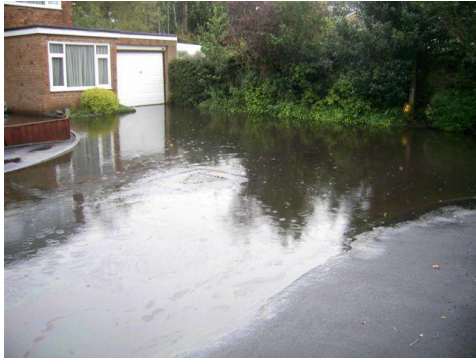
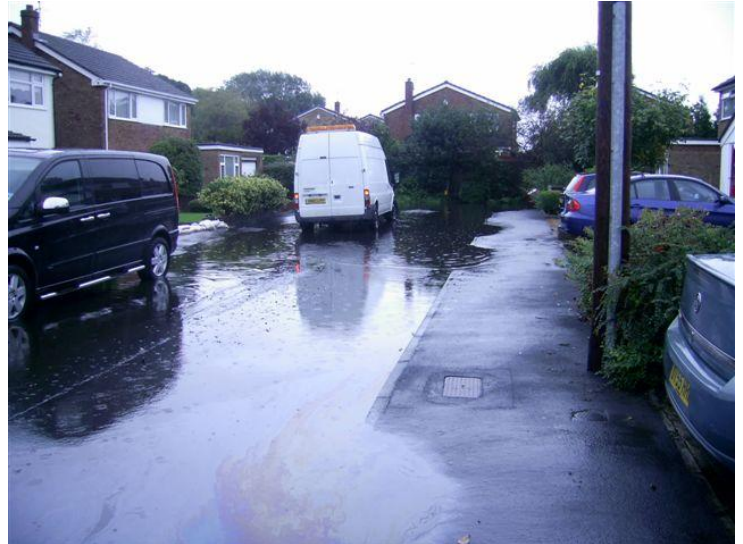
The first source was from the surface water system not being able to discharge into Eight Acre Brook due to high levels. The impact of this was that 4 properties were flooded and there was some minor damage to the highway around a gully.

The second source of flooding came from Eight Acre Brook overtopping the embankment close to the A565. This water pooled behind the defence and flowed along the footpath.

Figures 19 and 20: show the flooded area, both taken on the 25/09/2012

Number	Recommendation	Lead Risk Management Authority
1	Co-ordination of maintenance priorities and works between the Risk Management Authorities	Environment Agency
2	The level of the low spot in the embankment should be raised to the same level as the rest of the embankment.	Environment Agency
4	Investigate if there are flap valves/non return systems on the outfalls into Eight Acre Brook. And if not, consider the merit of installing them.	United Utilities

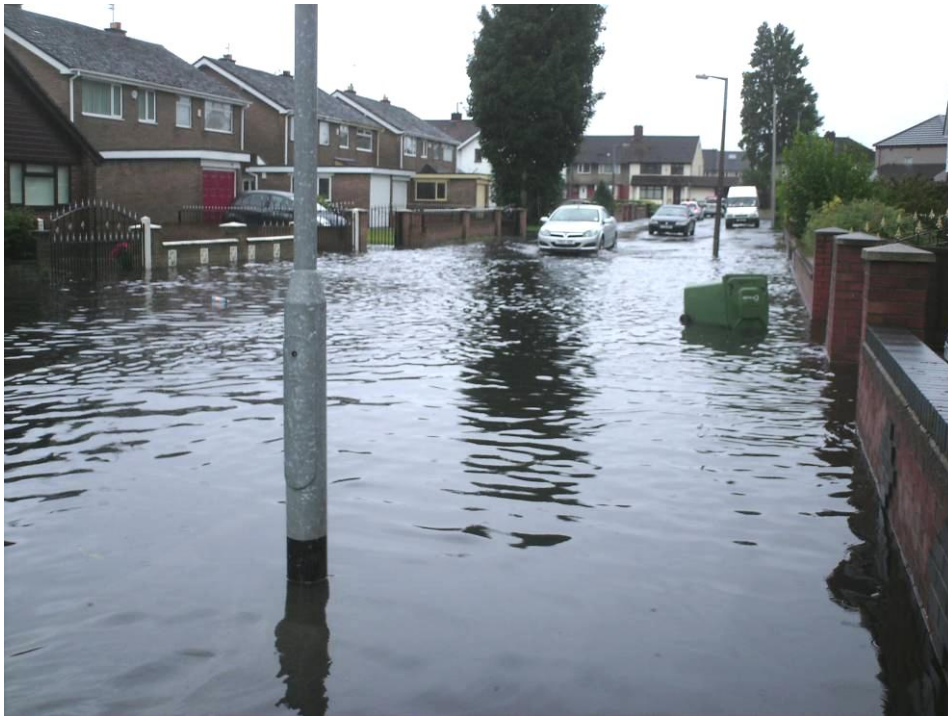
This area is prone to flooding and has a history of frequent flooding, this year alone Water Street has been inundated 4 times. The photograph below (figure 22) shows the extent of flooding on Water Street taken during an incident in July 2010.

Figures 22: showing the flooded area, taken in July 2010
