Section 19 Flood Investigation Liverpool Road North – Maghull 10/11th August 2020

Executive summary

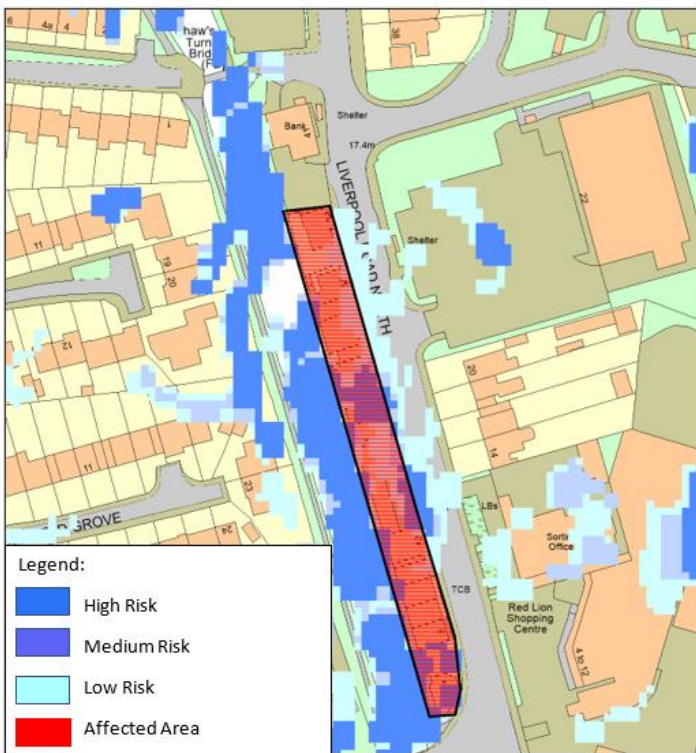
Figure 1 Surface water flood risk map for 1-39 Liverpool Road North

The surface water flood maps show that the area to the rear of the businesses (canal side) is at high risk and the highway is at medium risk with a few businesses at high and medium risk of flooding. The area that suffered from flooding is included on Figure 1. The surface water maps reflect the topography of the area as it is in a dip, as the opposite side of the road is higher and between Westway and the Red Lion Bridge all go down to the lowest point in front of the Number 15/17 .

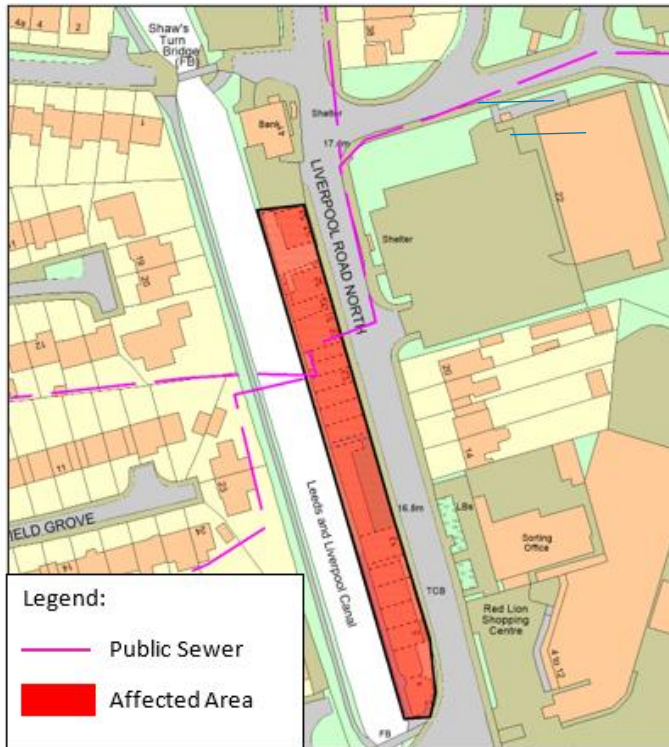
Figure 2 Drainage Network 1-39 Liverpool Road North.

The surface water public sewer drains an area between Westway and the Red Lion Bridge including Stafford Morton Way. Outside No.29 Liverpool Road North, the public sewer changes direction and flows towards the canal under the property. Behind No.25 the surface water sewer enters a combined sewer (foul and surface water) and there is a an overflow system and both systems go under the canal see Figure 2.

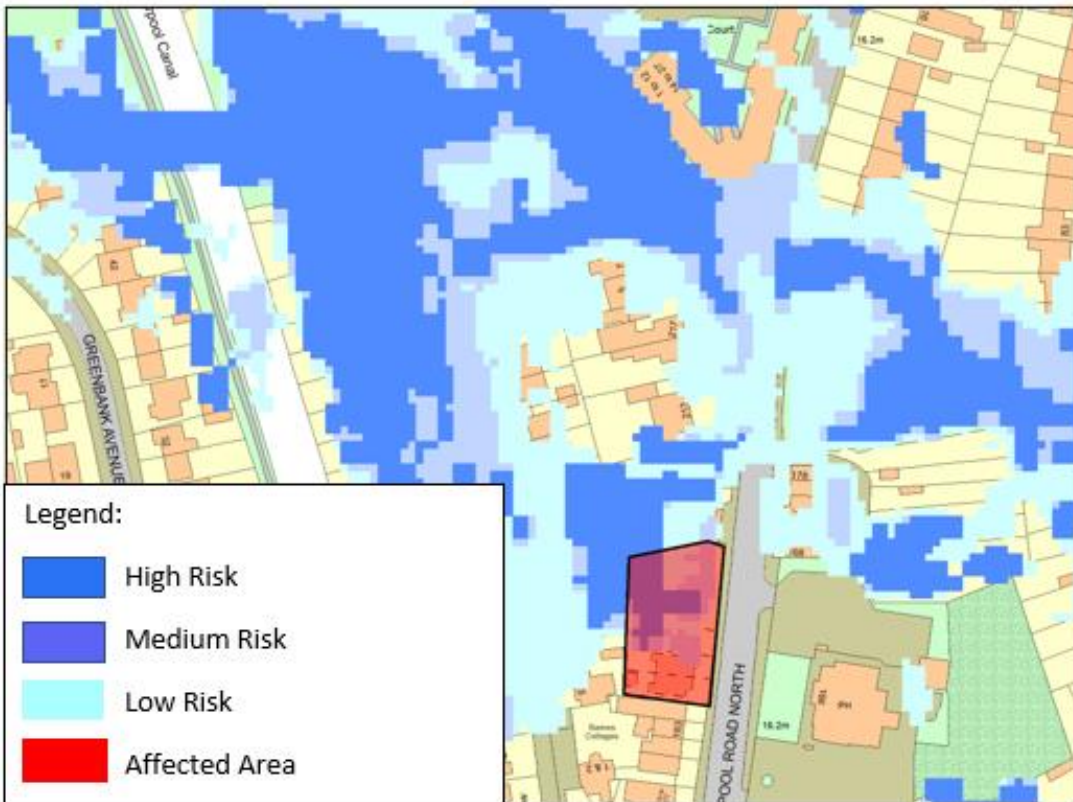
Figure 3 Surface water flood risk map 187-197 Liverpool Road North

The surface water flood maps (Figure 3) show that the area at highest risk is to the properties on Hickson Avenue. The map shows that the surface water flood risk to the properties on Liverpool Road North starts at No. 189 and is mainly low to medium risk running down the road to the junction with Liverpool Road. Again this surface water flood risk reflects the topography of the location with the lowest areas at highest risk. The area that suffered from flooding is included on Figure 3.

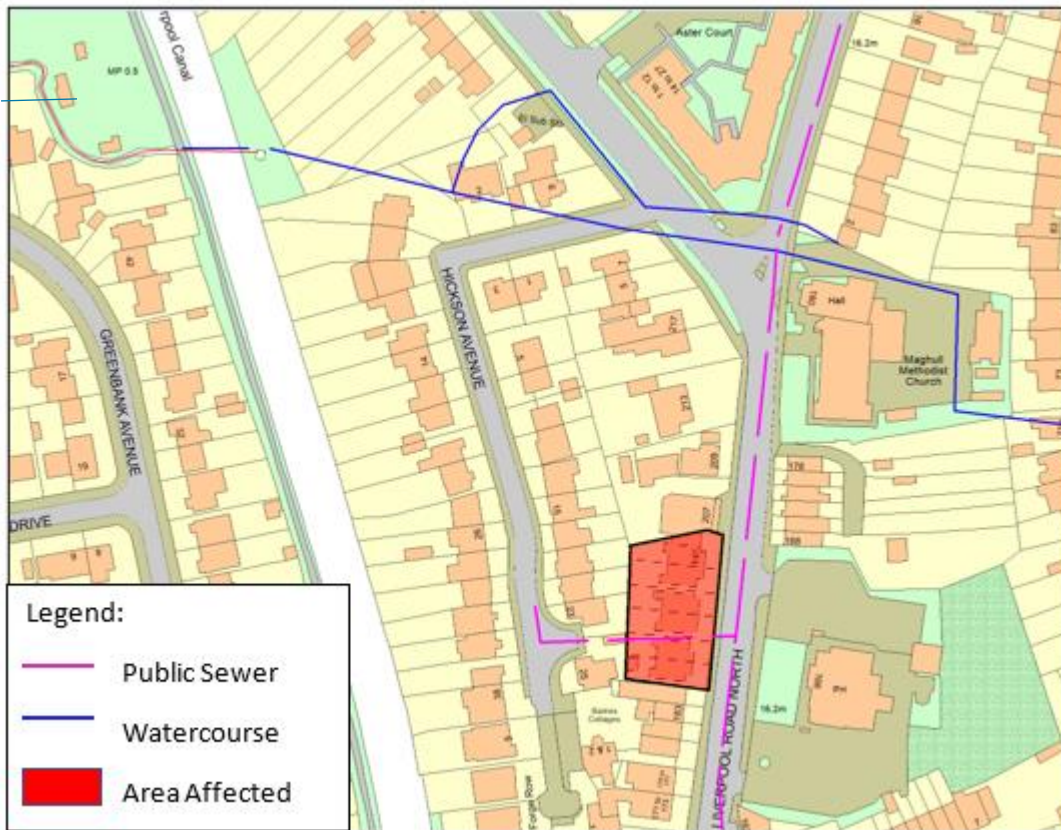
Figure 4 Drainage network 187-197 Liverpool Road North

The system that drains the area that flooded, between Green Lane and Southport Road, stretches from Westway to Nedens Lane with over 75 highway gullies. The surface water system starts as a highway drain flowing from Westway and becomes a public sewer where water from Granville Avenue enters it. At the junction of Southport Road, Liverpool Road North and Liverpool Road, the surface water sewers, draining the area, flow into a watercourse (Maghull Brook) and from there crosses under the canal. Figure 4

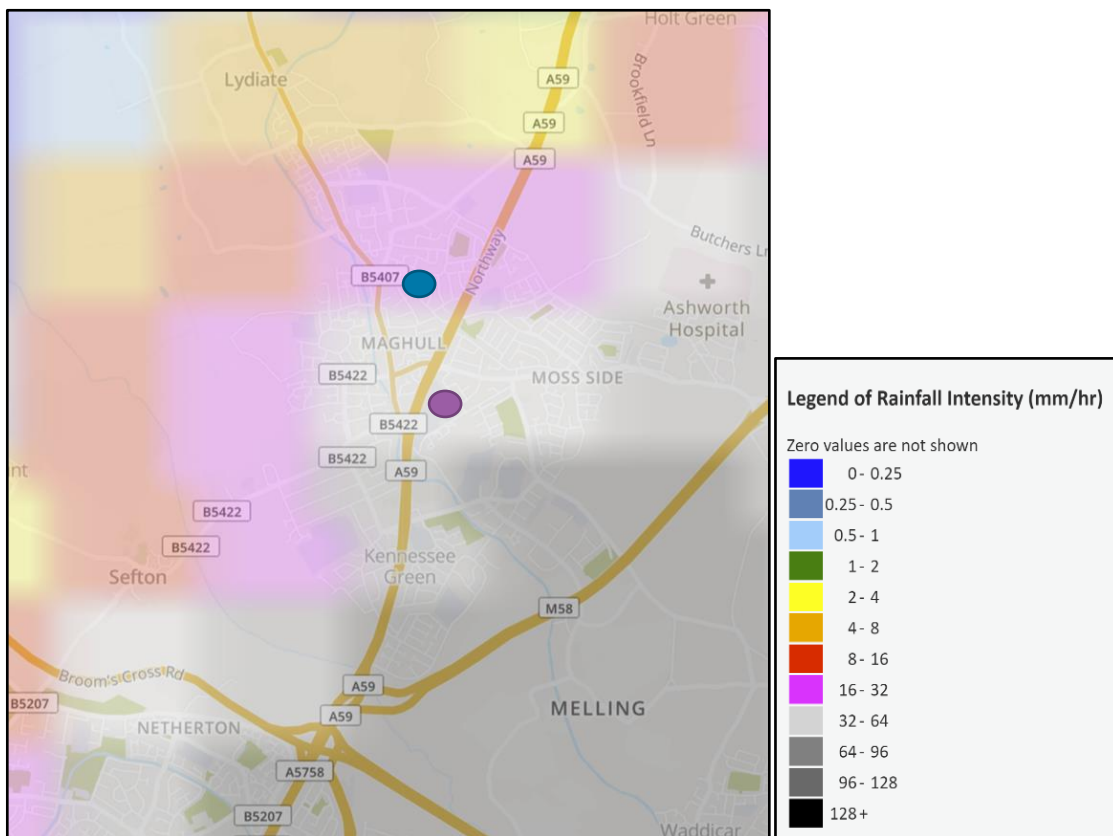
Figure 5 Rainfall radar (Source: Meniscus MapRain software) at 23:15 hrs. with legend

The storm was moving fast over the area in a northerly direction, affecting the southern site 1 -39 Liverpool Road first with light rainfall (2 – 4mm/hr) starting at approximately 23.00, but increasing intensity within 10 mins to between 32 – 64 mm/hr, seen in figure 5.

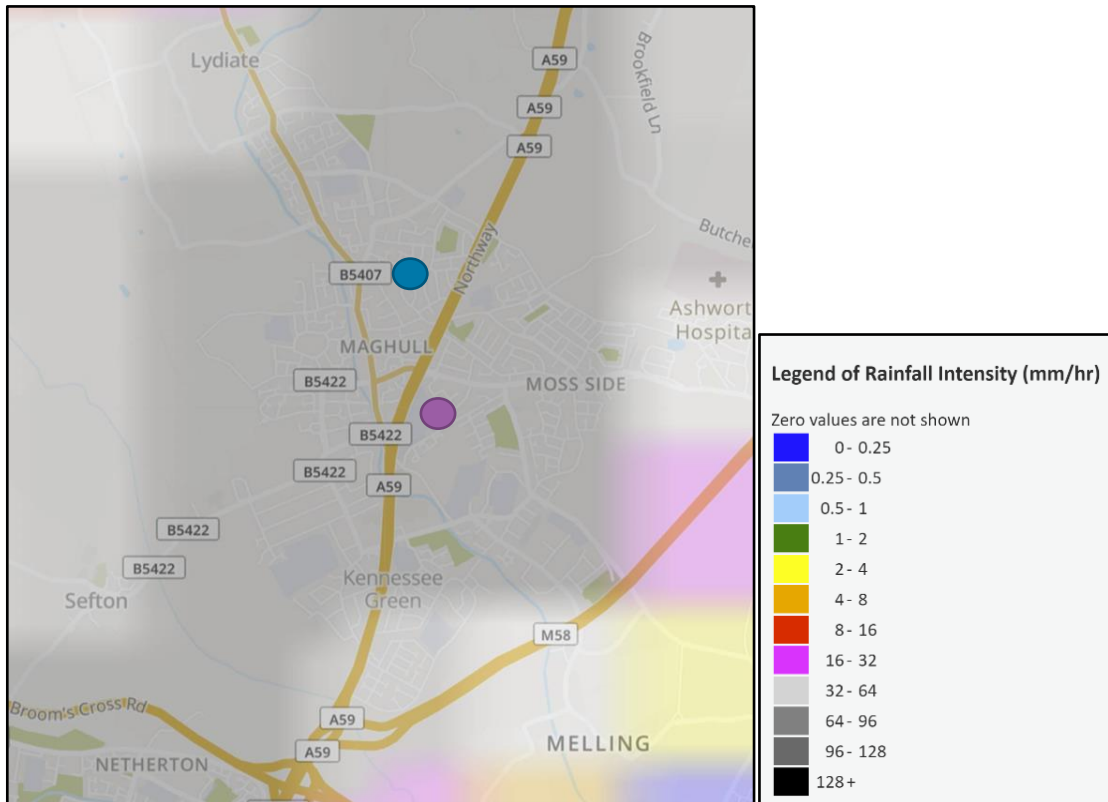
Figure 6 Rainfall radar (Source: Meniscus MapRain software) at 23:20 hrs. with legend

The radar picture (figure 6) at 23:20 shows the rainfall affecting the area to be between 64 - 96mm/hr. Again, this intense rainfall moves over the area fast and within 5 mins the rain fall intensity eases to 16-32 mm/hr, but this is still a significant amount of rainfall. The rainfall carried on affecting the area, at different intensities until 03.05hrs on the 11th August.

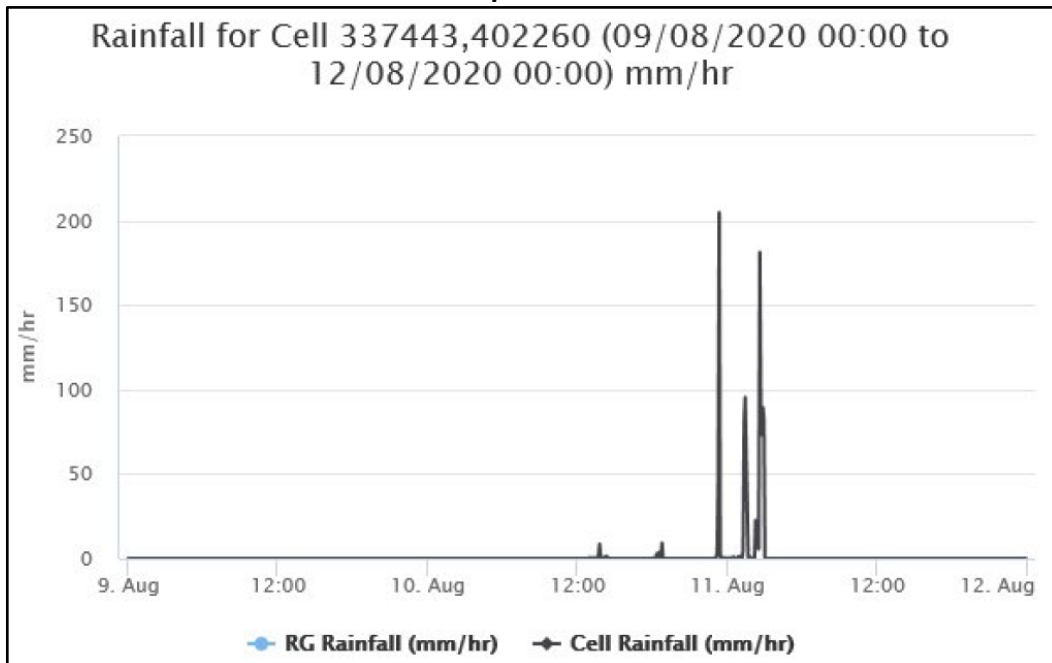
Figure 7 Rainfall amounts mm/hr. for 1 – 39 Liverpool Road North

The return period calculated for 1-39 Liverpool Road North is 24.20, which translates into a 4% chance of this type of rainfall occurring in any one year. Whilst the return period for 187-197 Liverpool Road North is calculated at 30.57 or just over a 3% chance of this type of rainfall occurring in any one year.

Start of peak rainfall	10/08/2020	23:15 hrs
End of peak rainfall	10/08/2020	23:30 hrs
Duration (mins)		15
Rainfall depth (mm)		20.95
*FEH **return period		24.20

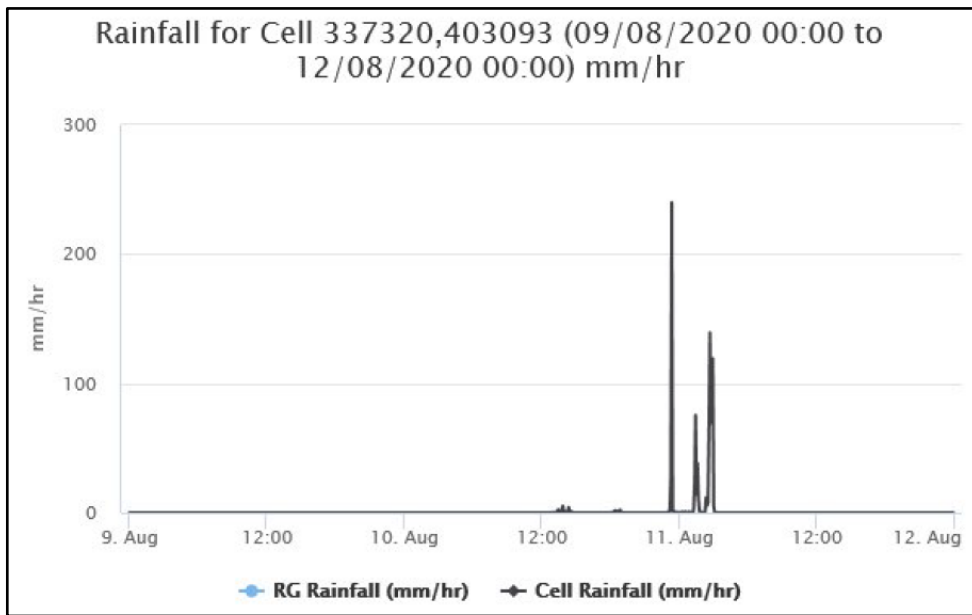
Figure 8 Rainfall amounts mm/hr. for 187 - 197 Liverpool Road North

Start	10/08/2020	23:15 hrs
End	10/08/2020	23:30 hrs
Duration (mins)		15
Rainfall depth (mm)		22.33
FEH return period		30.57

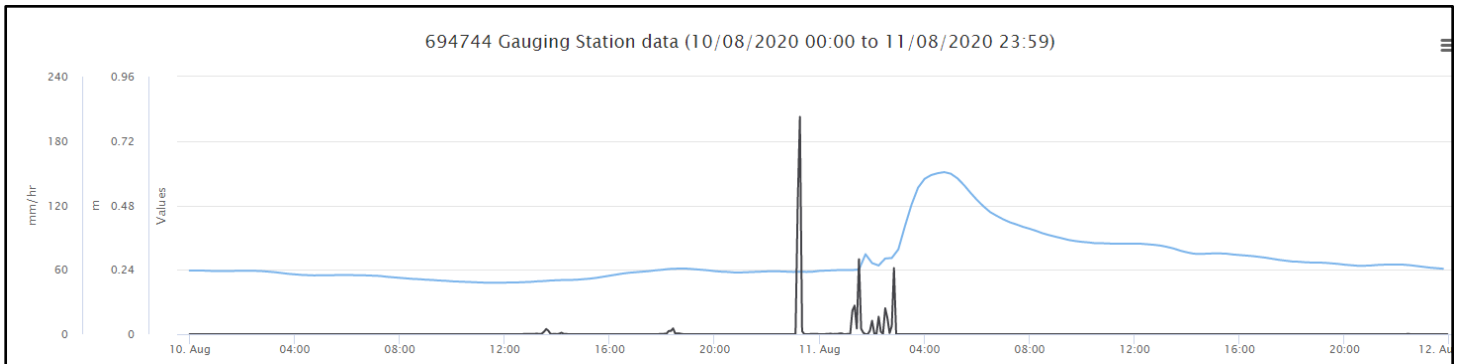
Figure 9 Rainfall and river gauge levels for the River Alt

The flooding was not related to watercourses, however, it is interesting to note that the rainfall event was significant enough to raise the river levels in both the River Alt by 37cm (Figure 10) and Dovers Brook by 80cm (Figure 11).
