# Flood Investigation Report

Fouracres (Maghull), Sefton Lane (Maghull),  
Hawksworth Drive (Formby), Water, Street (Thornton)  
and Moss Lane (Lydiate)

Date of flooding: 24/09/2012

Version 1.2  
November 2012

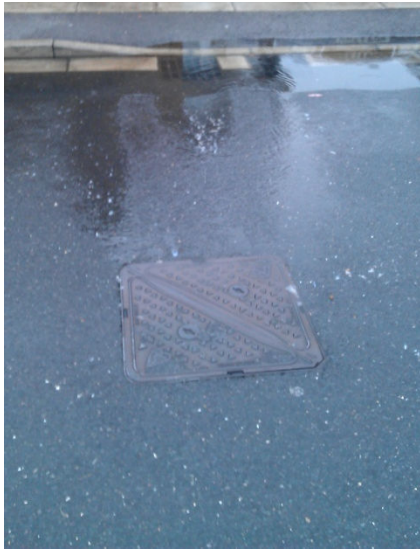
There was foul water flooding to at least 3 properties along The Crescent. Some foul water escaped through the manhole (see Picture 1) in the road but the majority of it came from the manholes in the residence gardens and from the side drain that takes water from the kitchen.

*Figure 4: Toilet type debris emanating from a drain in the road*

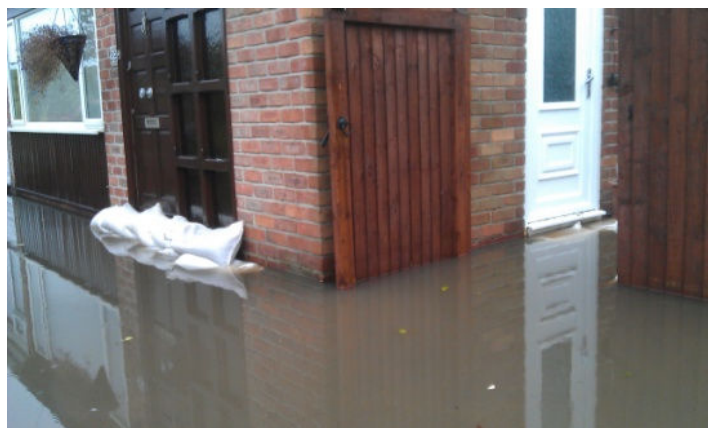
Along Fouracres itself approximately 40 properties were affected by flood water with 24 properties being internally affected. The road itself was not affected by the flood water as it is higher than the properties.

*Figure 6: Illustrating the level of flooding around houses in Fouracres*

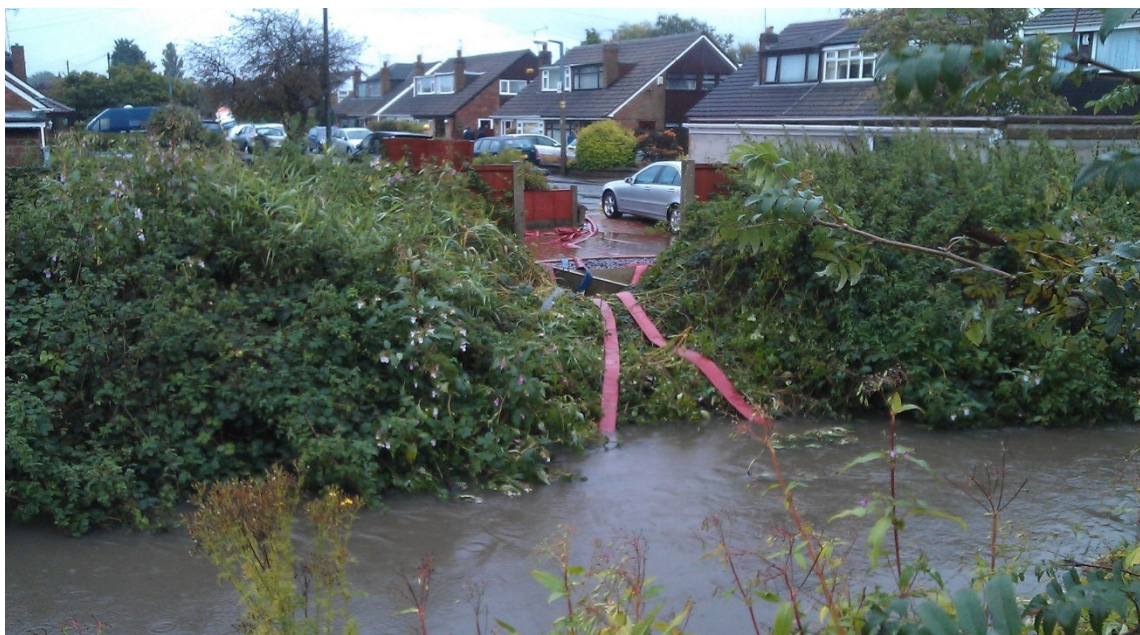
There was a suggestion that the cause of the flooding was that Dover's Brook had breached its bank, subsequent inspection by the Environment Agency has found no evidence of a breach or overtopping on either Dover's or Whinny Brook. As can be seen in the picture below of Whinny Brook (looking towards the head of Fouracres), the levels in the Brook were high but did not reach its full the capacity.

*Figure 7: Illustrating the height of water in Whinny Brook (looking towards Fouracres)*

Dover's Brook, and Whinny Brook were already scheduled for maintenance and this is planned to be completed during this financial year. The Environment Agency will also have completed their Lunt Meadows scheme by the end of the financial year; it was partially operational at the time of the flooding but when fully operational will be able to take a greater amount of water from the system and store it until there is capacity for it to drain away.

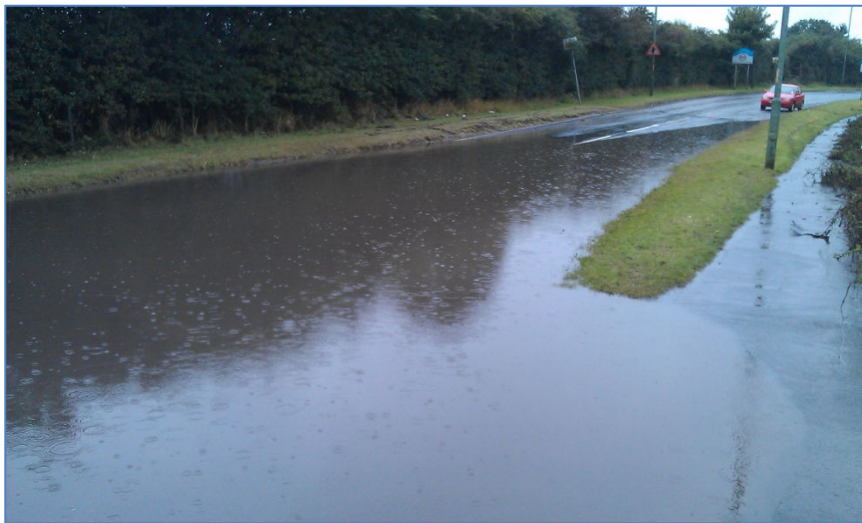
The first source (*A, figure 11*), was from the surface water system not being able to discharge into Dover's Brook or the River Alt due to high river levels.

The first area of flooding, travelling from Sefton village towards Maghull, was a 60m stretch between the village and the bridge over the River Alt. Rainwater had come off the field on the north side and pooled in the dip and inundated the road to approximately 15cms deep.

*Figure 11: Bridges Lane, area A, taken 25/09/2012*

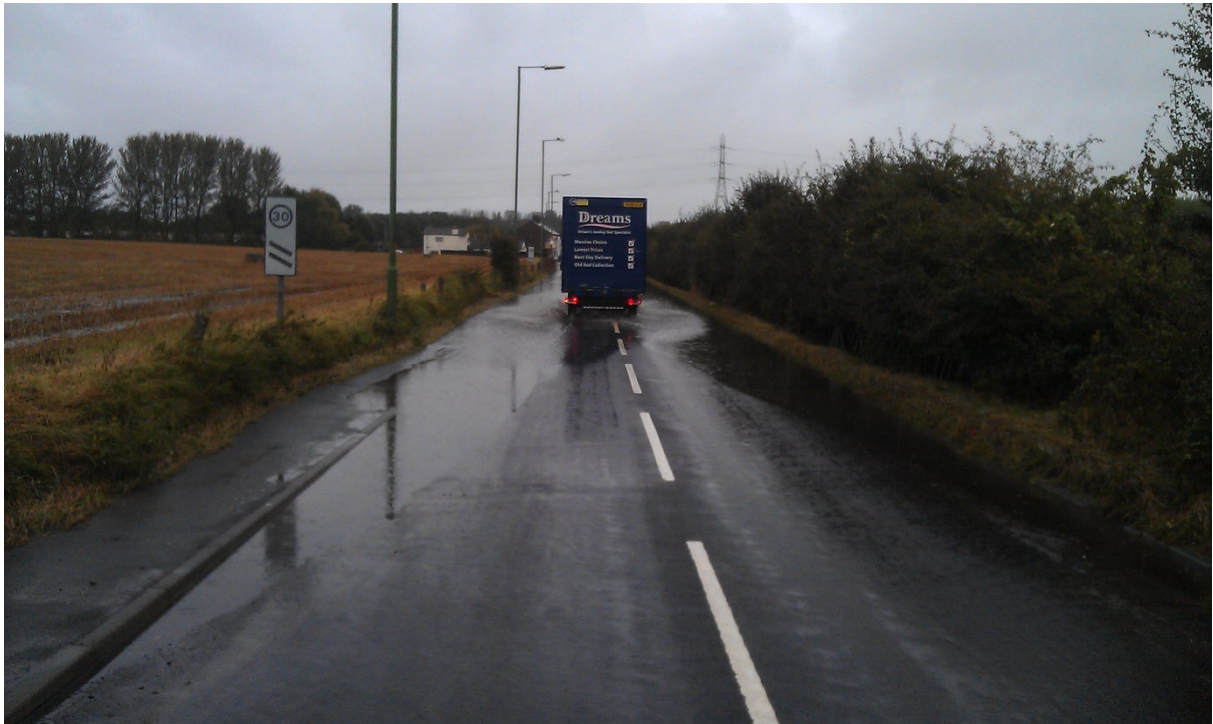
The second stretch (B, Figure 13 and figure 14), of highway flooding was between the bridges over the River Alt and Dover's Brook to a depth of approximately 15 cms.

Figure 13: Bridges Lane, area B, taken 25/09/2012

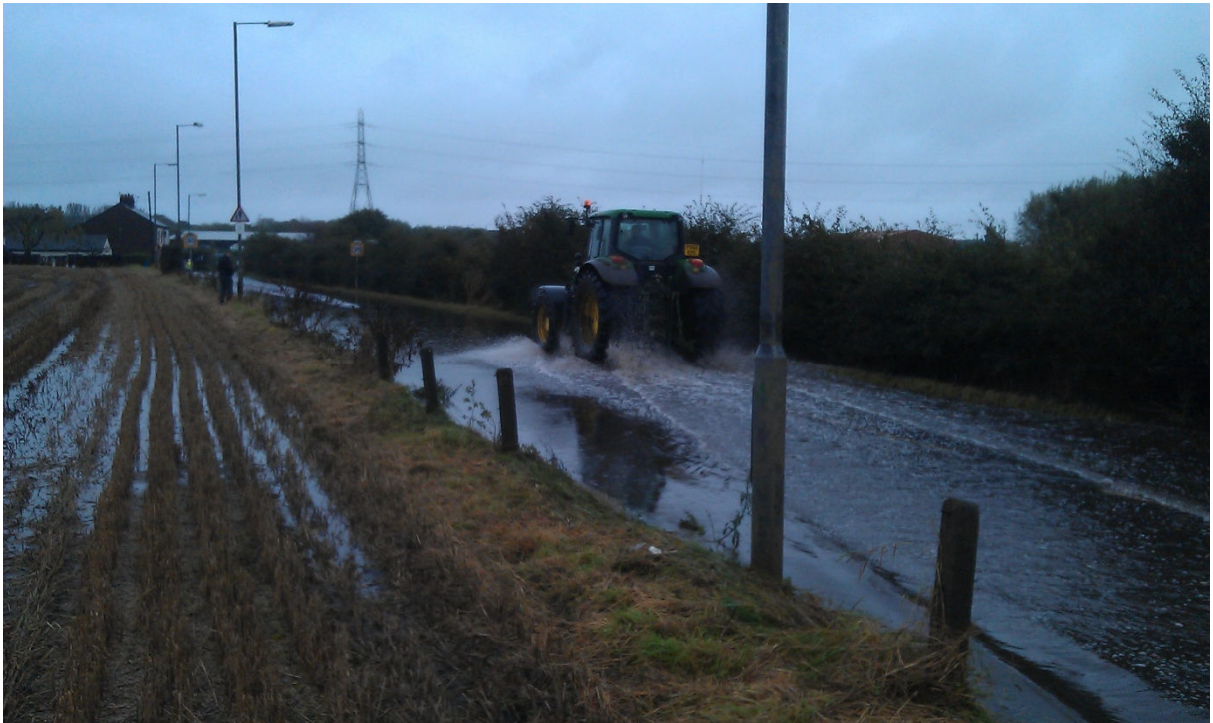
Figure 14: Bridges Lane, area B, taken 25/09/2012

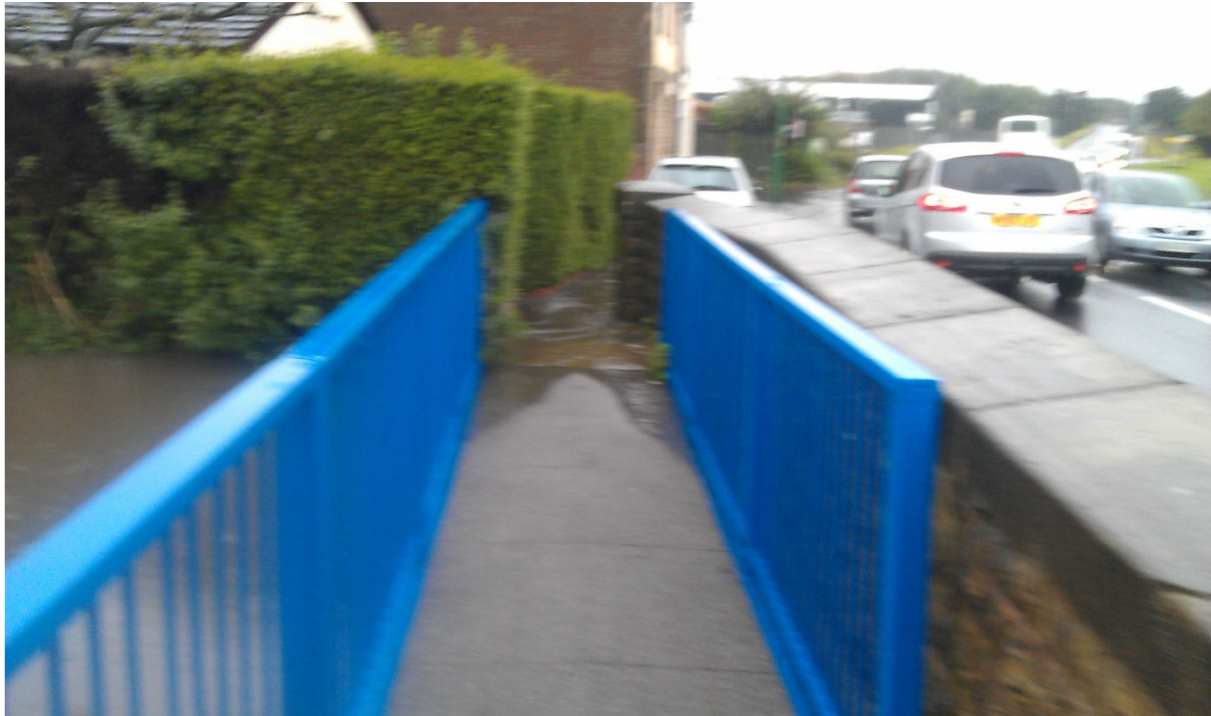
The final area of flooding (C, Figure 15), was on Sefton Lane between Dover's Brook bridge and the Cheshire Lines Bridge. There was some surface water

flooding at this site as the highway drain on the opposite side of the road was “tide” locked by the river level on Dover’s Brook.

However, the major source of flooding was from Dover’s Brook overtopping the embankment at a low spot close to Dover’s Bridge, as can be seen in the photograph below (Figure 15). The water flowed along the footpath into the highway and joined up with the surface water flooding, forming a pool across the road, approximately 12cm deep. Some water flowed along the road towards the waste recycling centre and pooled at the entrance, and some water flowed around the backs of the properties on Sefton Lane damaging outbuildings, a caravan and ingressed into at least 1 property.

*Figure 15: Dover’s Brook flooding into Sefton Lane, taken 24/09/2012*

The other source of flooding was again caused by high river levels in Dover’s Brook. The water level rose to a sufficient height that it was able to overtop the flood embankment at a low point close to the footbridge.

<b>Number</b>	<b>Recommendation</b>	<b>Lead Risk Management Authority</b>
1	Investigate installing flap valves/non return systems on the outfalls that discharge into Dover's Brook and the River Alt.	Sefton MBC
2	Environment Agency should engage in further discussions with the riparian owner at Dover's Bridge about raising the embankment, to raise the low point	Environment Agency

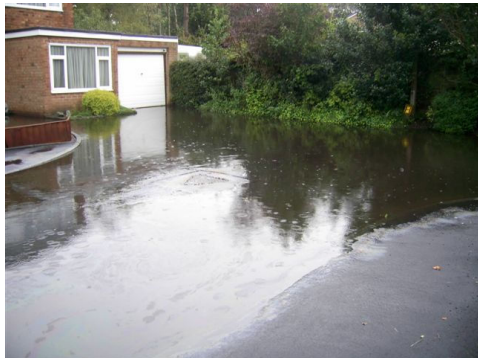
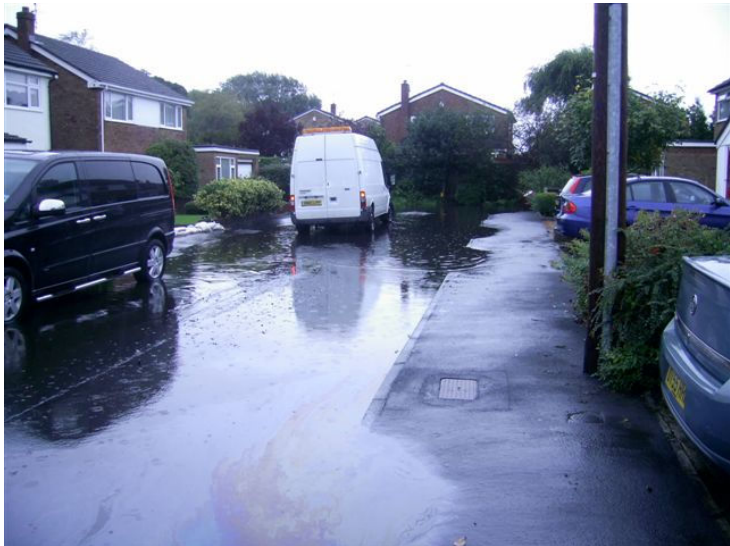
*Figures 19 and 20: show the flooded area, both taken on the 25/09/2012*

The probable cause was that Eight Acre Brook was high, due to the significant amount of rainfall, which "tide" locked the highway drainage system which in turn was unable to discharge. Once the pipes had reached their capacity the water started to flow from the gullies into the highway, the water then pooled and found a low point in the pavement line and flowed down into the properties. It is not known by the Council at this time as to whether there are flap valves on the outfalls here, further investigation is required.

The flooding along the footpath was again caused by high river levels in Eight Acre Brook. The water level rose to a sufficient height that it was able to overtop the flood embankment at a low point close to the culvert under the A565.

Number	Recommendation	Lead Risk Management Authority
1	Co-ordination of maintenance priorities and works between the Risk Management Authorities	Environment Agency
2	The level of the low spot in the embankment should be raised to the same level as the rest of the embankment.	Environment Agency
4	Investigate if there are flap valves/non return systems on the outfalls into Eight Acre Brook. And if not, consider the merit of installing them.	United Utilities

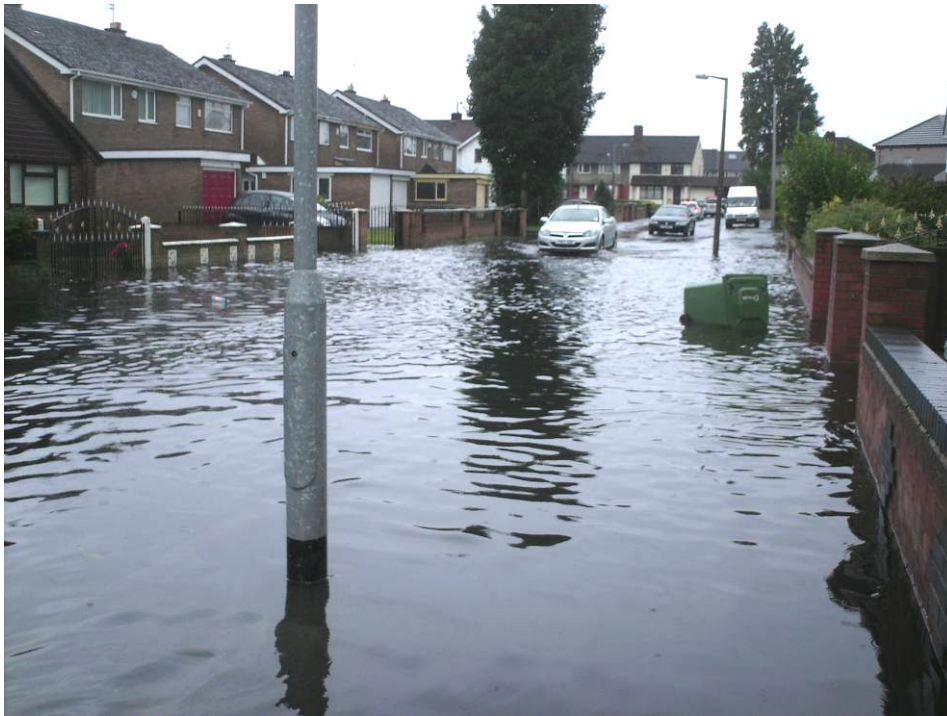
This area is prone to flooding and has a history of frequent flooding, this year alone Water Street has been inundated 4 times. The photograph below (figure 22) shows the extent of flooding on Water Street taken during an incident in July 2010.

*Figures 22: showing the flooded area, taken in July 2010*

Number	Recommendation	Lead Risk Management Authority
1	The Council will continue to work towards a solution that remedies defects (including the collapsed pipe) and increases capacity for this area within financial constraints.	Sefton MBC
