Christ Church

Conservation Area Appraisal
Adopted April 2016

This Conservation Area Appraisal was prepared by Sefton Council in 2015 and amended following public consultation between January and March 2016 and was adopted by Sefton Council on 27th April 2016

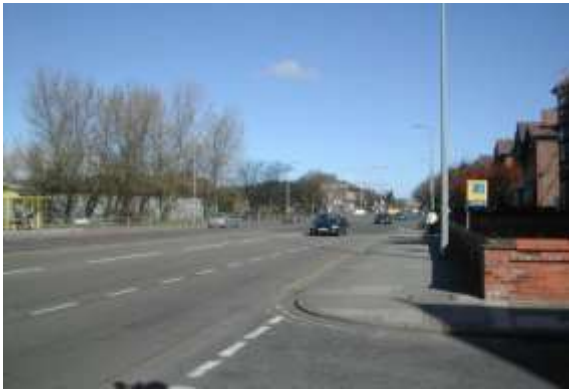
CR1: Crosby Road South looking north

However, the scale of the properties which line Crosby Road South is not disproportionate to the width of the road, and, despite some modern development which has slightly eroded the western side, this approach is still redolent of Victorian grandeur.

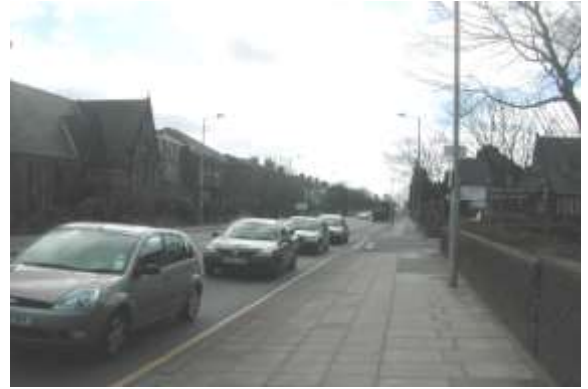
CR4: Crosby Road South looking south

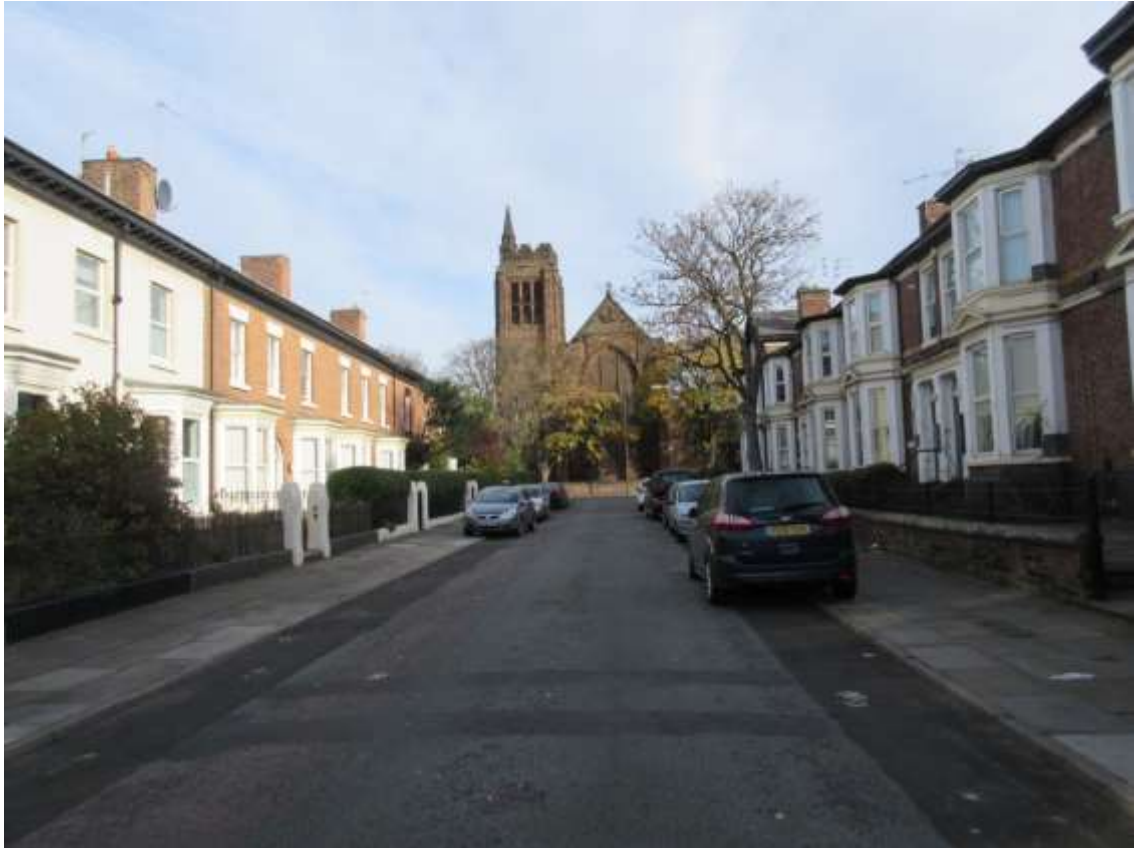
BRP3. View of Christ Church as seen along Stanley Road.

This view not only captures the intimacy which characterises the tertiary routes but also the dominance of the Church itself.

The houses on both sides of Stanley Road form a pleasant street scene. This is of particular interest as these houses flank an important view of Christ Church (see Section 4.0) and provide a pleasant and interesting row of properties.

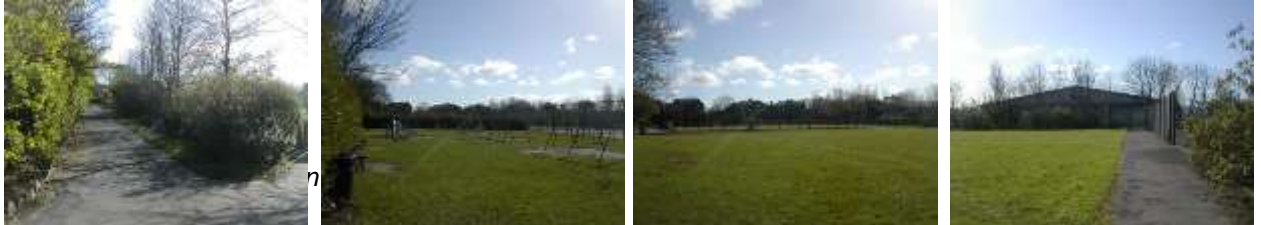
1. The largest and most positive is the Potters Barn Recreation Ground. The land was acquired by the Waterloo-with-Seaforth UDC in 1903 and is now owned by Peel Ports and leased to Sefton Council. A designated recreational green space, the footpath layout remains much as it was designed and as it appears on the Ordnance Survey Map of 1908.

Today it not only continues to provide an appropriate setting to the Potters Barn, but also acts as a buffer between the historic Christ Church area and the industrial dockland beyond.

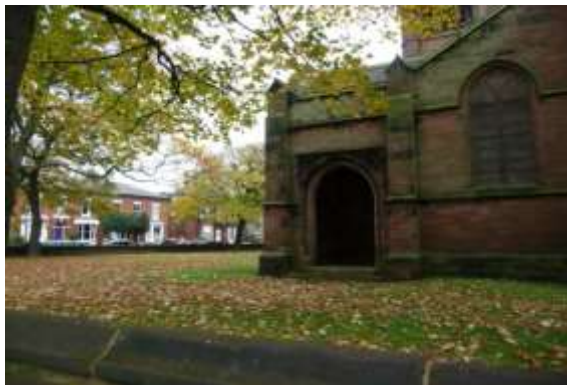
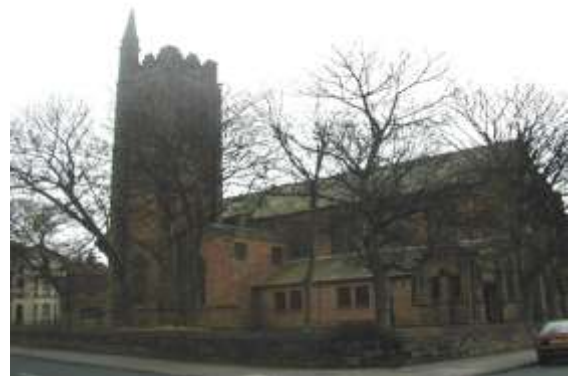
2. The second most notable green space is the area around Christ Church itself. The grass and mature trees complement the building and contribute greenery to the street scene as a whole. It is protected by a specific Tree Preservation Order.

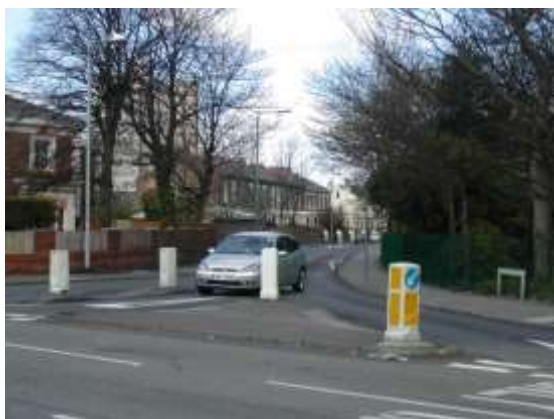
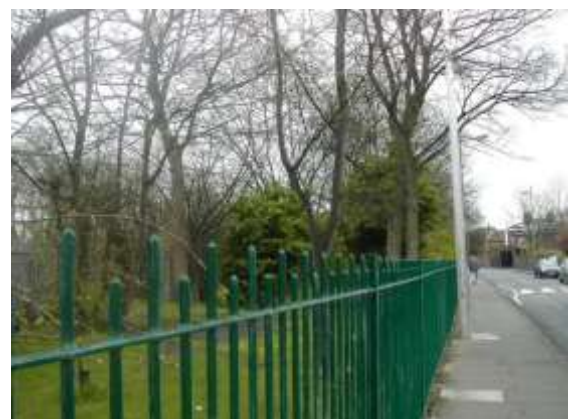
3. The strip of greenery on Walmer Road acts as a buffer zone between the houses and the railway line and also helps to conceal the modern building situated there. This planting, together with the slight curve of the road, give Walmer Road a slightly calmer and slower feel, in contrast with the other much straighter roads within the area. The green space is protected by a specific Tree Preservation Order.

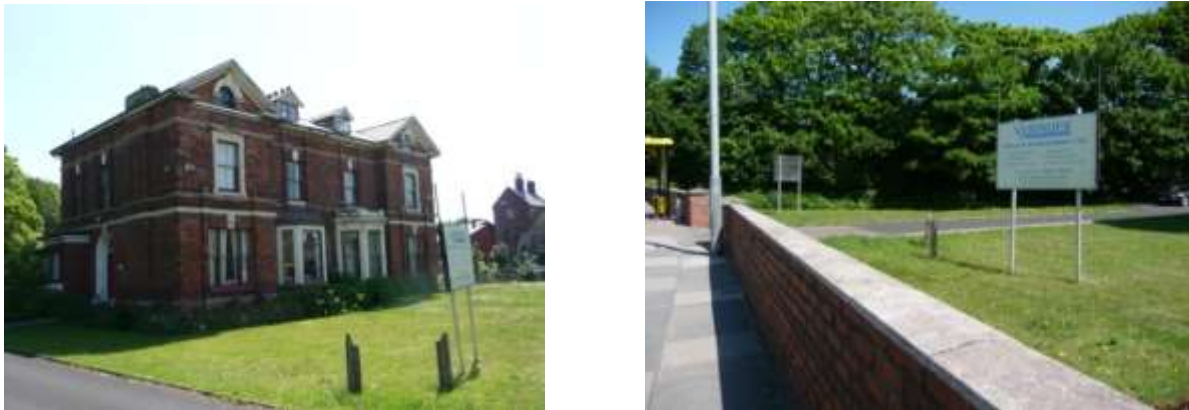
4. The final notable area of greenspace is the area within the curtilage of 1-3 Crosby Road South. The grass and mature trees presents a pleasant setting for the Victorian villa. The line of mature trees along the boundary with the railway complements the building and streetscene as a whole.

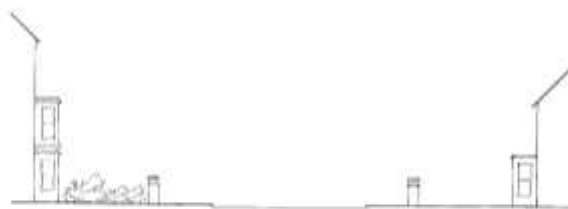
1: Section through Crosby Road South

Section No 1 - Crosby Road South

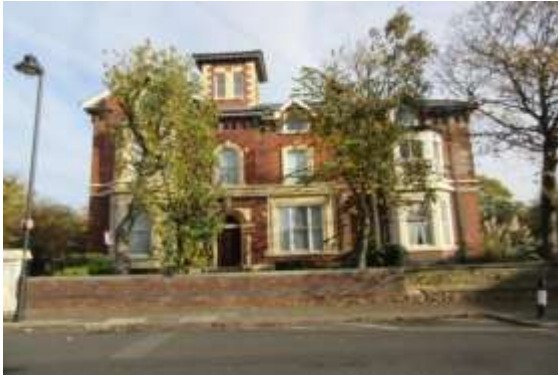
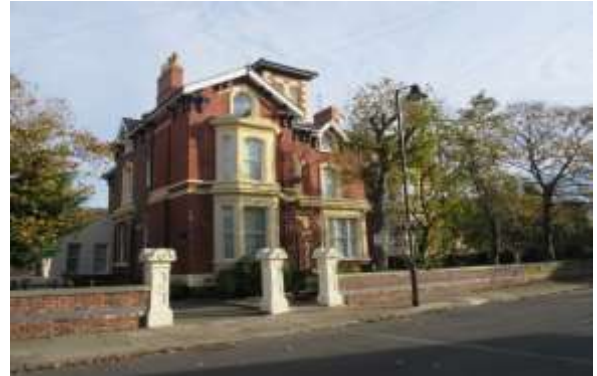
Elevation of 11 Cambridge Road and its other half... 23 Waterloo Road

A special feature of this zone is the semi-detached houses on corner plots which have been designed to read as single villas from each road (see section 5.1.4). No specific reference to these properties has been found with regard to their design, and further research is therefore required. Whilst this approach to design is not uncommon in the 19th century (and examples are to be found in pattern books of that time), these types of property usually occur in more planned developments.

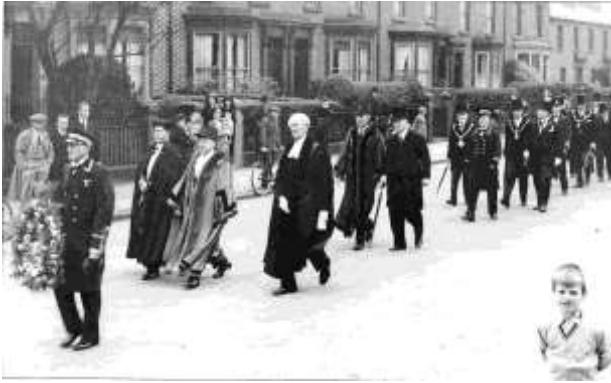
3. 12-32 Waterloo Road

The patterned brickwork of these houses sets them apart from others within the area, providing a distinctive feature to the street scene

1937 Waterloo Road: Crosby Charter celebrations
Photograph courtesy of Information Services Dept,
Sefton Libraries

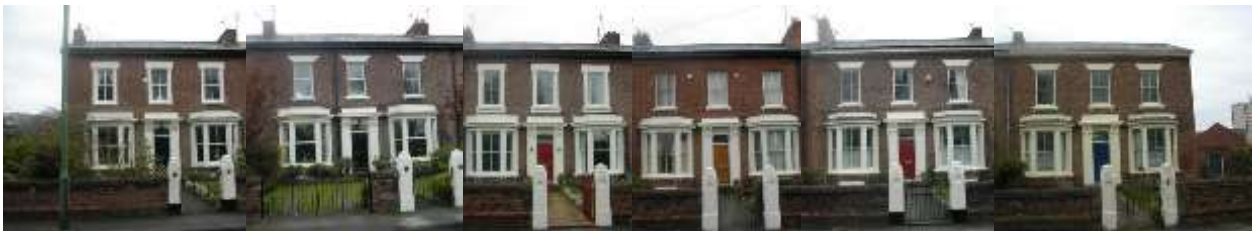
4. 16-26 Walmer Road

The quality, regularity and rhythm of these properties combine with their set-back position to form a strong frontage to the street.

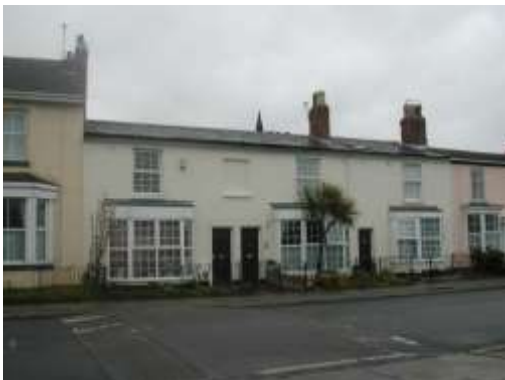
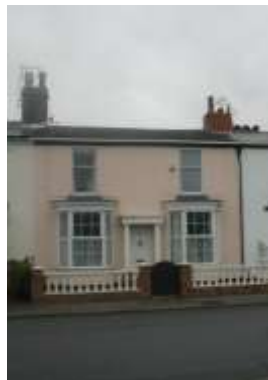
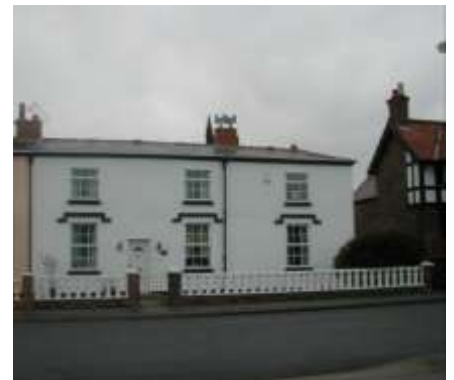
5. 6-13 Brunswick Parade

Although severely compromised, these smaller-scale older cottages are particularly distinctive as they are disproportionate to the grand width of the street.

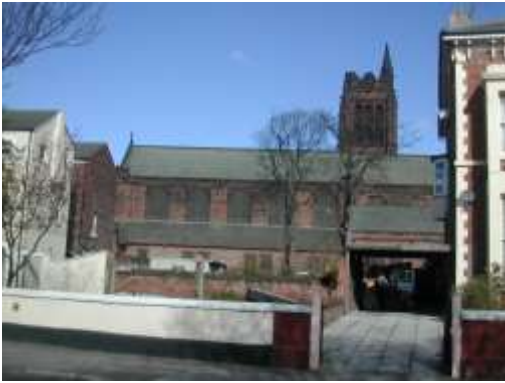
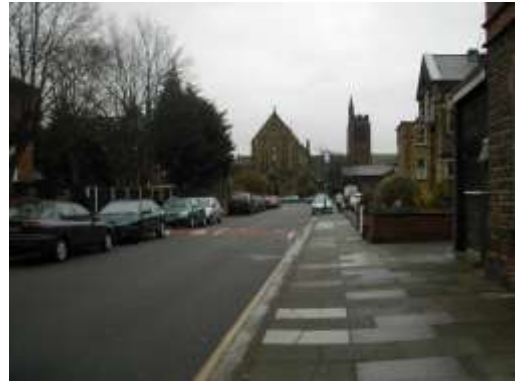
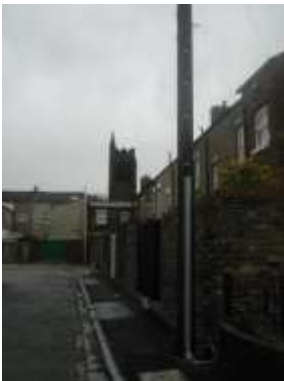
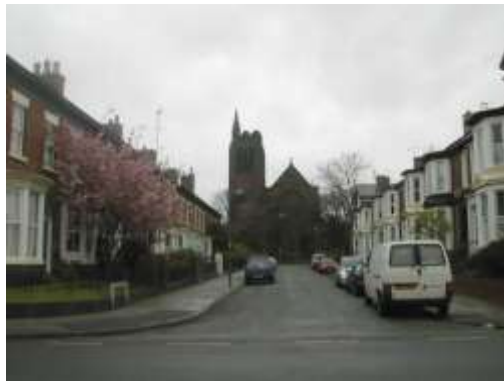
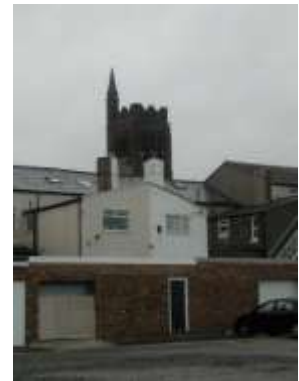
1. Parish Church of Christ Church

Designed by H. J. Austin (of Austin and Paley), following a competition won by Birkett and Langham. Christ Church was built in 1899 to replace an earlier church. This red sandstone church is the largest building in the Conservation Area. Its tower is visible for some considerable distance around the area. Its presence is evident throughout the area, but most notably from Stanley Road, where the houses either side frame the view perfectly.

View of the tower as seen from Church Rd

View of Christ Church along Stanley Road

The Christ Church Tower is reputed to have been used as a landmark by ships entering the Mersey. The Church was listed in 1952 and is grade II*. The church is currently used for various activities through the Friends of Christ Church.

Pevsner describes it as "an outstanding design. Red stone, with a mighty N tower with strongly displayed higher stair-turret. The features of the church not all Perpendicular, but with free tracery details". He notes that, internally, the "most surprising and prominent member is a tremendous inner buttress for the tower treated in a way Lutyens would have done later". Although the building is in a good condition generally, there is deterioration to the tower caused by the salty sea air and wind has taken its toll on the majestic pink sandstone tower. As a result, the Grade II* listed church has been added to Historic England's Heritage at Risk register, and the Churches Conservation Trust (CCT) has launched a nationwide public appeal to save the historic landmark.

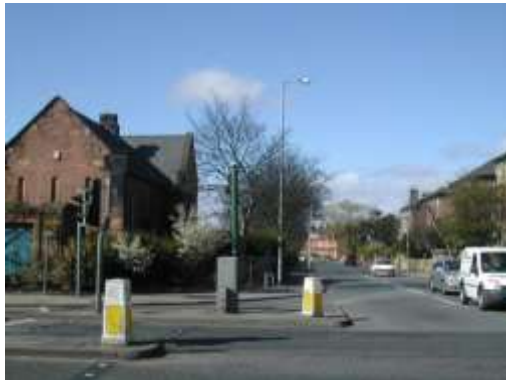
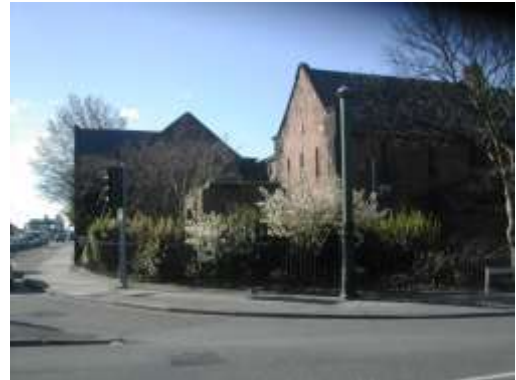
2. Potters Barn

Although a small scale building, the location of the Potters Barn (at the junction of Cambridge Road and Crosby Road South) gives it landmark status. It is a particularly useful reference point for those travelling the length of Crosby Road South, though the buildings are most visible for those heading south. It is the focus of views from Cambridge Road, although the highways paraphernalia and electricity sub-station seriously impair this view.

Potters Barn was listed grade II in 1973 and previously used by a Friend's group but now is largely vacant. It is owned by Peel Ports and leased to the Council. It is currently in a poor condition, although the openings have been made secure, there are issues with the condition of part of the general fabric, which are currently being addressed. It is an identified 'Building at Risk'.

The majority of the buildings within the Conservation Area appear to be occupied and therefore dereliction is not prevalent. However, the Potters Barn is currently unused and is registered as a 'Building at Risk'. Works are currently being secured to make the building safe, wind and watertight to arrest further deterioration. It is likely that the smaller properties are in single family occupancy and these are generally well-maintained. Larger properties are generally in multiple occupancy, either as flats or nursing homes. Both uses have resulted in some alterations and condition is variable. Number 9, Cambridge Road (at the junction with Waterloo Road) has been refurbished since this appraisal was adopted in 2005.

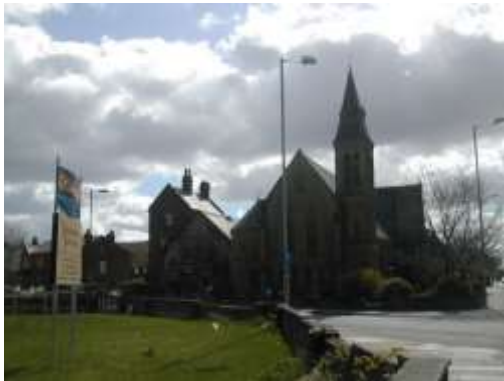
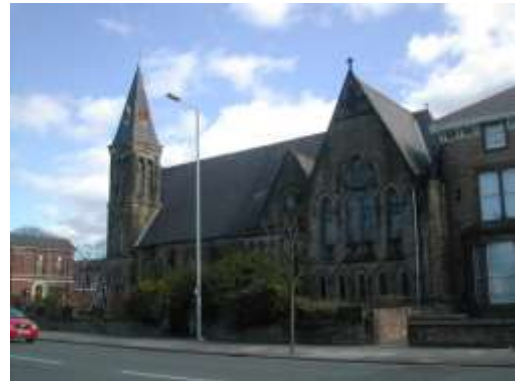
3. Welsh Presbyterian Church

The Welsh Presbyterian Church is distinctive in its contrast to the neighbouring houses. Its position, at the junction of Crosby Road South and Sandringham Road, is exposed when approached from the north due

to the acute angle at which Sandringham Road is set. The building has planning permission for conversion into flats and these works are underway at the writing of this report. The photos below were taken prior to the work commencing.

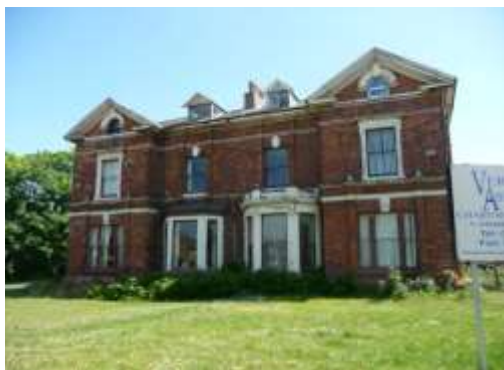
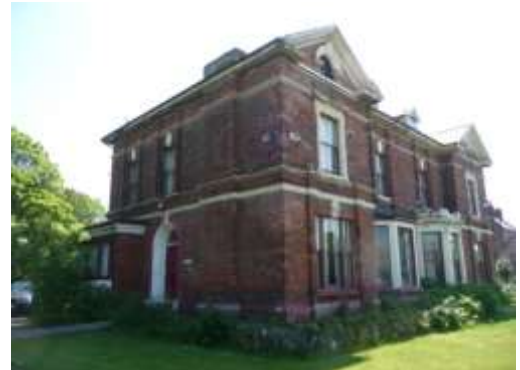
4. 1-3 Crosby Road South

This pair of semi-detached houses sits adjacent to the Welsh Presbyterian Church, but on the opposite corner of the Sandringham Road junction. They, too, present a distinct contrast to the other houses which line Crosby Road South. They have pedimented gables to wings which are pulled forward and 3-storeys expressed by attic windows and dormers. Without front garden shrubbery to obscure views, these properties are very exposed and constitute a dominant feature. The setting of this building is important as is the large plot and area of greenspace it sits within. These two properties are in a poor state of repair and lack of maintenance which is considered to have a negative impact on the amenity of the area.

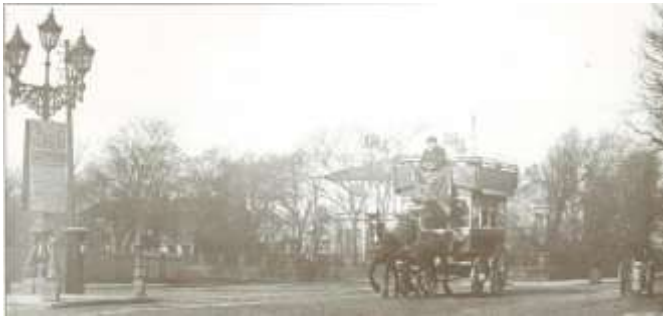
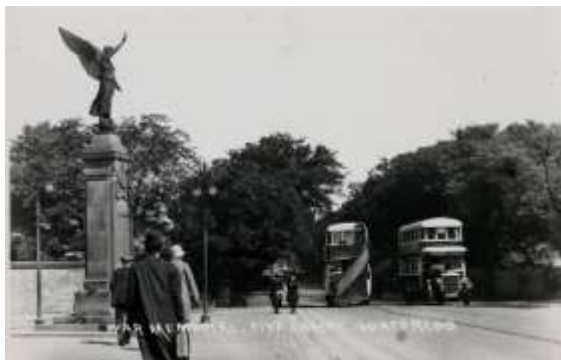
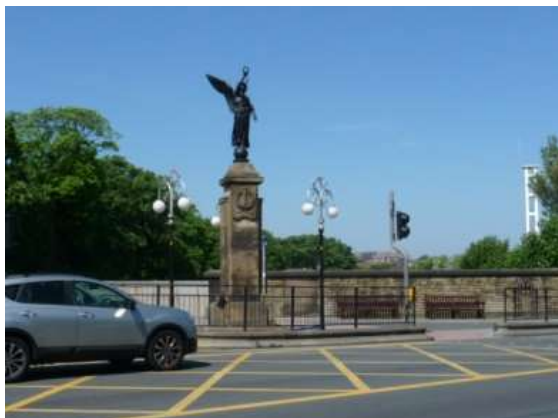
5. Five Lamps War Memorial

The sandstone and bronze monument is a prominent feature on Crosby Road South. Despite the clutter of traffic lights which have been added at this busy junction, and the later 'Five Lamps' which were subsequently re-arranged around the memorial, the sculpture stands out against the sky on its slender plinth. The memorial and lamps are listed grade II.

*The original Five Lamps late 19th Century
Photograph courtesy of Information Services,
Sefton Libraries*

*The War Memorial with new Five Lamps around it (c1926)
Photograph courtesy of Information Services, Sefton
Libraries*

The War Memorial today

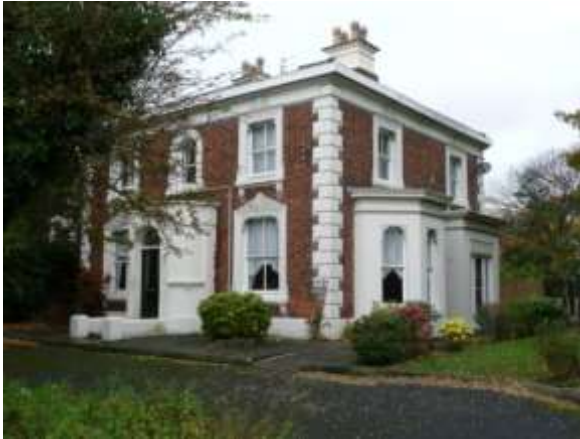
37 Great Georges Road

Turning from Crosby Road South into Great Georges Road, this house is a prominent feature. Set in a corner plot, its side elevation to Walmer Road

is as carefully considered as its frontage on to Great Georges Road. The introduction of a modern boundary with timber fence somewhat detracts from its setting.

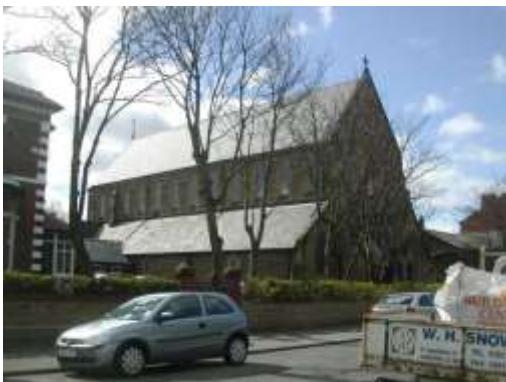
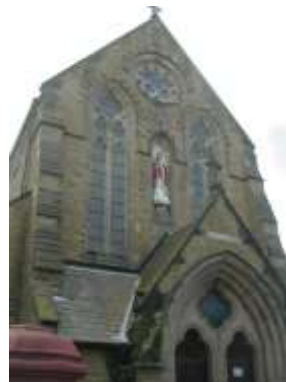
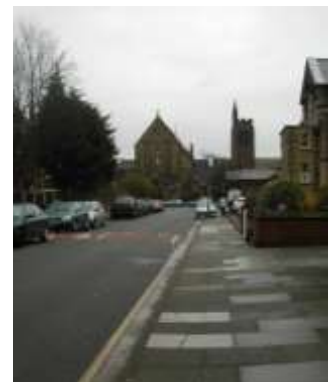
7. RC Church of St Thomas

The size of this church and its vast roofscape make it a notable landmark on the approach from both Great Georges Road and Church Road. It terminates the view from the latter.

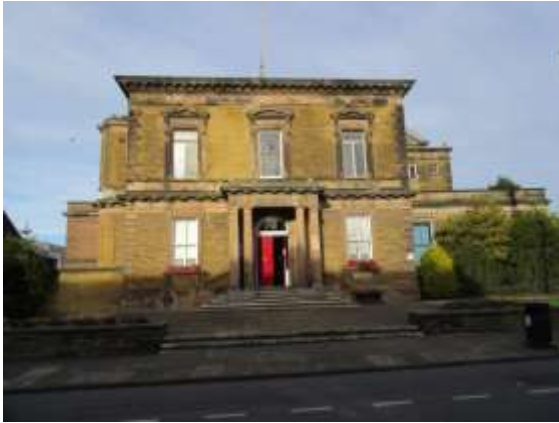
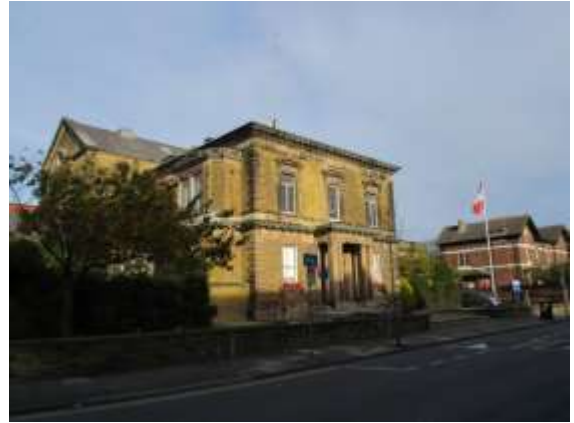
8. Town Hall

The original front portion of the Town Hall in many respects resembles the larger houses of the area. However, the use of stone, the portico and arrangement of steps, and the much larger scale of the rear extension all contribute to the buildings distinct landmark qualities. It was listed grade II in 1973. There is some evidence of external fabric deterioration, which has arisen due to lack of regular maintenance.

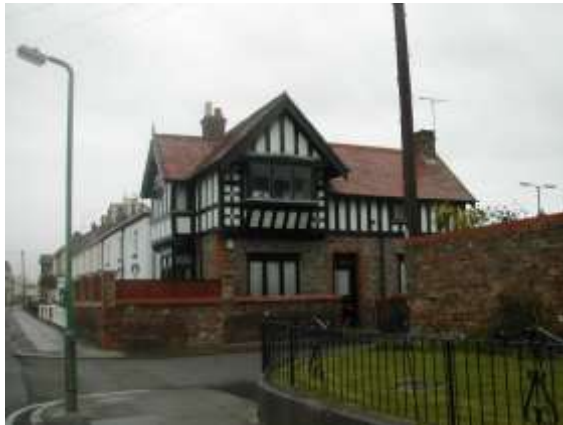
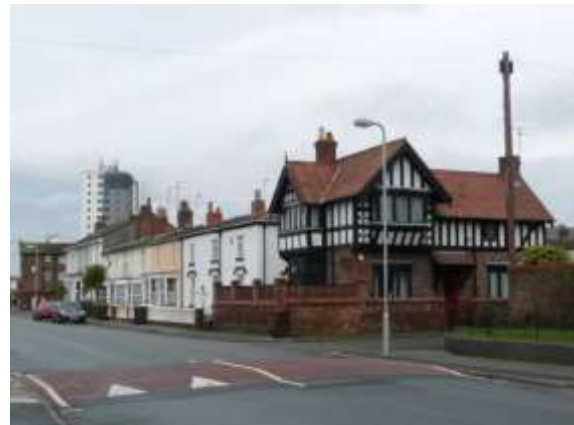
9. 13a Brunswick Parade

This 1900's house, although small, provides a very distinct contrast to the other historic properties on Brunswick Parade. Half-timbered and gabled, with a tiled roof, in its appearance it is reminiscent of park gatehouses.

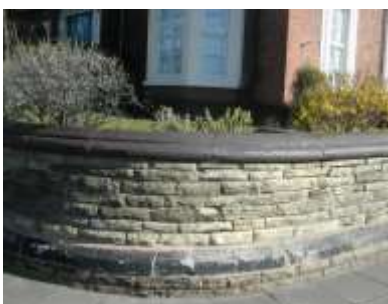
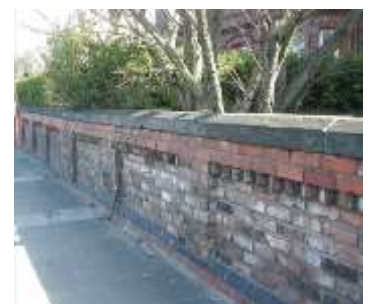
Original brick walls are frequently decorated by recessed panels and some with an exposed arris detail. Copings are generally of stone (plain saddle-back design) or terracotta.

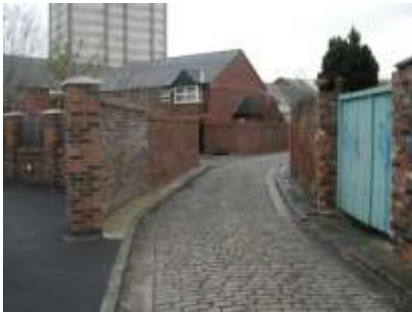
Rear boundaries (where these are visible) are high brick walls. Many of those which face back alleys have been replaced with roller shutters, garage doors or unsympathetic new bricks.

Brick walls to the back alley between Olive Road and Walmer Road

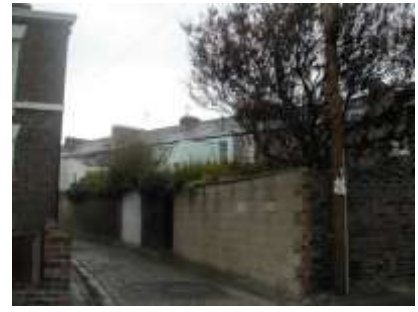
Mixture of materials for rear walls along the alley from South View

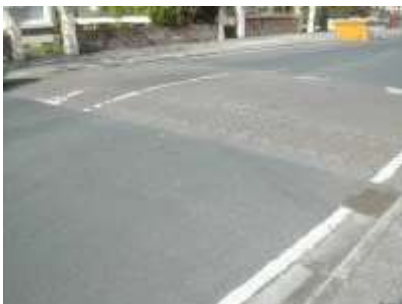
Surface of Waterloo Road

Surfaces throughout the Conservation Area are almost exclusively modern. Tarmac is used for road surfaces and concrete slabs and kerbs for paving, with brick pavements for speed humps.

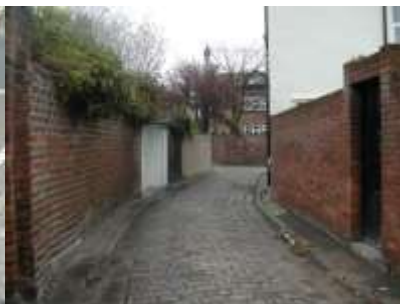
Cobbled surface to the back alley between South View and Olive Road

The exceptions to this are Brunswick Mews and the back alley linking South View and Olive Road, where original granite setts and Yorkstone paving have been retained. The occurrence of original materials makes a positive contribution towards the special character and appearance of the Conservation Area and these should be retained.

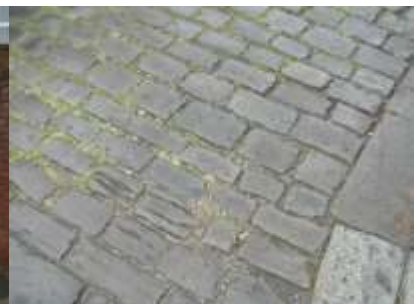
Cobbles in Brunswick Mews

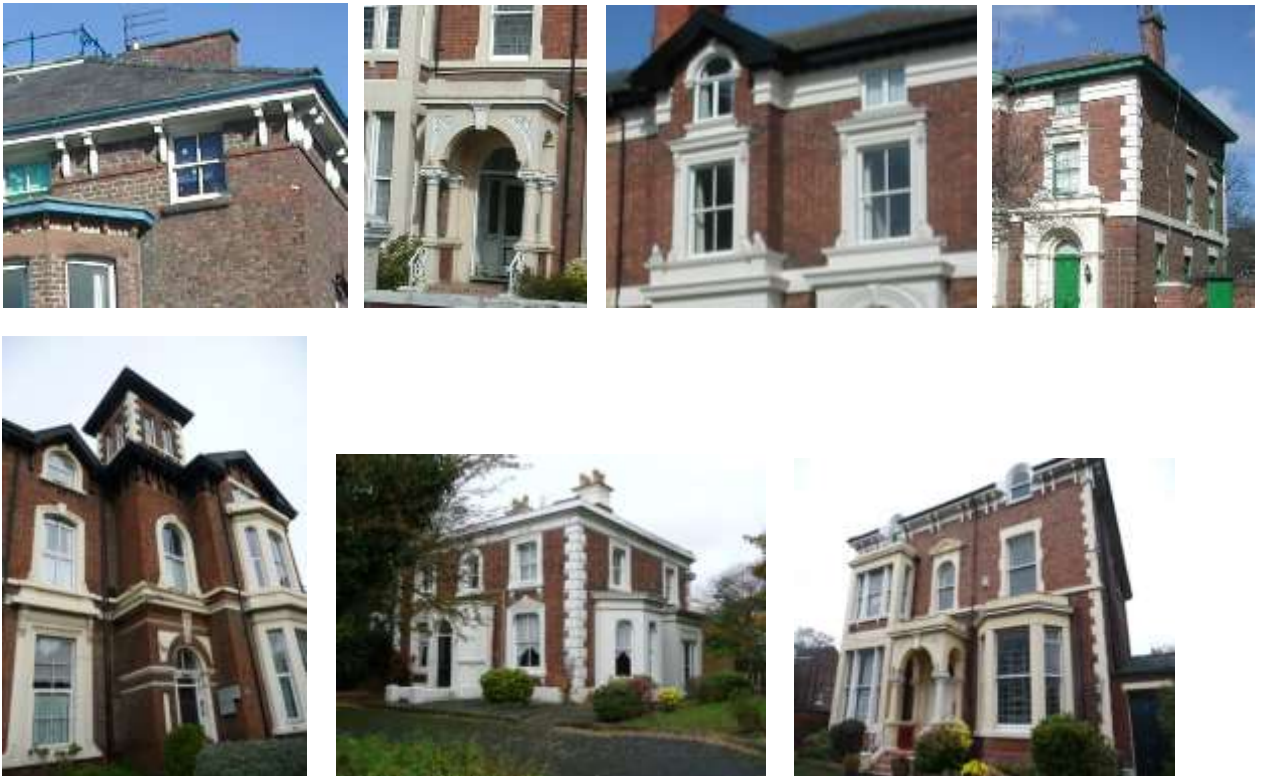
Throughout the area the style which predominates is 'Suburban Italianate'. Many of the houses demonstrate features of the style such as stuccoed quoins, double-bracketed eaves, stuccoed window surrounds, classically inspired pilasters or columns to porches. The Town Hall is also of an Italianate design.

Typical Italianate features found throughout the Christ Church Conservation Area

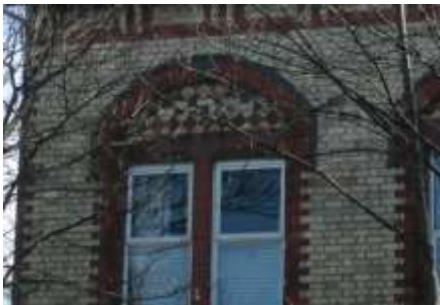
*Patterned brickwork for window head
On Crosby Road South*

Throughout the Conservation Area a varied palette of construction materials has been used. However, brick is the dominant material and is used almost exclusively for the houses. There is, though, considerable variety in the type and colour of brick used, from pale yellow calcium silicate to hard red pressed bricks. Bricks are also used decoratively both two-dimensionally (eg dark and light patterning of the Waterloo Road terraced houses; polychromatic arched window heads to houses on Crosby Road South) and three-dimensionally (eg corbelled eaves detail on Cambridge Road).

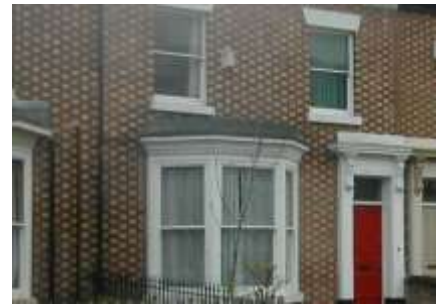
*Patterned brickwork for houses on
Waterloo Road*

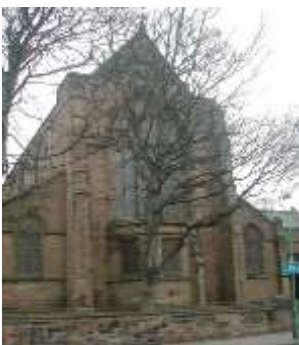
Sandstone, both red and buff, are also used throughout the area primarily for the churches, Town Hall and Potters Barn. However, a number of houses have buff sandstone frontages (for example, 21 Cambridge Road) and matching boundary walls).

*Red sandstone for Christ
Church*

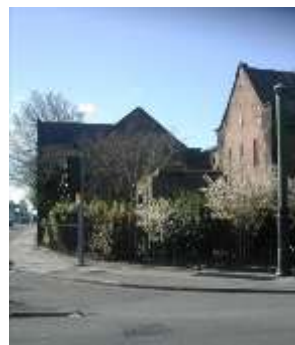
*Red sandstone for Potters
Barn*

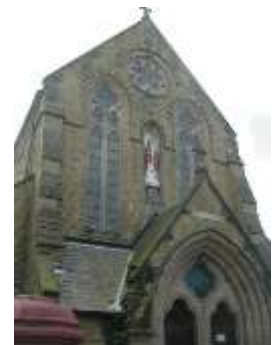
*Buff sandstone
for St Thomas Church*

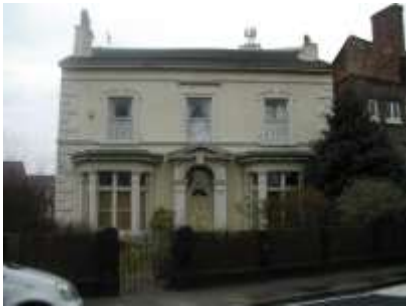
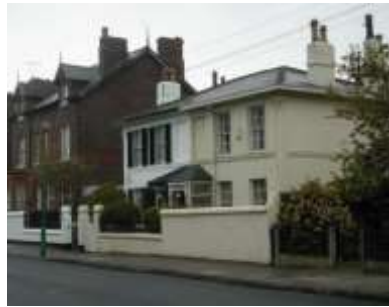
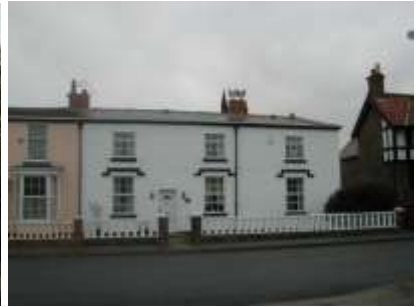
A number of houses are stuccoed and painted. These tend to be the older properties such as 6-13 Brunswick Parade and Ennis Cottage (58/58a Waterloo Road)

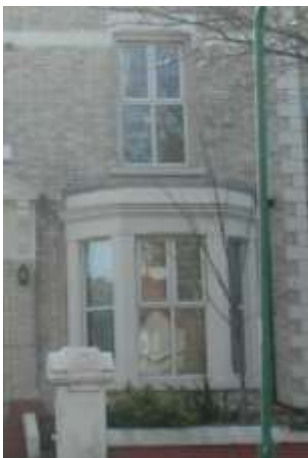
Single-storey canted bay

Although many houses have had their windows replaced, original timber sliding sash windows (typical of the period) are to be found in the Conservation Area and where properties have retained this original feature, they make a significant positive contribution to the overall character of the area.

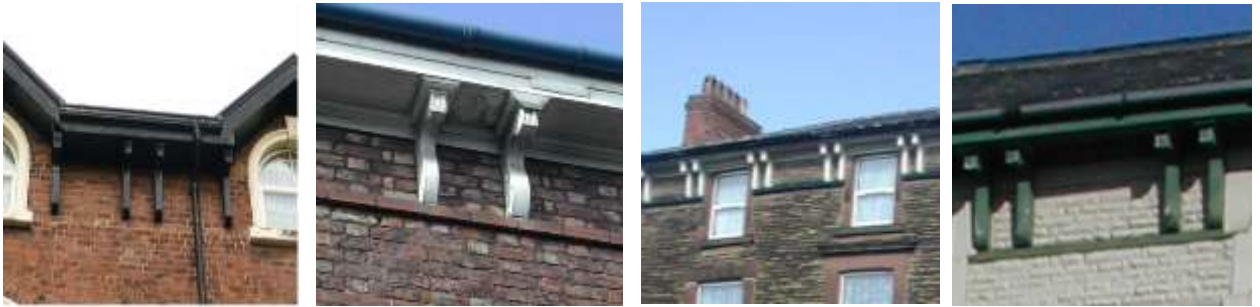
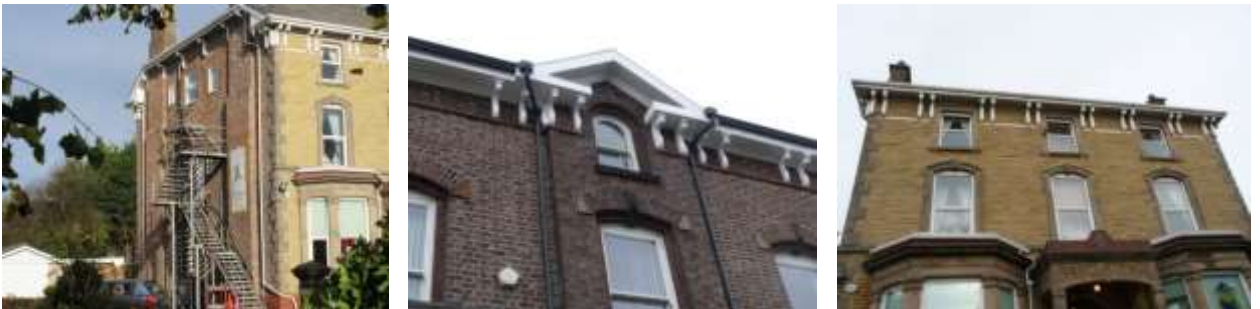
Double eaves brackets, which are a feature of the Italianate style, are common throughout the Conservation Area.

A variety of double eaves brackets found throughout the Christ Church Conservation Area

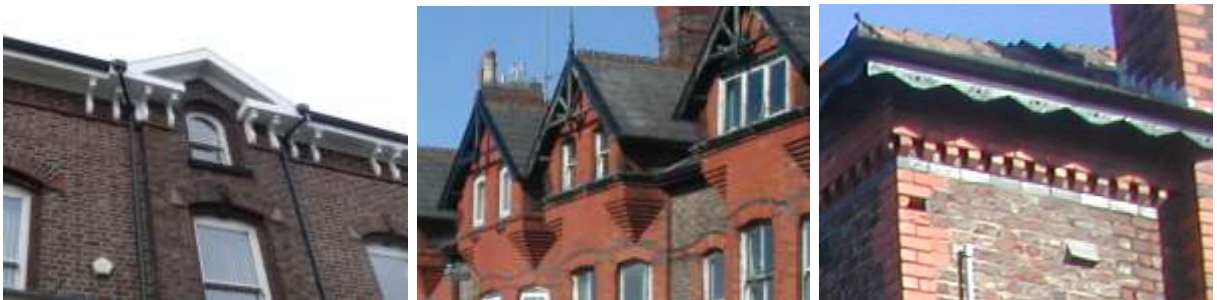
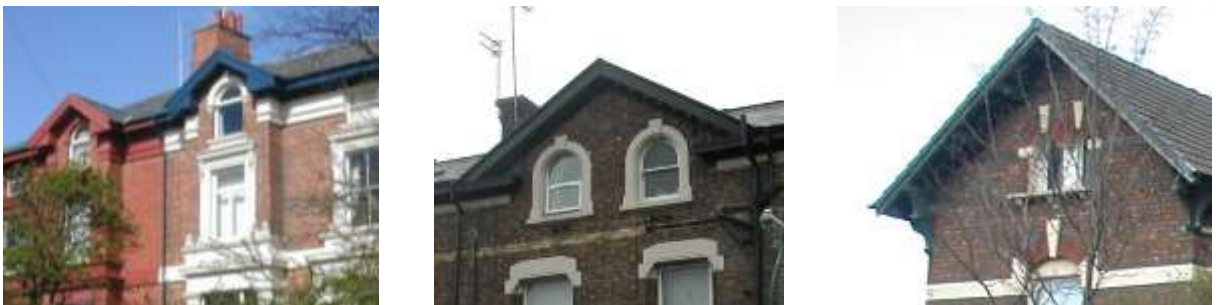
Where gables are incorporated into the design of the houses, decorative fascia boards sometimes form a feature, but generally these tend to be plain.

Examples of decorative and plain fascia boards

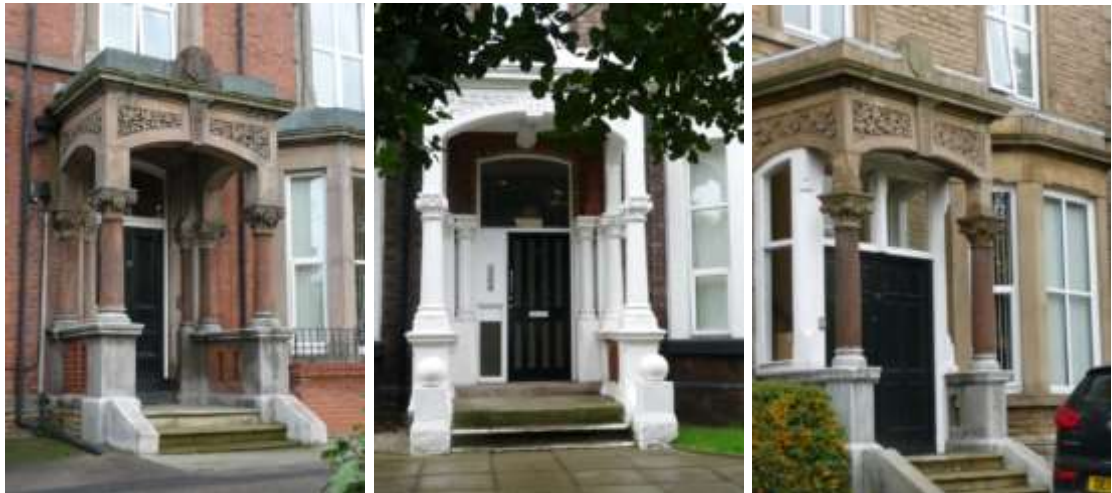
Whilst not found in all parts of the Conservation Area, projecting porches are found on some of the grander detached properties such as those in Cambridge Road and Crosby Road South. They are generally formed by two columns supporting a decorated stone canopy. However, a number of properties on Crosby Road South have simple pitched, slated canopies.

Examples of projecting porches

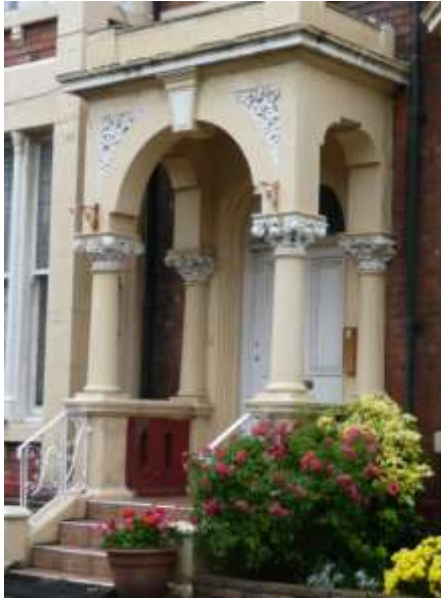
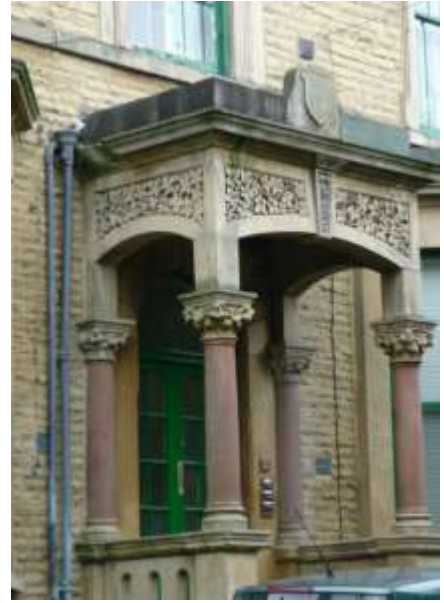
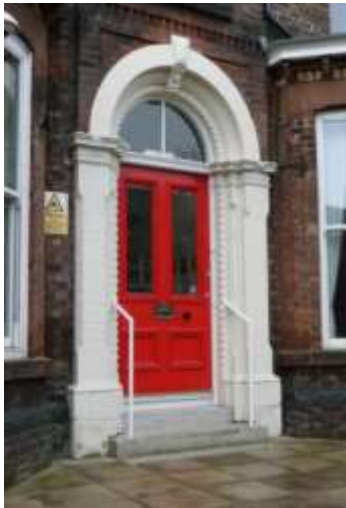
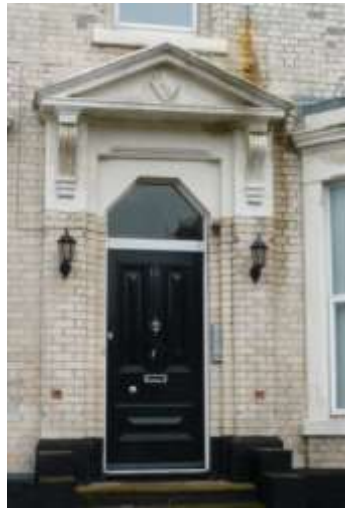
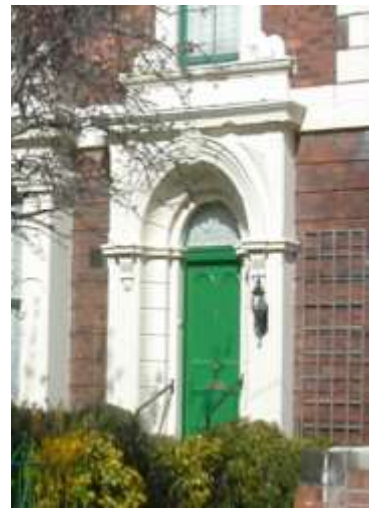
A greater number of properties have substantial, ornate door surrounds.

Examples of decorative door surrounds

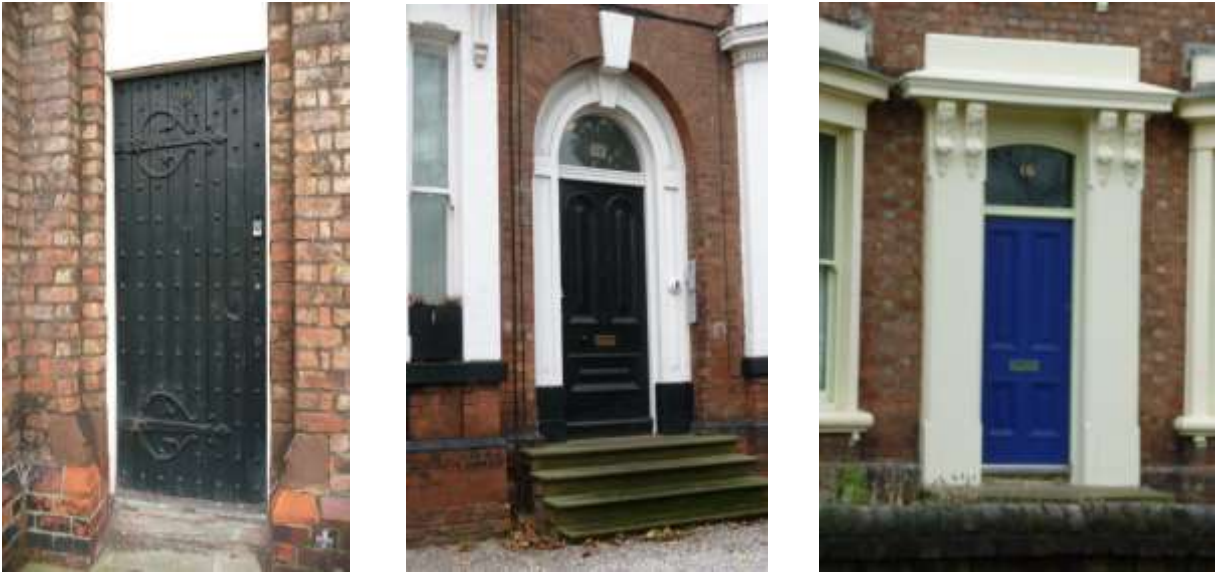
Examples of door surrounds

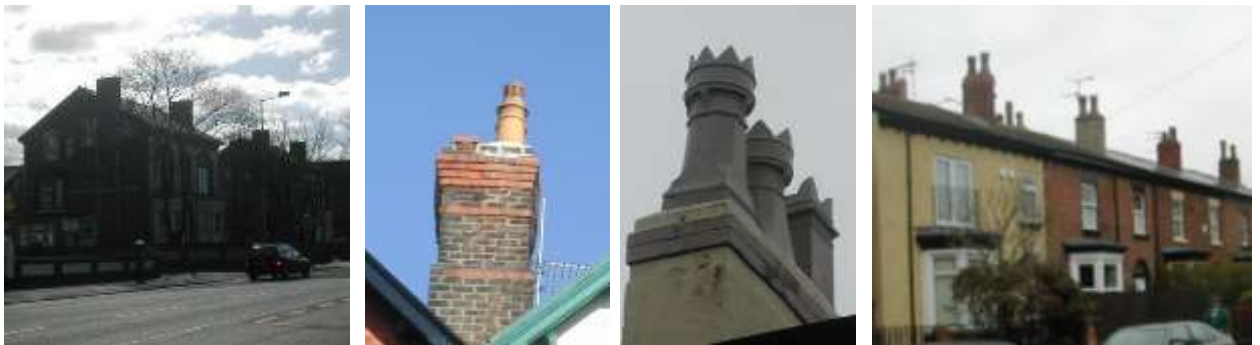
Chimneys are a common feature throughout the Conservation Area. Although they are not particularly tall, ornate or elegant and are primarily utilitarian, chimneys and their pots make a significant contribution to the skyline.

The contribution which chimneys make to the character of the area

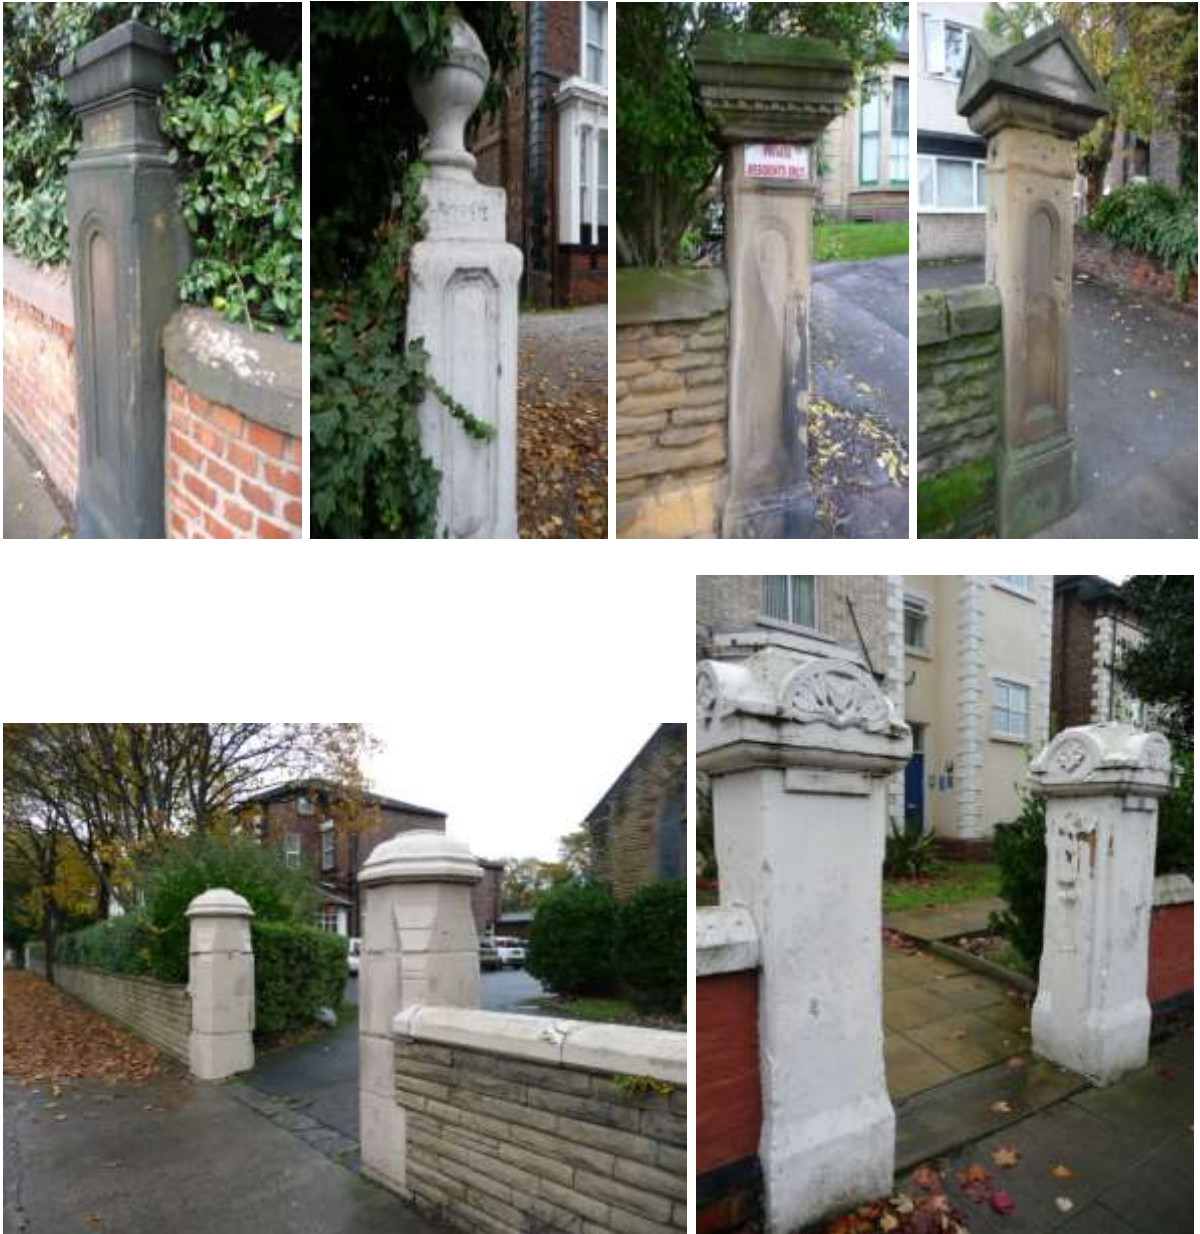
Sandstone gate piers are a typical feature throughout the Conservation Area. Their size and design vary with the grandeur and scale of the property to which they relate. It has become common practice for the piers to be painted. Their contribution to the rhythm and dynamic of the street scene is significant, even where the related property has been lost or replaced by new development.

Examples of the variety of gate pier designs within the Conservation Area

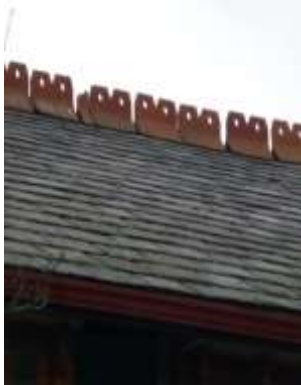
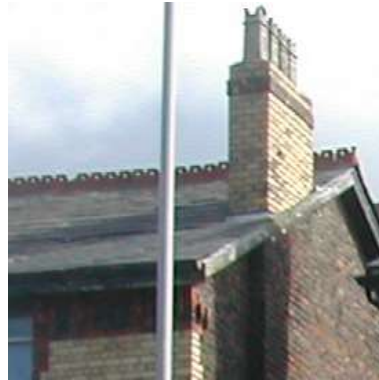
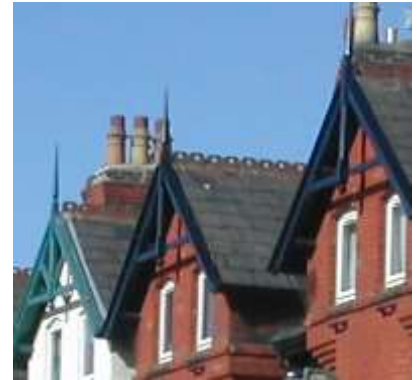
These are not a prominent feature across the Conservation Area. However, a group of properties on Crosby Road South, which still retain their slate roofs, have decorative terracotta ridge tiles, as do the terraced houses on Cambridge Road.

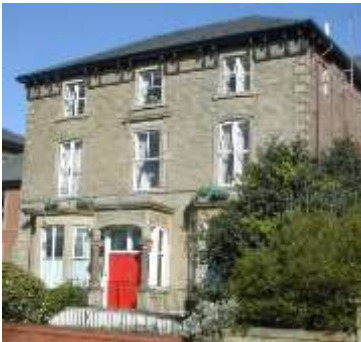
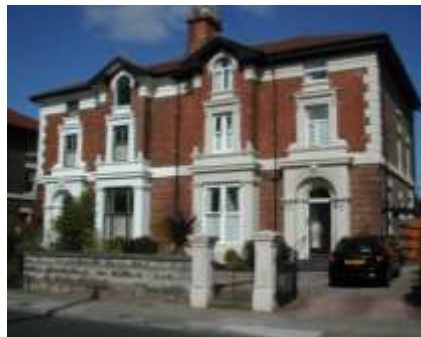
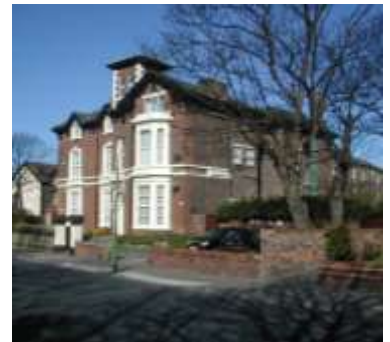
By far the largest zone consists of large, 2-3 storey (basements, where they exist, are concealed) detached or semi-detached properties positioned towards the front of substantial plots. Houses are generally loosely Italianate ('Victorian Suburb Italianate') in style, often with bay windows at ground floor level; hipped roofs with unbroken eaves to the main frontage; projecting porches or door-surrounds; decorative window surrounds; quoins; and medium-tall chimneys.

Examples of Italianate style houses within Zone 1
