Christ Church

Conservation Area Appraisal
Adopted April 2016

This Conservation Area Appraisal was prepared by Sefton Council in 2015 and amended following public consultation between January and March 2016 and was adopted by Sefton Council on 27th April 2016

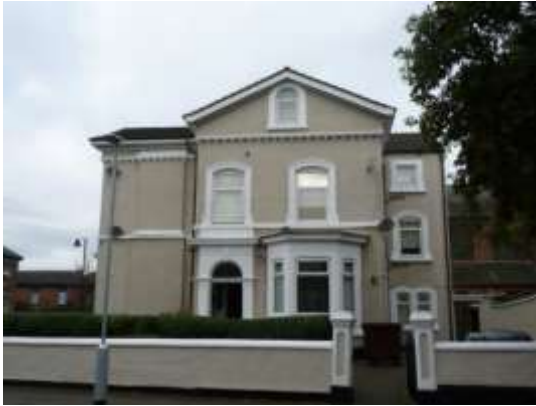
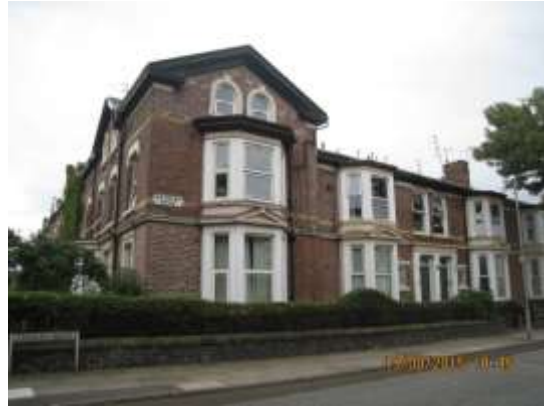
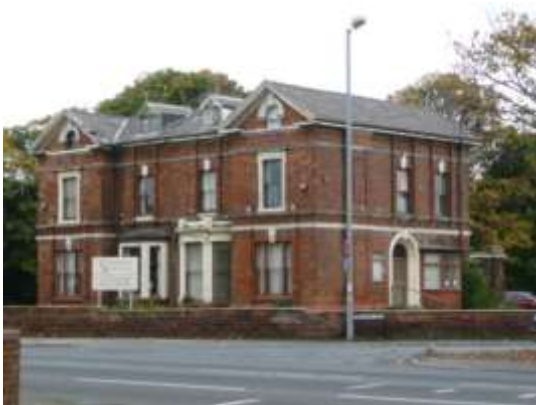
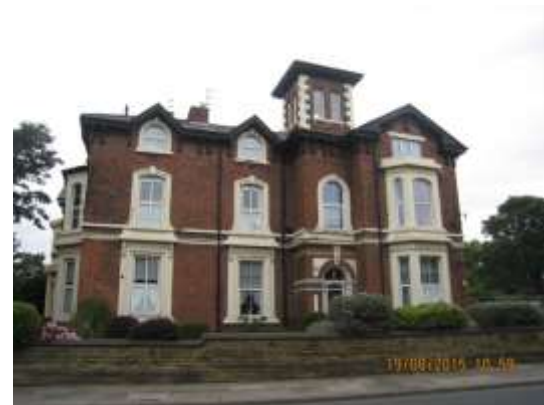
A special feature of this zone is the semi-detached houses on corner plots which have been designed to read as single villas from each road (see section 5.1.4). No specific reference to these properties has been found with regard to their design, and further research is therefore required. Whilst this approach to design is not uncommon in the 19th century (and examples are to be found in pattern books of that time), these types of property usually occur in more planned developments.

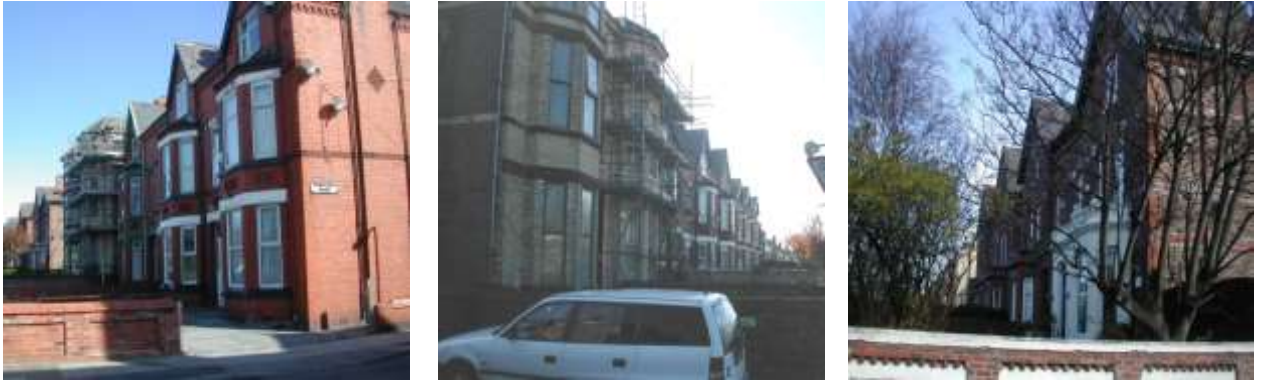
No.s 27 – 51 Crosby Road South

Along Crosby Road South, the larger detached properties give way to pairs of semi-detached properties. The strong, continuous eaves line, which is a feature of the detached properties further along Crosby Road South, is broken by gablets in this zone.

Whilst the frontages of the pairs of semi's are of a similar size to the detached houses and the spaces between the houses are also similar, the rhythm of the street is altered by the broken eaves line and the gablets. The triplet arrangement (see Section 5.1.3) is also lost.

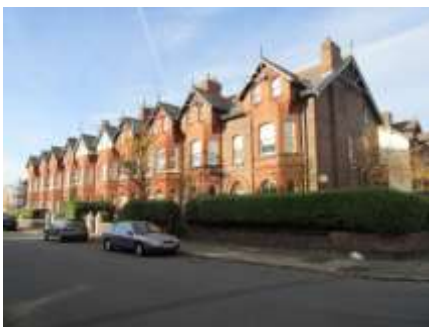
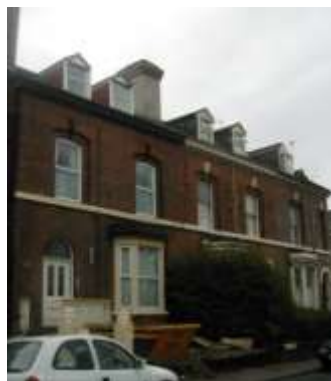
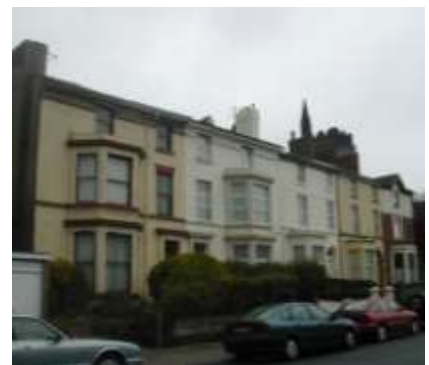
The third character type is defined by large 2-3 storey (plus visible semi-basements) terraced houses, mostly in narrow plots with narrow frontages (1-9 Cambridge Road being the exception). Projecting bays often extend over more than one floor; eaves are broken with gables or dormers; gables are presented to the main frontage. Front gardens are much smaller, limiting the opportunity for planting, and therefore privet hedges are more common than mature trees and shrubs.

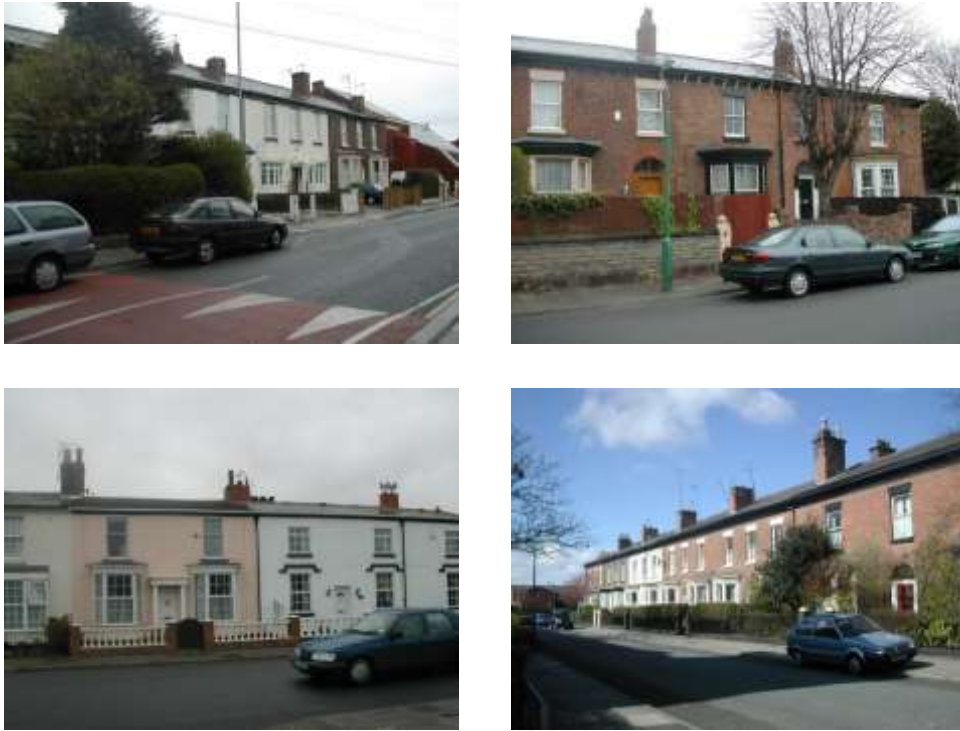
The fourth character type is defined by smaller 2 storey terraced properties, mostly in small, narrow plots (though 16-26 Walmer Road are in more generous plots and 1-11 Stanley Road have wider frontages). Houses are generally more modest (particularly the older 9-13 Brunswick Parade), with bay windows only at ground floor level. Eaves lines are unbroken; windows and doors generally lack decorative surrounds (though there are exceptions).

Generally the houses in this zone have a closer relationship with the street and front gardens are smaller (see Section 5.1.1), limiting the opportunity for planting (16 -26 Walmer Road excepted). In consequence, the character of this zone is generally much more intimate, although Brunswick Parade is the exception.

Examples of the smaller scale properties and more intimate character of Zone 4

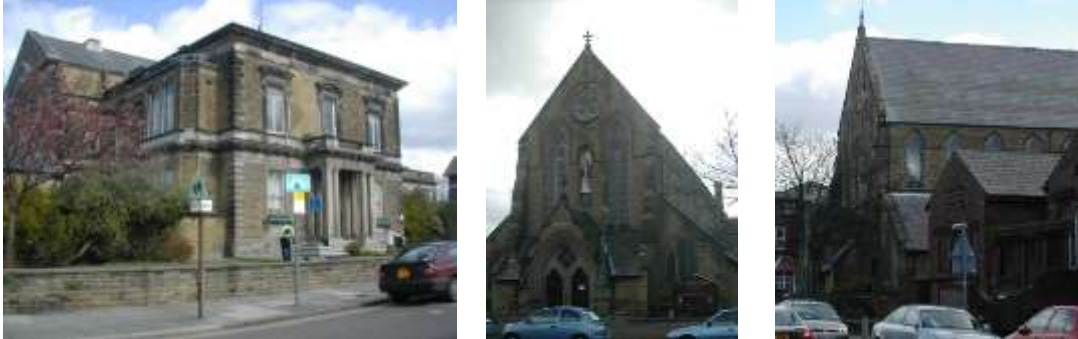
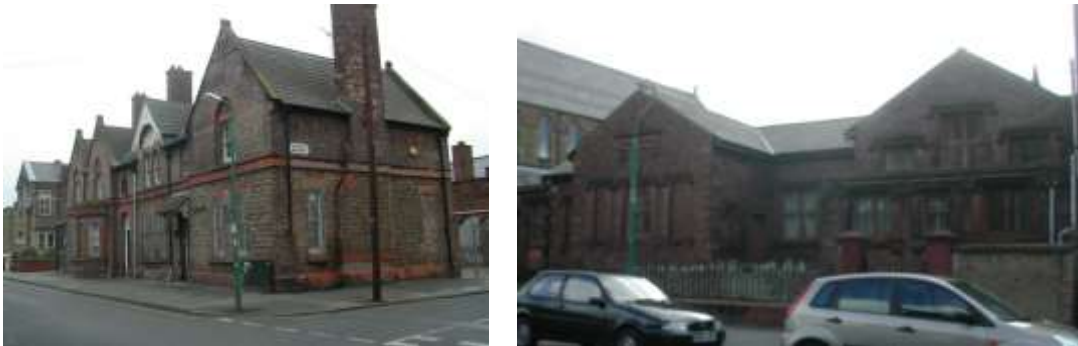
As identified in Section 5.1.6, this cluster of civic buildings forms an important townscape feature. Given that the remainder of the Conservation Area consists of houses, this zone has a very different character. The scale of the main buildings (Town Hall and Church of St. Thomas) is considerably larger than the neighbouring buildings. Their low boundary walls give these two buildings and the former school a much more open and visible relationship with the street. The former Police Station rises hard on the 'back of pavement' line.

The relationship of the Zone 5 buildings to the street makes them visually more accessible and the character of the zone is therefore much more 'public'.

The more accessible public buildings of Zone 5

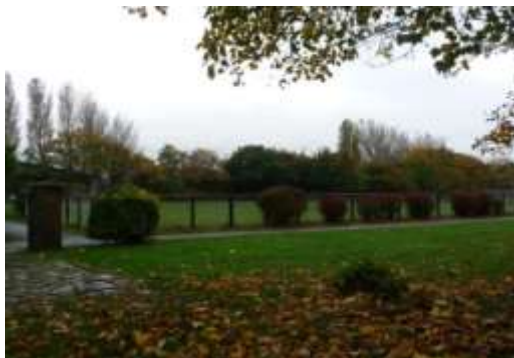
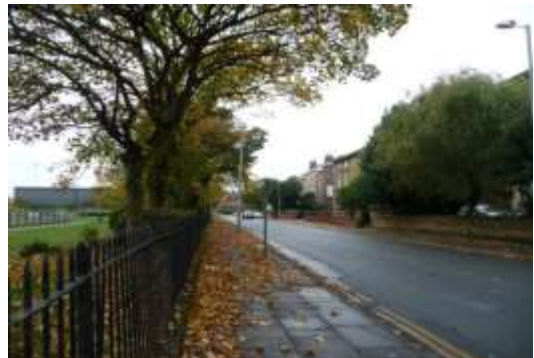
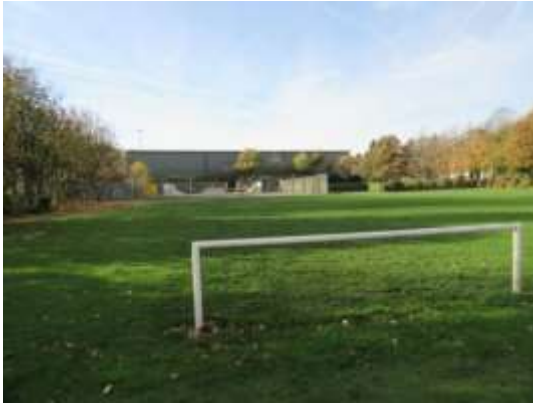
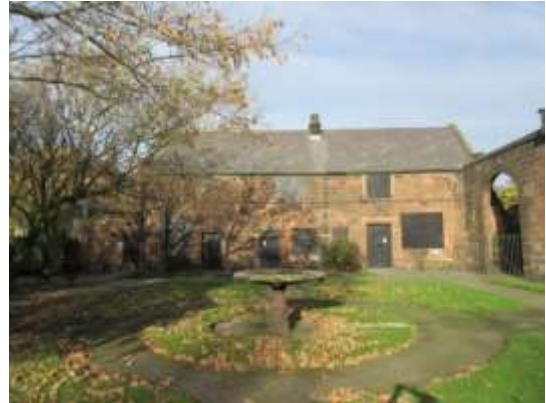
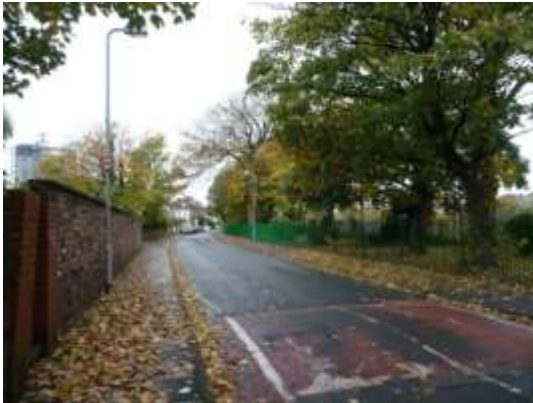
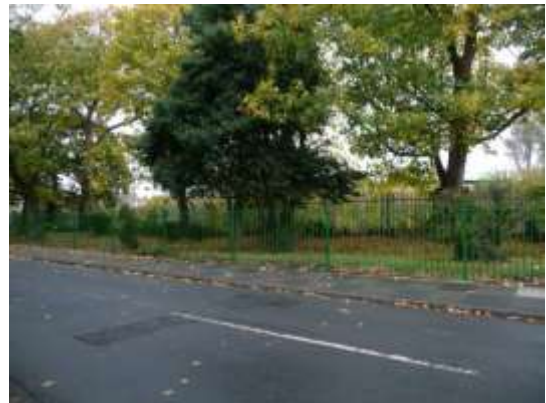
Finally, the green spaces of Potters Barn and Walmer Road represent a sixth character zone, where greenery dominates. Both are enclosed by dense shrub planting and small trees, although at Potters Barn the space opens out to flat grassed recreation areas (see also Section 4.4.1).

Zone 6 Greenery of Potters Barn Recreation Ground and Walmer Road

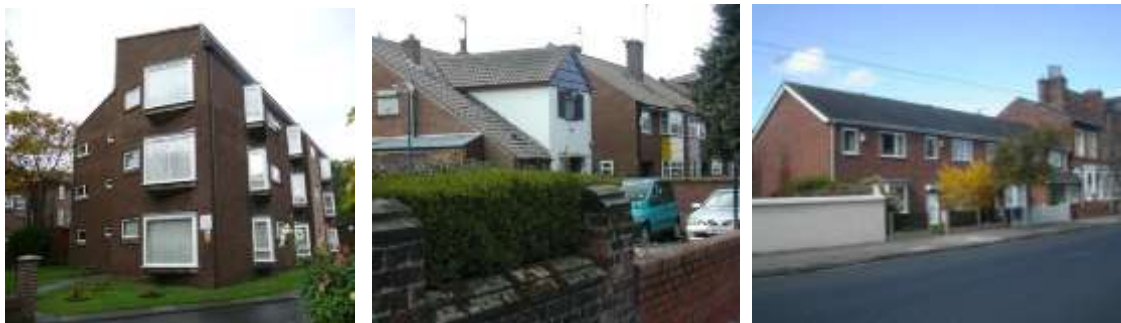
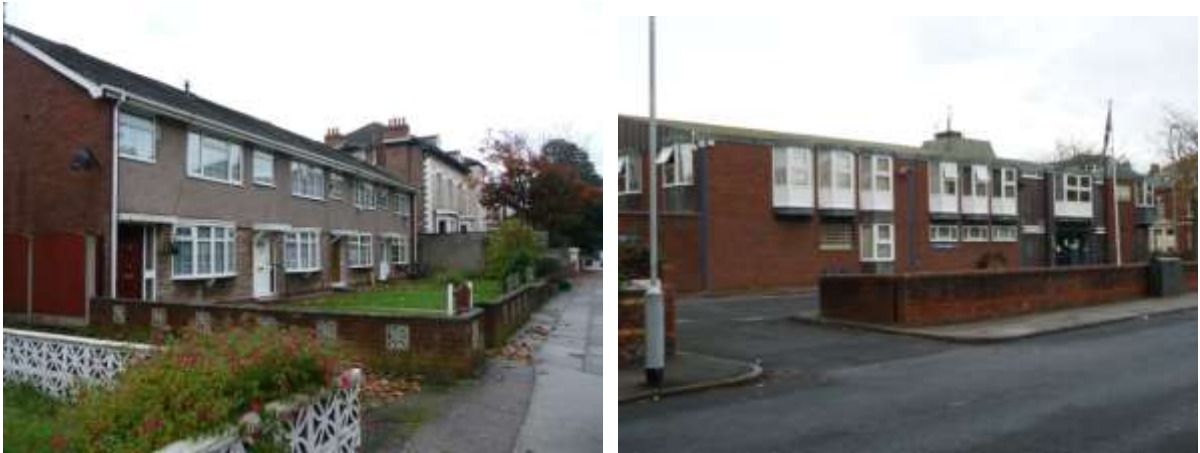
Other buildings are of an inappropriate scale and form.

Examples of inappropriate development found within the Conservation Area

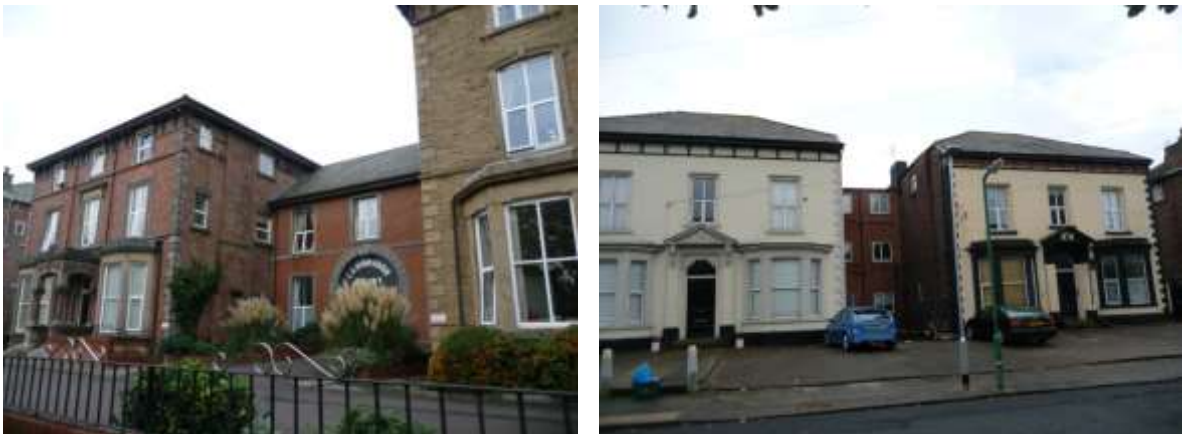
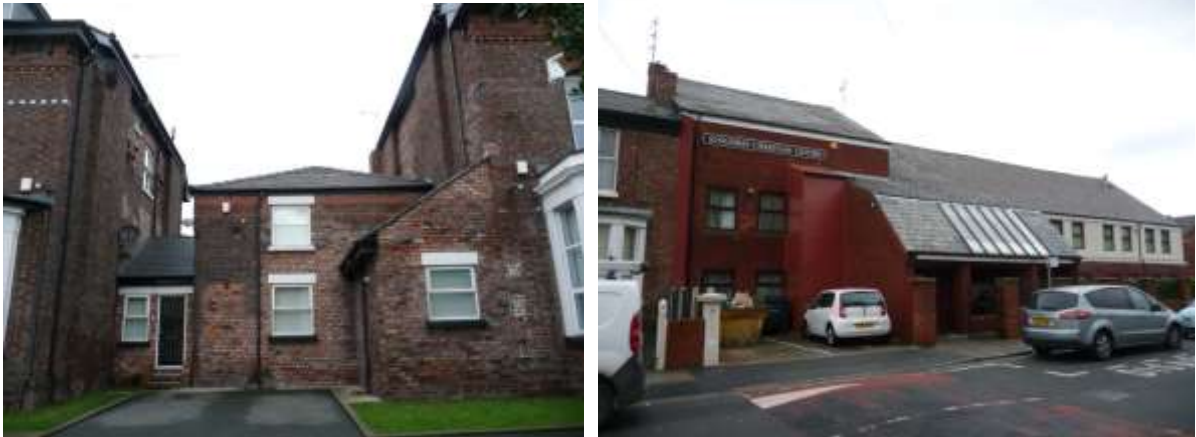
There are a number of examples throughout the Conservation Area of extensions which have been used to link historic buildings. This destroys the spacious qualities of the area, presenting a continuous frontage (like terraced properties) where there should be depth of views between buildings. Such 'links' are also detrimental to the rhythm of the street (see Section 5.1.3).

Examples of detrimental 'linking' and inappropriate extensions found within the Conservation Area

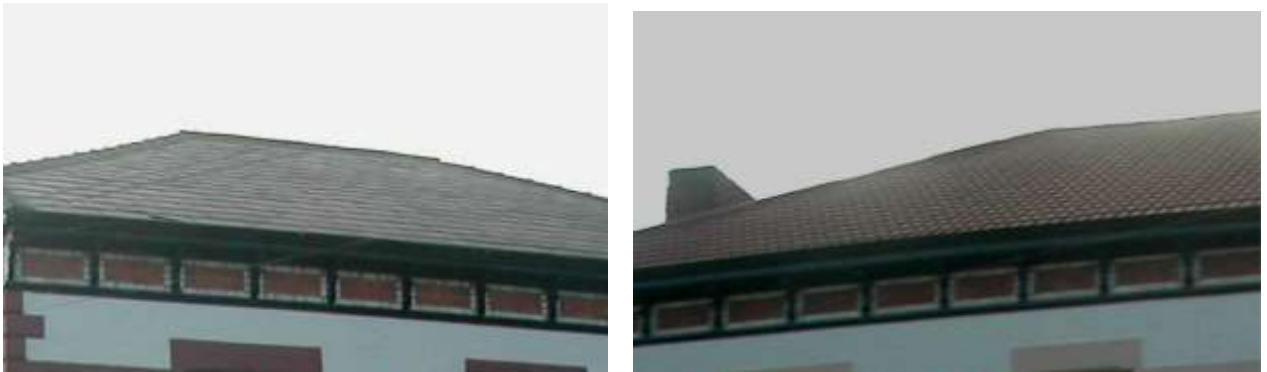
Roofs: Original slate roofs have been replaced in many instances by clay or concrete tiles. Although roofs are not always completely visible, they nevertheless contribute to long views and, given the width of many of the streets within the area, they are often seen. Where properties form a run (either as a terrace or a group of the same design), the alteration of one roof seriously detracts from the quality of the street scene.

The contrast of texture and colour between a traditional slate roof and a modern tiled roof.

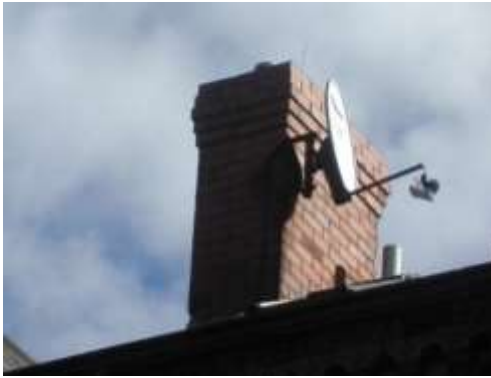
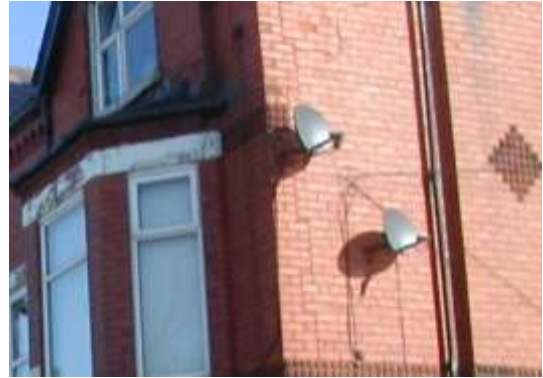
Satellite dishes: The installation of satellite dishes is not unachievable within Conservation Areas, as long as they are positioned sympathetically and are kept as small as possible. There are, however, many instances throughout the area of poorly positioned and very visible satellite dishes. Their visibility is often increased because they are seen against the sky.

Examples of inappropriately located satellite dishes

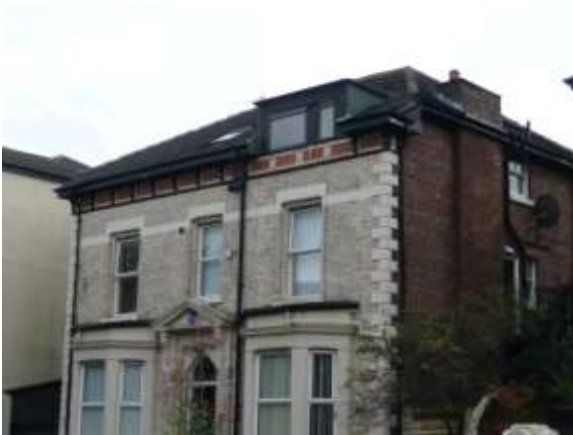
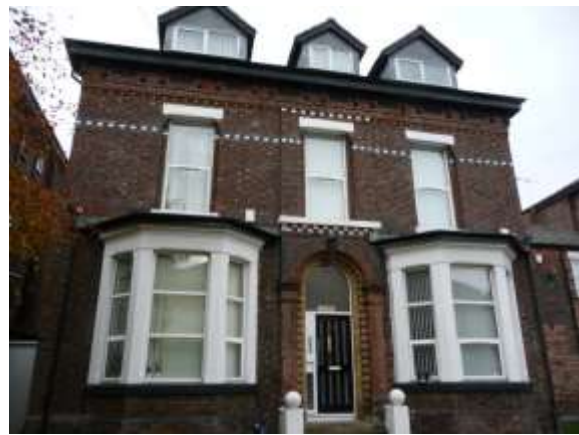
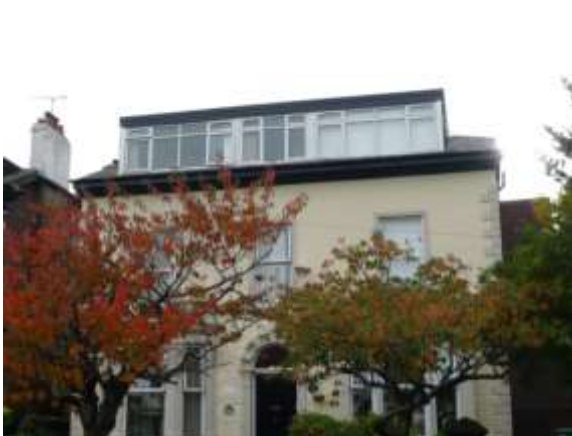
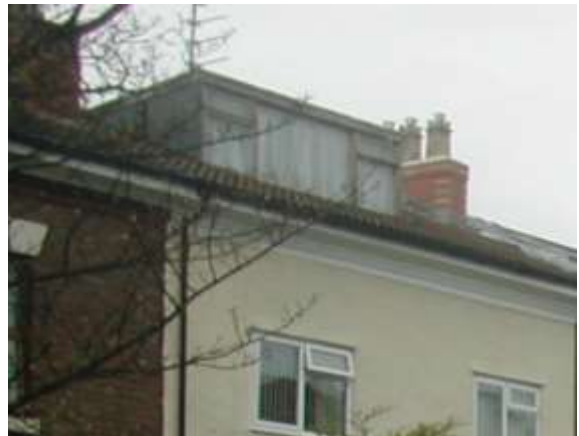
Dormers: Whilst dormers are a traditional feature of the designs of a number of the properties within the Conservation Area, there are examples of recently inserted unsympathetic dormers. Such alterations have a detrimental effect not only to the individual house, but also to the streetscene. Eaves may be broken and rooflines altered. The effect is particularly detrimental where this occurs to one of a pair of semi-detached properties or to one of a number of the same design.

Examples of unsympathetic dormers inserted into front elevations

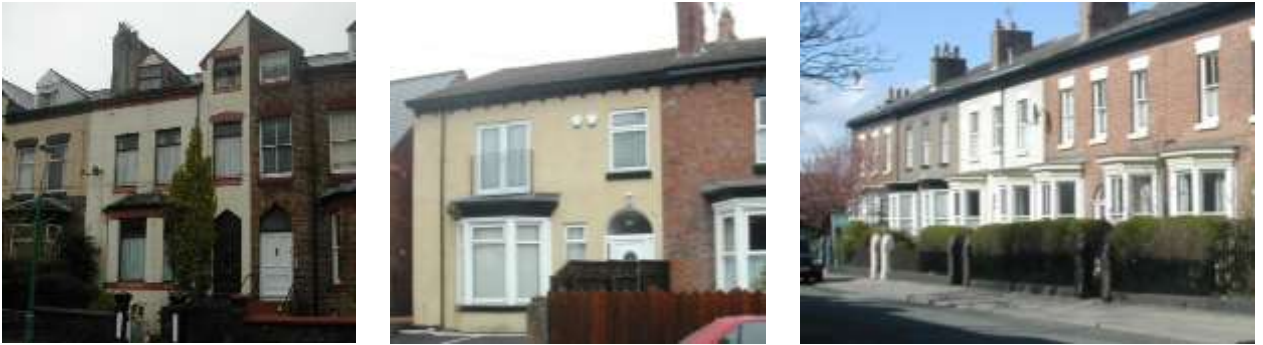
More disturbing, however, are the examples which are found throughout the area of brick houses which have been painted. On a practical level, this action is potentially damaging to the brickwork, trapping moisture within the fabric. Aesthetically, it is detrimental to the streetscene where individual houses within a terrace are painted and the character is altered.

Examples of brick terraced houses which have been painted

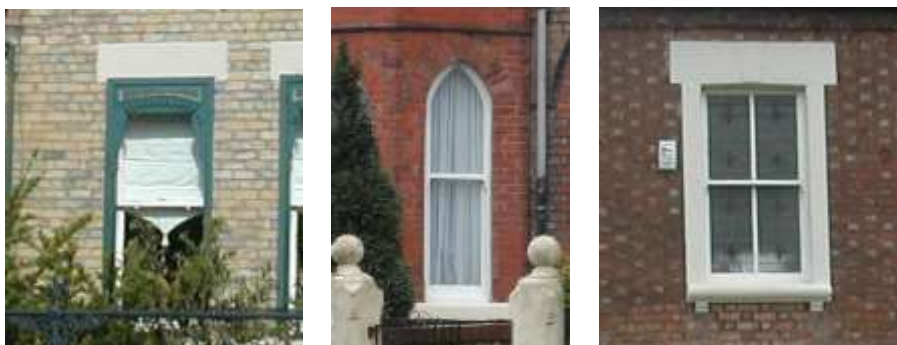
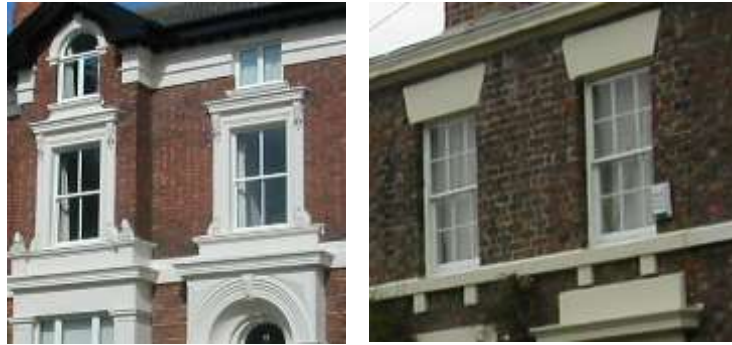
Windows and doors: Houses of the period of those found within the Christ Church Conservation Area would typically have had timber sliding-sash windows. Whilst the earliest properties are likely to have had multiple small-panes with glazing bars, the majority (dating from mid-late 19th century) would have had four panes (two over two). A number of houses have retained these.

Examples of traditional sliding-sash windows found in the Conservation Area

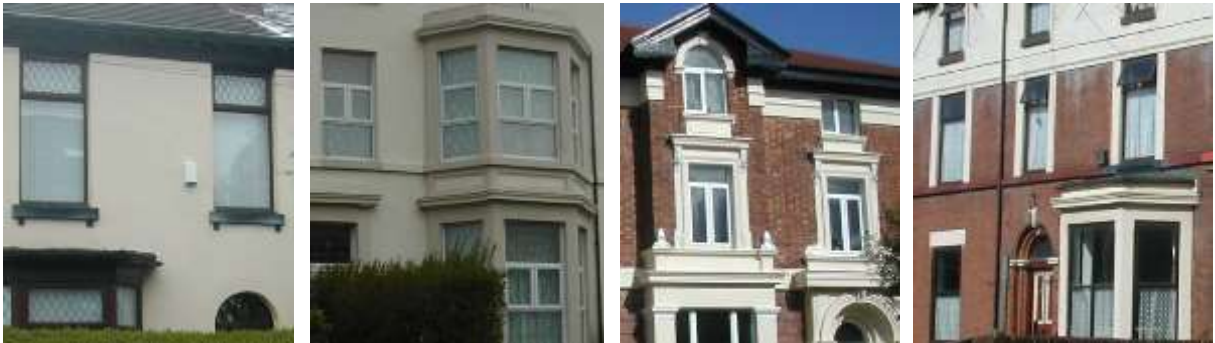
There are many examples throughout the area of poor quality replacement windows which not only differ from those of the neighbouring properties but also differ from others within the same façade.

Examples of inappropriate replacement windows

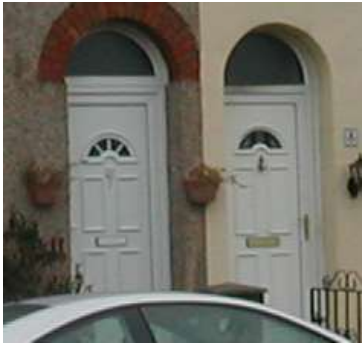
Though less common than replacement windows, replacement front doors are also detrimental to the character of the area. Where uPVC is used, replacement doors are particularly obtrusive and lack the quality of design and detail found in timber originals (eg to attempt to replicate the recessed panels of traditional doors, mouldings are applied). However, they tend to appear only on the smaller properties, as the larger doors required for the grander houses are not a standard item.

Examples of uPVC doors

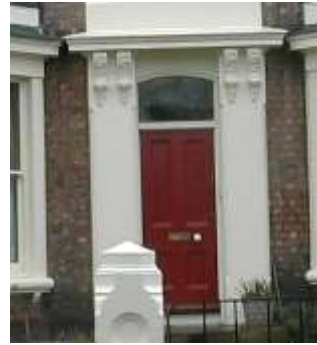
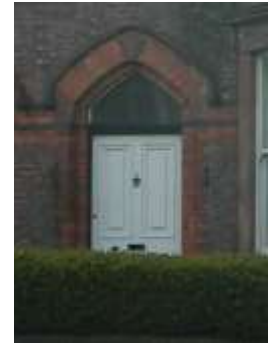
Examples of traditional timber doors

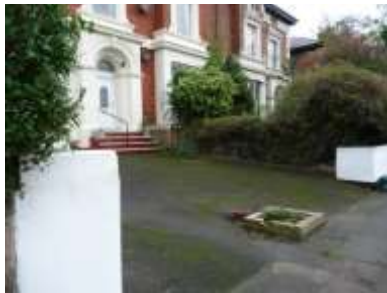
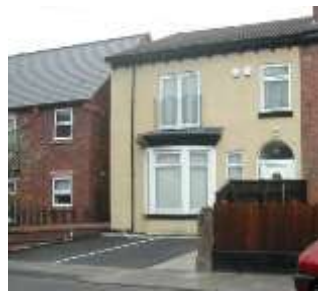
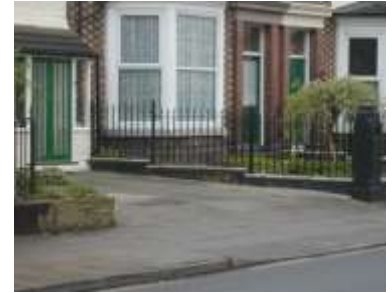
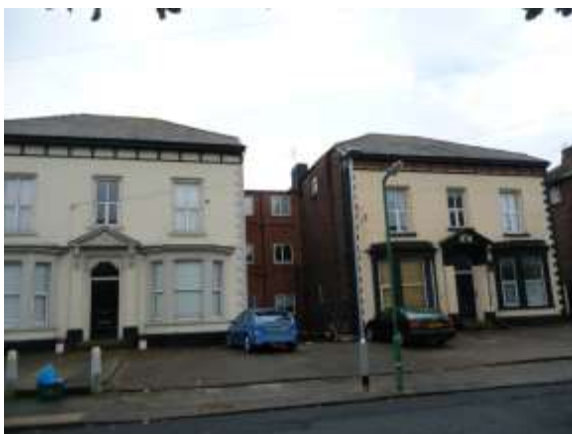
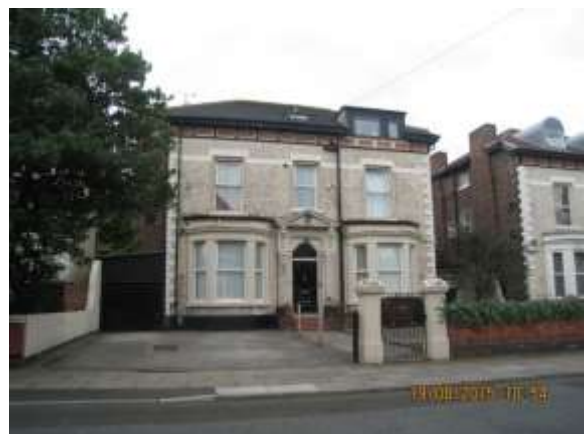
Loss of boundaries: As identified in Section 5.3, front boundary walls are an important feature of the streetscene within the Conservation Area. They contribute to the rhythm of the street and clearly define public and private space. Their loss is, therefore, detrimental and particularly damaging where this has occurred in conjunction with the hard-surfacing of front gardens for car-parking.

Examples of properties where boundaries have been removed

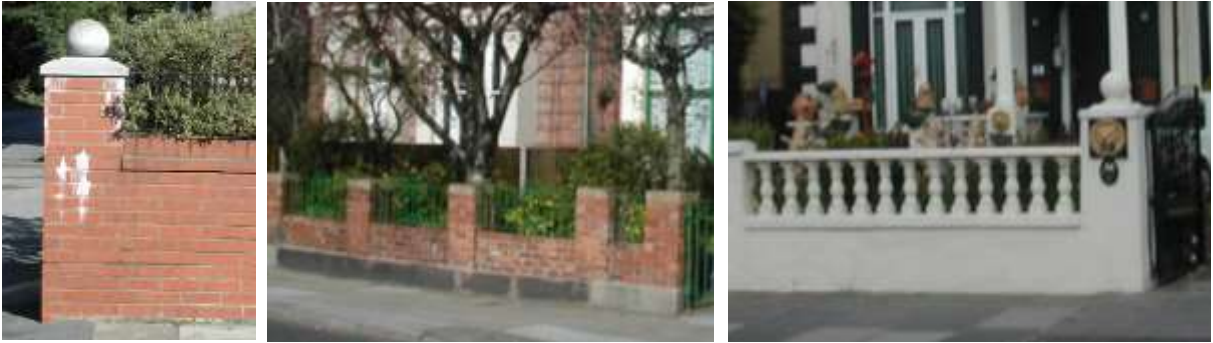
Replaced boundaries: As with the removal of boundary walls, their replacement with inappropriate materials has had an equally damaging effect on the streetscene, destroying continuity and uniformity. It is particularly

detrimental when it occurs in a terrace or one of a pair of semi-detached houses.

Examples of inappropriate replacement front boundary walls

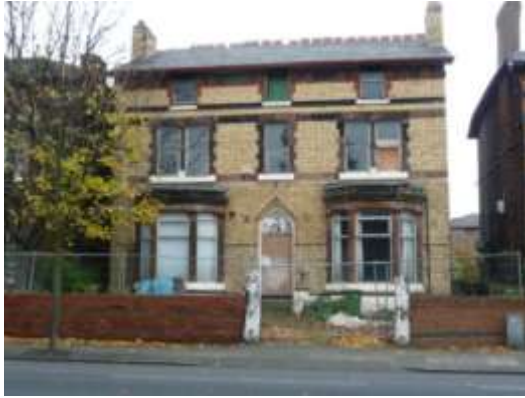
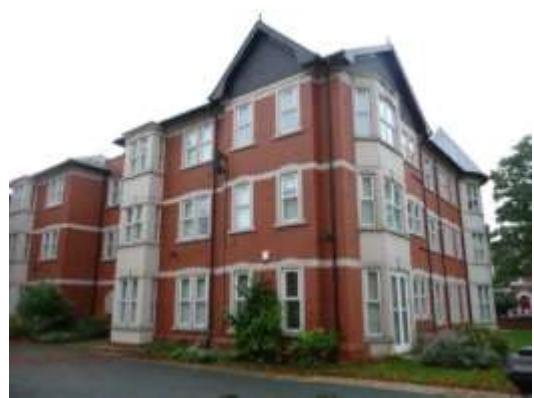
Within the Christ Church Conservation Area there are no vacant sites. However, development pressure is clearly evident in the level of building activity, with a number of properties being (or having recently been) converted to apartments and one substantial new build apartment block. Such pressure requires careful management if it is not to result in loss. That is, not simply the loss of individual properties, but also, and more commonly, the loss of details and elements, such as windows, gate piers, front boundaries, slated roofs, etc. No. 13 Crosby Road South (below) is in a poor condition.

Examples of current building activity and loss of traditional buildings with new build

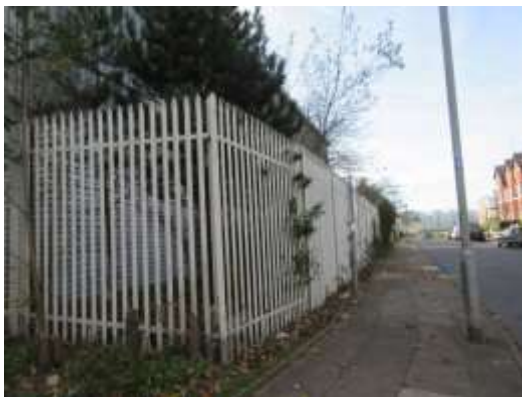
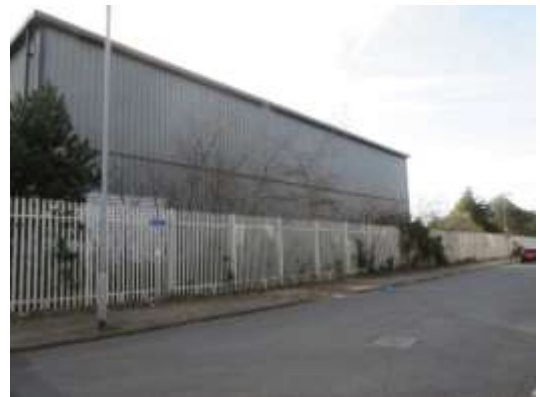
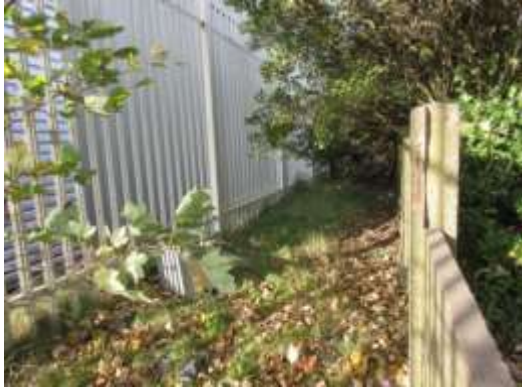
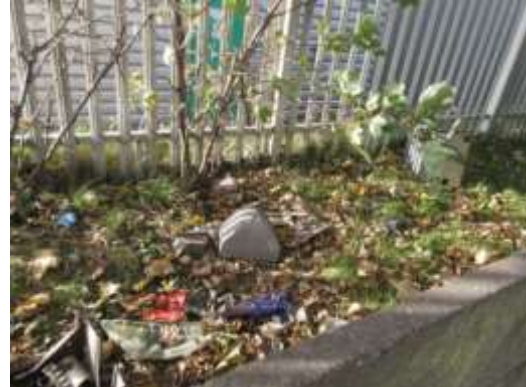
There is a small strip of land between the boundary fences of Potters Barn and Peel Holdings where litter accumulates and fly tipping occurs. This has a negative impact on the appearance of the Conservation area and would benefit from regular litter picking and made inaccessible to the public to reduce

the potential for fly tipping.

Examples of palisade fencing and fly tipping along Cambridge Road

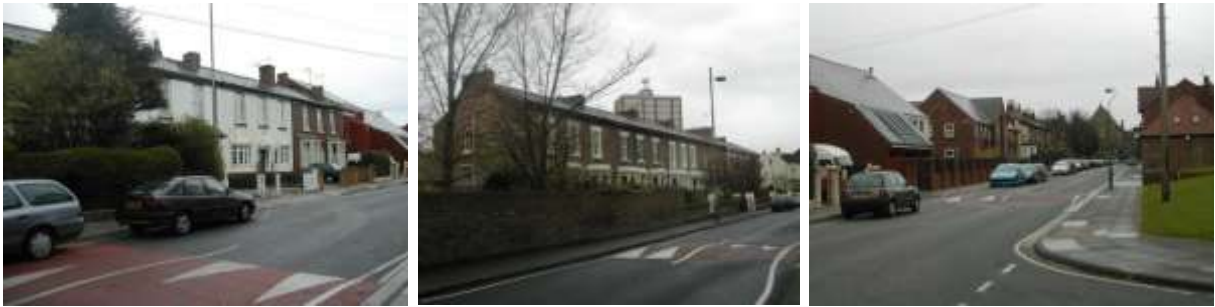
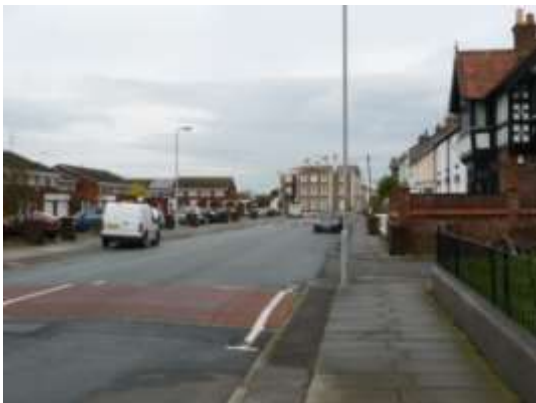
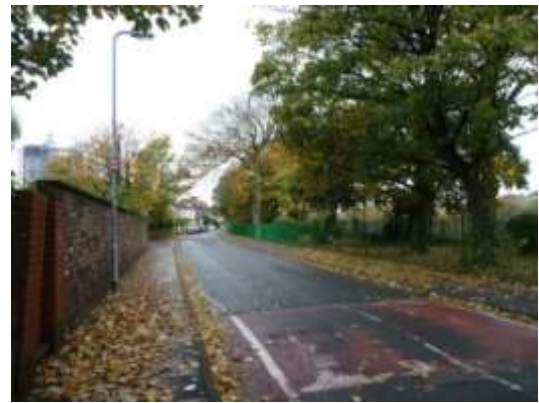
Whilst it is seldom possible or appropriate to completely remove the intrusion of vehicles, the impact which traffic has on a Conservation Area needs to be minimised. The existing traffic calming measures along Great Georges Road, Church Road,

Brunswick Parade and Waterloo Road are partially effective in reducing the speed of traffic, but are visually detrimental.

Examples of the impact of existing traffic calming measures

Consideration should be given to:-

- i. managing traffic speed in other ways, such as the introduction of 'pinch points' or 'rumble strips'.
- ii. improving the appearance of the existing speed humps by the use of other more appropriate materials (such as grey granite setts).
- iii. supplementing the existing humps with more or other forms of speed control.
- iv. investigating and implementing appropriate traffic calming to reduce the impact of 'through traffic'.

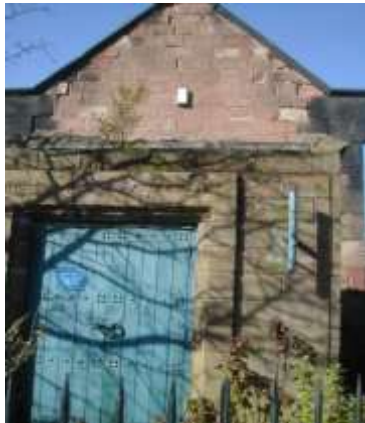
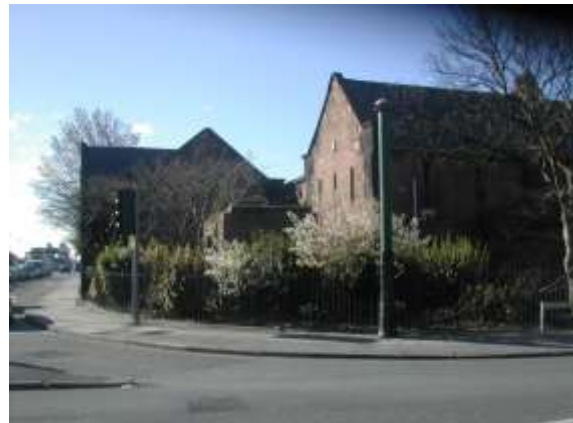
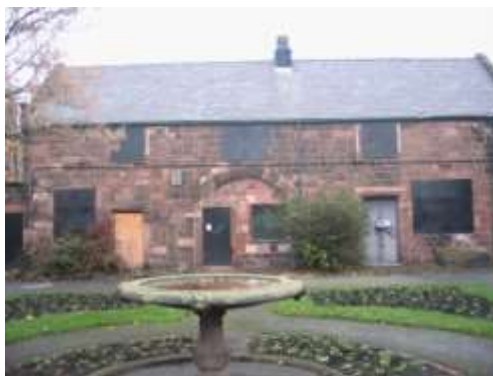
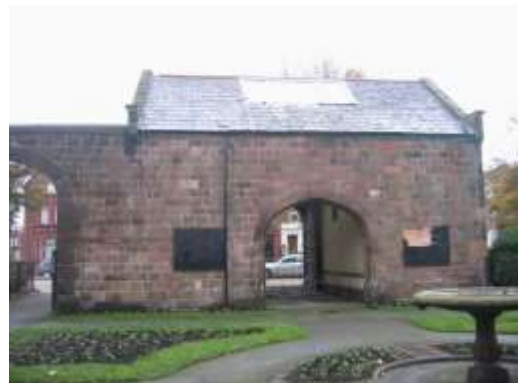
8. Town Hall Complex and car park to the rear

The Town Hall civic complex, which includes the Grade II listed Town Hall, the Town Hall extension along Prince Street, the Prince Street Clinic, the former Police Station on Church Road and the remaining parts of the former Carnegie Library also on Church Road make an important contribution to the character of the Conservation Area. These buildings are suffering from a lack of maintenance and repair, varying levels of usage and require a programme of repairs to be implemented. The buildings

should also be targeted for re-use and enhancement to prevent further deterioration through lack of use.

The introduction of some planting would help to soften the impact of this hard space, complement the planting at the front of the Town Hall and would improve the setting of the Listed Building. Removal of any redundant signage or poles is recommended to reduce clutter and enhance the appearance of the Conservation Area.

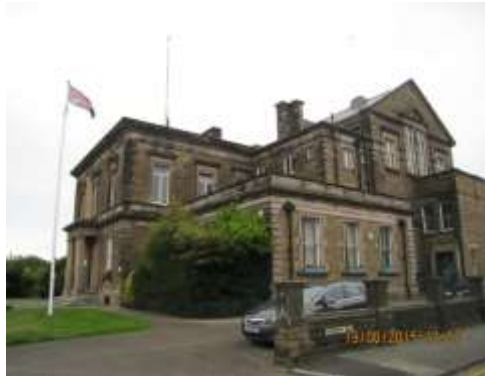
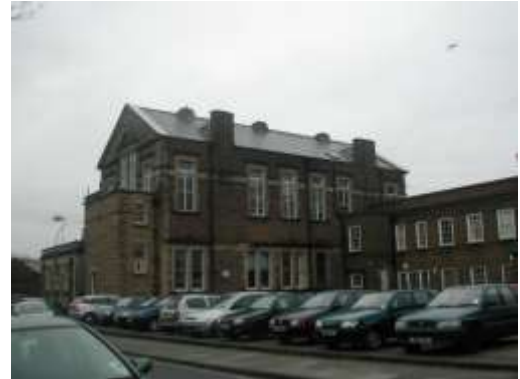
Town Hall car park and planting adjacent to the front entrance

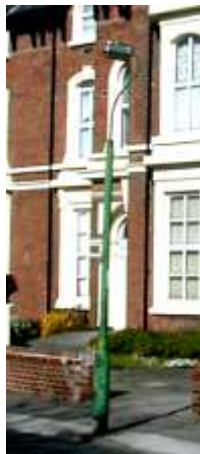
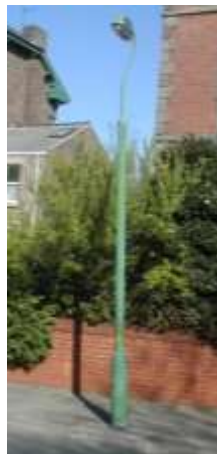
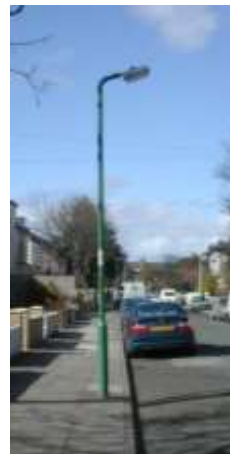
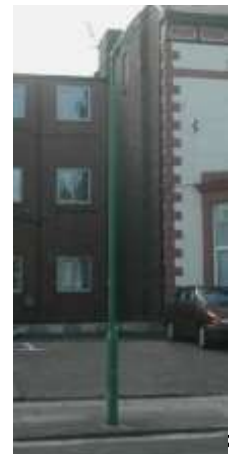
The design of some of the lampposts within the Conservation Area is acceptable. However, they are currently painted green. It would greatly improve the quality and appearance of this street furniture if they were to be repainted black. Consideration should also be given to consistency of design, with a single style only being used throughout the area. (Crosby Road South may be an exception due to statutory highways requirements). In some parts of the Conservation Area, particularly along Victoria Road, new galvanised lampposts have been located adjacent to the existing, which are still in situ. These are unpainted grey aluminium and appear to be the low energy type lighting, which give a bright, almost white light. Again, the concern is the inconsistency in design with a mix of styles, colour, height and illumination. New and unsuitably designed lampposts have a detrimental impact on the Conservation Area, and they reinforce the inconsistencies and range of styles present.

Examples of acceptable style lampposts

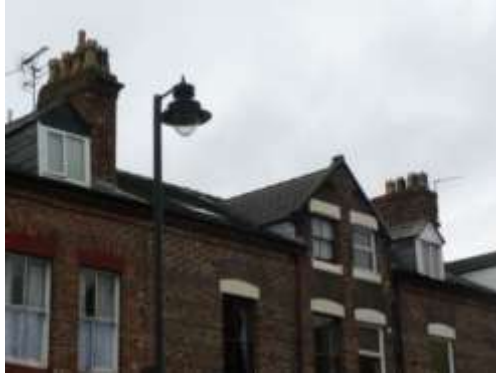
Examples of poorer quality lampposts

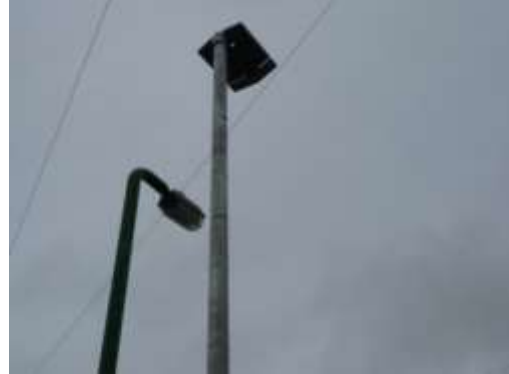
Conservation type lampposts on Waterloo Road New lighting columns on Victoria Road

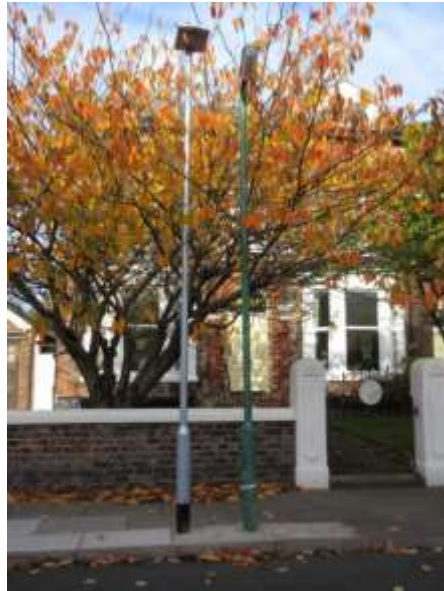
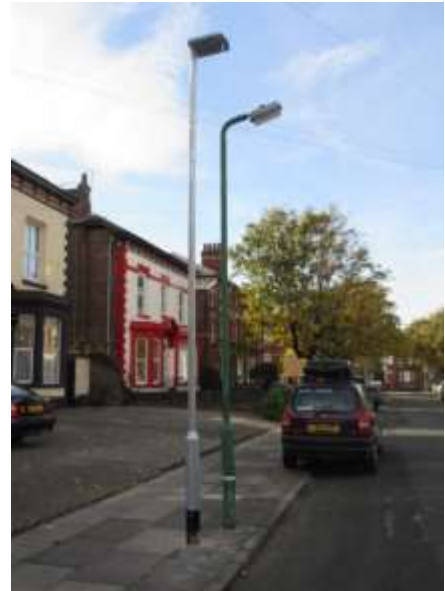
Replacement lighting columns on Victoria Road adjacent to existing

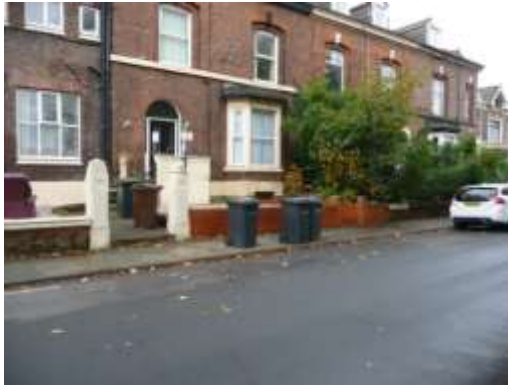
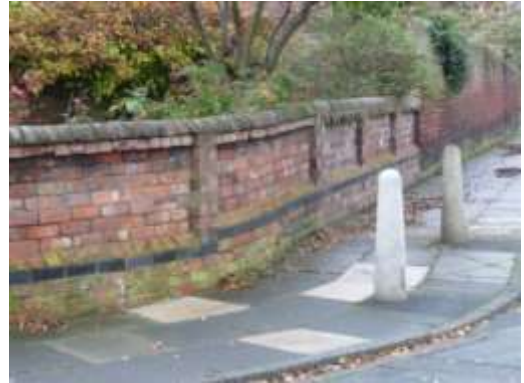
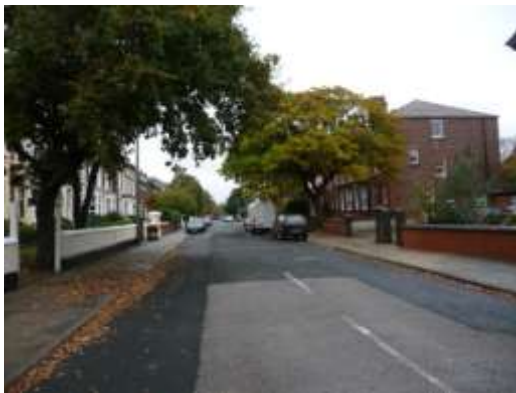
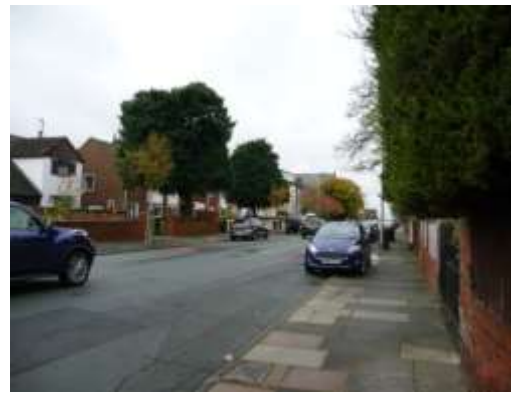
10. Pavement and road surfaces

The area currently uses tarmac and concrete road and pavement surfaces respectively. A patchwork of colours exists throughout the area, where broken flags have been replaced and utilities works to the roads have been undertaken. To signify and express the special quality and status of the Conservation Area, consideration should be given to improving the quality of the public realm surfaces. A comprehensive scheme would also help to unify the area.
