West Birksdale
Conservation Area Appraisal
Adopted March 2008

This conservation area appraisal was prepared by Donald Insall Associates in August 2007, amended following public consultation in November 2007 and fully adopted including the suggested boundary changes shown below in March 2008. For more reasoning on boundary changes please see Section 8.0

WEST BIRKDALE CONSERVATION AREA APPRAISAL

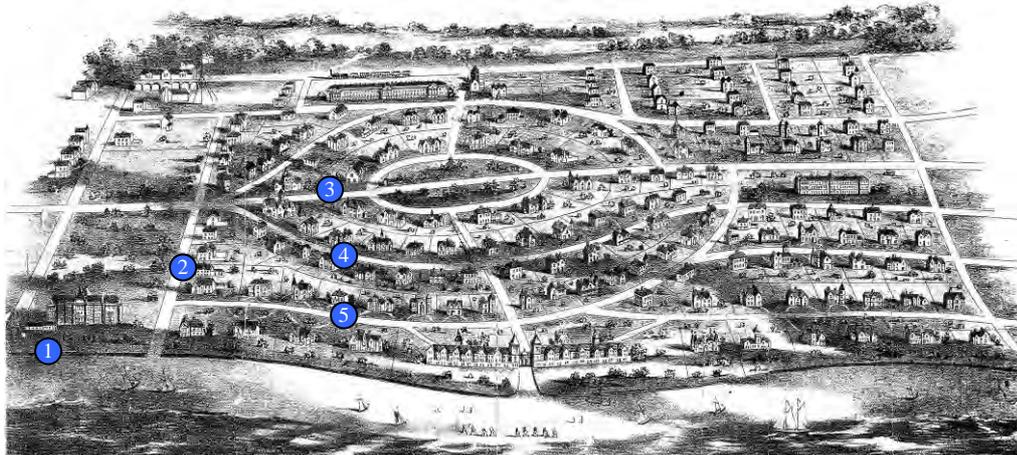
Reade and Goodison's original 1866 perspective for the layout of the second phase of building at Birkdale Park. Although quite different to what was actually built a few currently existing / well documented features can be discerned on the plan: 1) The Palace Hotel; 2) Oxford Road; 3) Waterloo Road; 4) Lancaster Road; 5 Westbourne Road.

The perspective also illustrates the newly constructed Birkdale Palace Hotel, on its bottom left corner. The hotel which opened in 1866, was situated between Weld and Oxford Roads, on a site that is now between the Birkdale Park and West Birkdale conservation areas. The grand building was 200ft or 17 bays long built amongst 20 acres of landscaping.

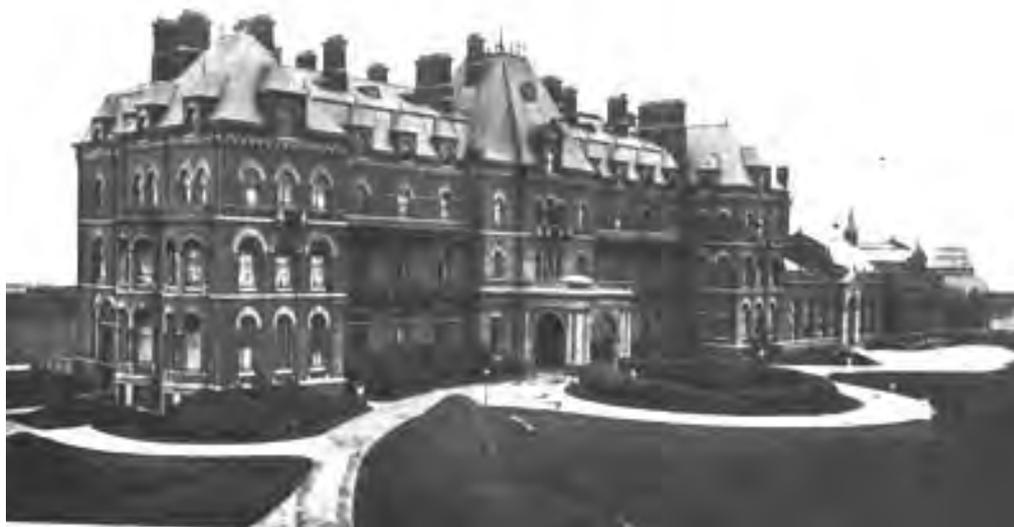
The inland-facing elevation of the nearby Birkdale Palace Hotel which was demolished in 1969.

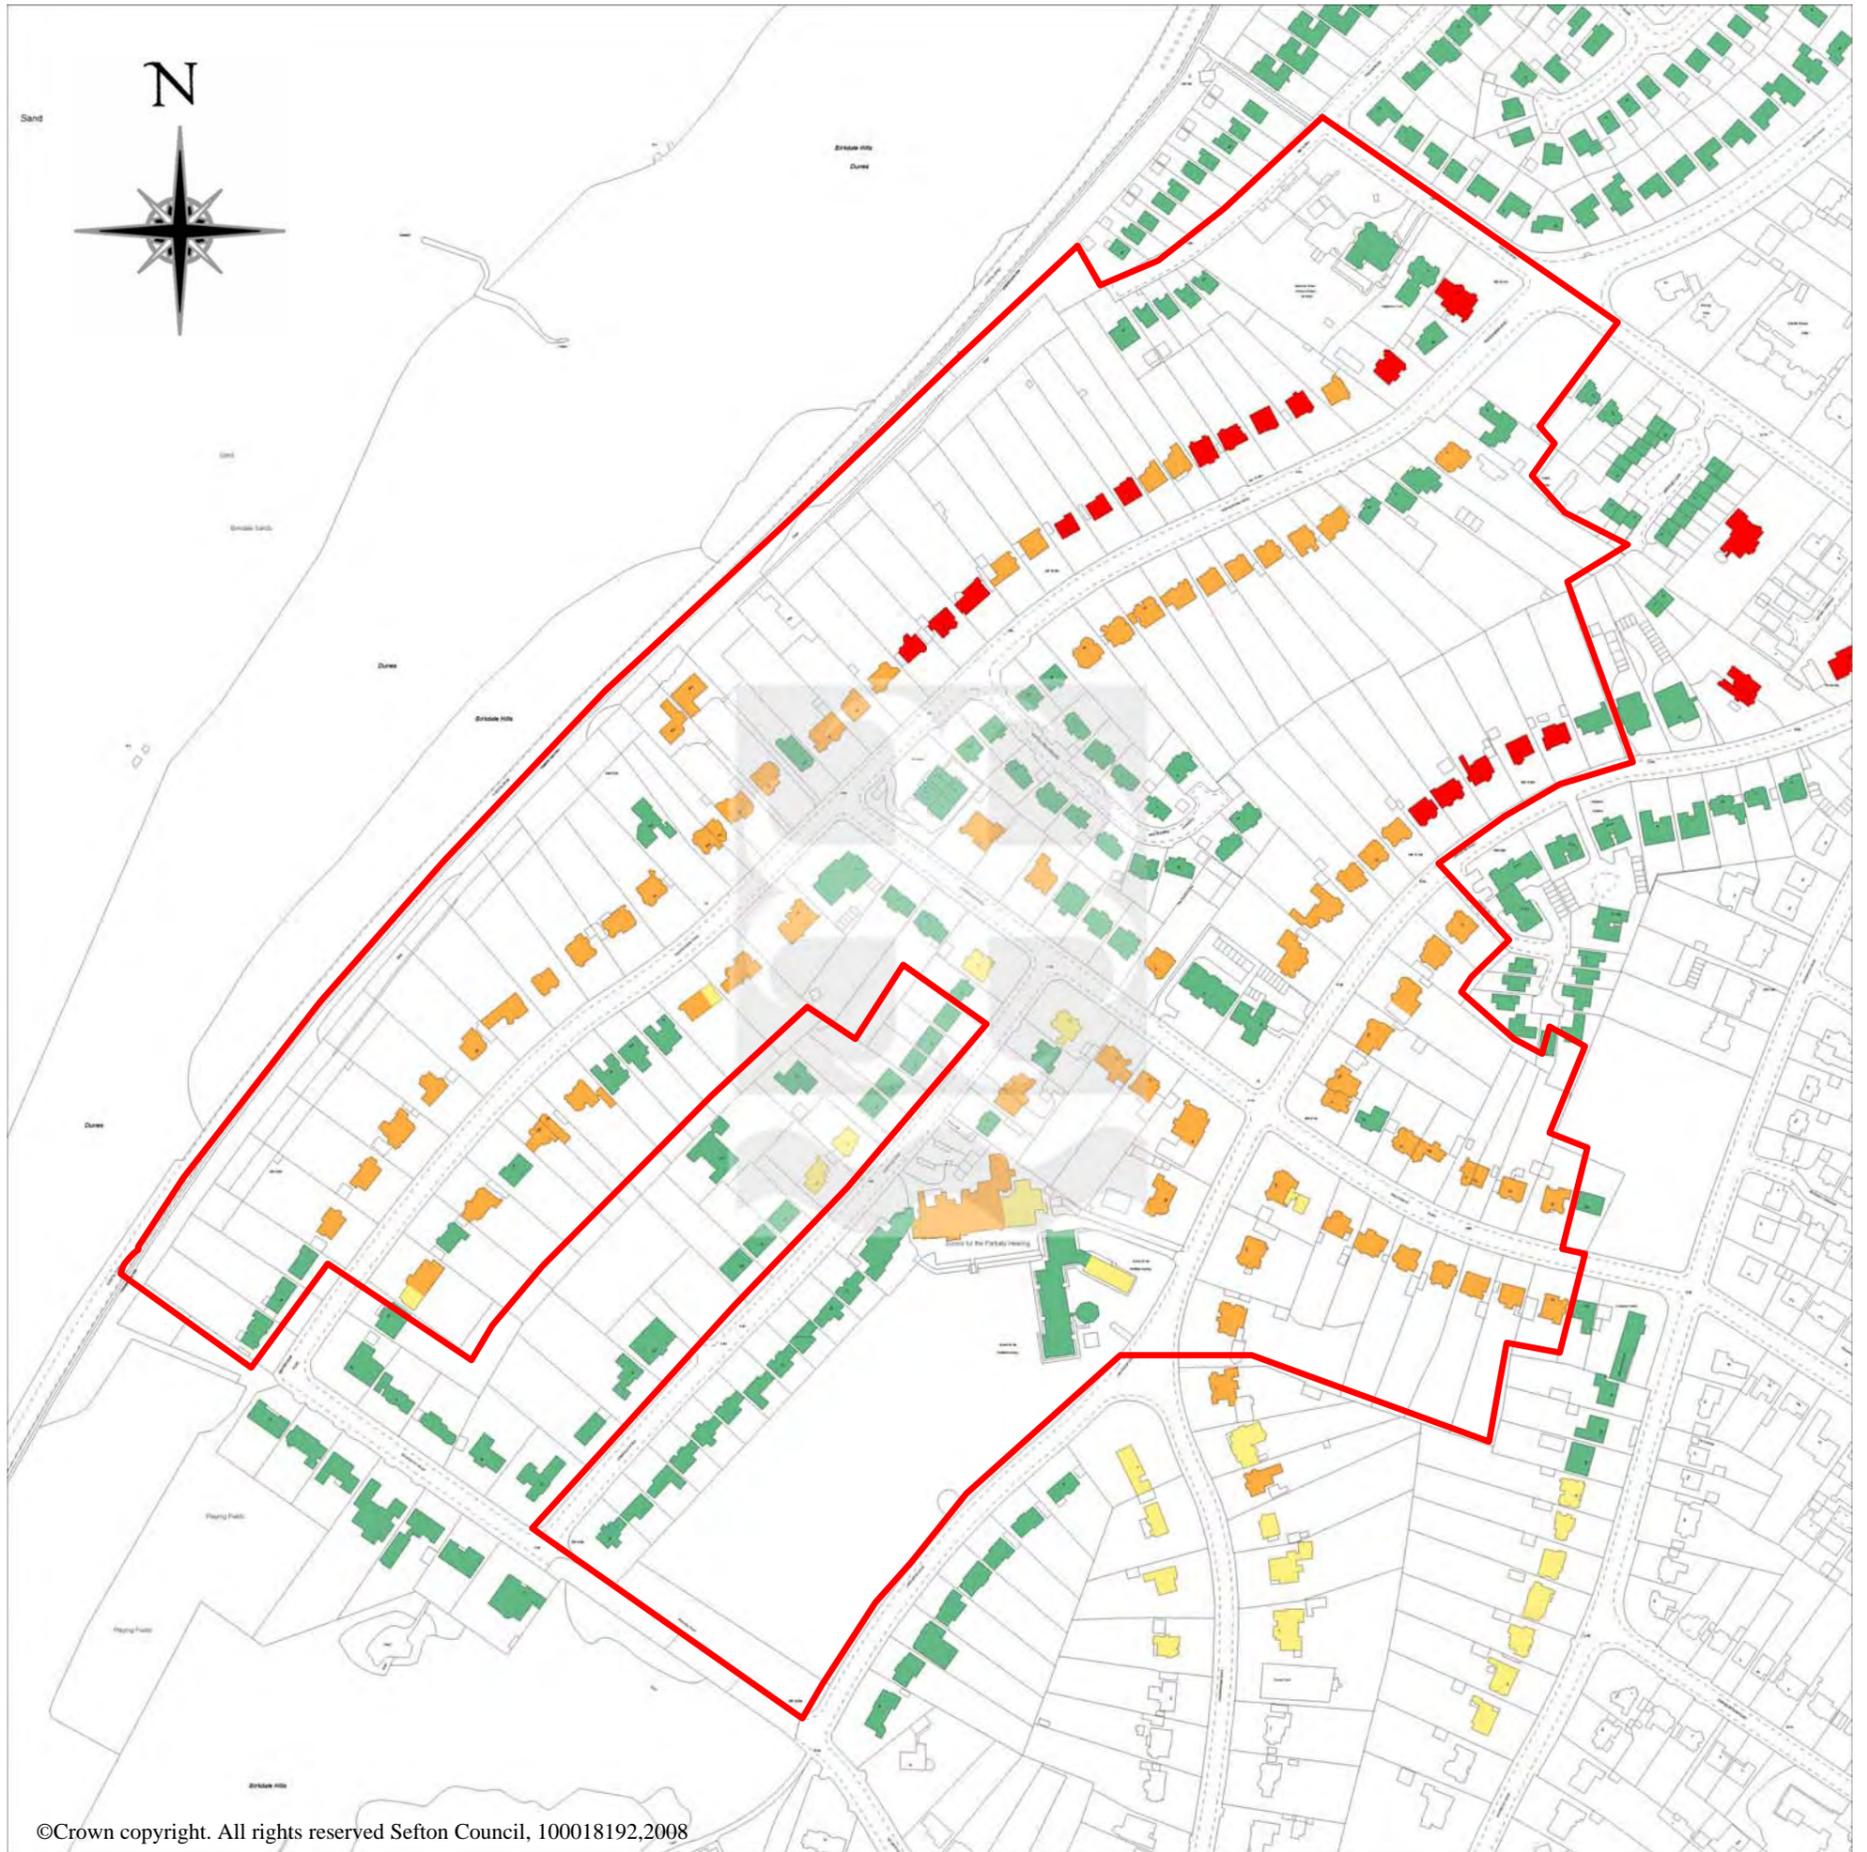
- Buildings built before **1893**
- Buildings built between **1893** and **1908**
- Buildings built between **1908** and **1927**
- Buildings built after **1927**

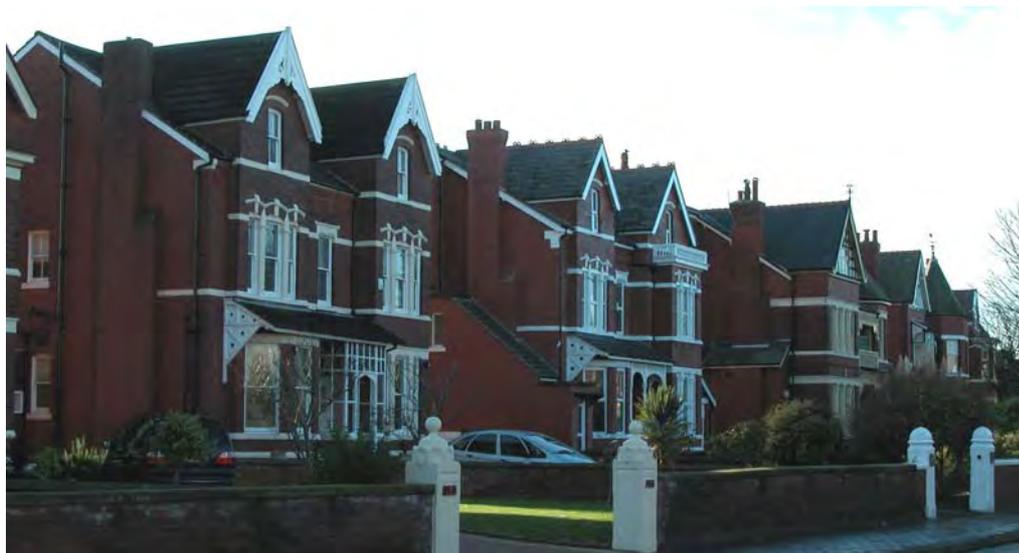
The rhythm of buildings on Westbourne Road

The rhythm of most areas of housing in West Birkdale is critical to its character. Westbourne Road has a particularly long, uninterrupted length of houses. Almost all housing built between the 1890s and the 1930s is of the same palette of materials, a comparable scale, a similar form (including roof pitch), an equivalent set back from the road and is at a repeated spacing. These factors make for a strong rhythm in the conservation area. Where there is a breakdown in the rhythm such as at Westbourne Gardens or 44B Westbourne Road, the building in question becomes more conspicuous and therefore more likely to be detrimental to the conservation area.

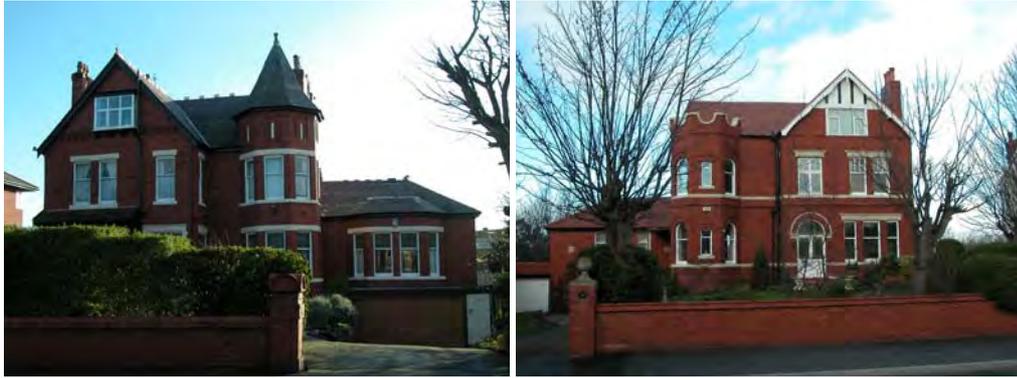
Repeated building forms given their own character by the different architectural treatment of almost all key features.

These repeated building types, although not identifiable as being such in decoration and detail, often share a common layout and are recognised as being similar by, for instance, chimneys in the same place to the same design. Although materials are kept to a limited palette, individuality of the original buildings was clearly important, with each house having its own combination of features, many of which were unusual or even unique. An example is in the treatment of bay and towers. Although the buildings can clearly be linked together by their plan forms, the architectural treatment of these features gives them distinct characters.

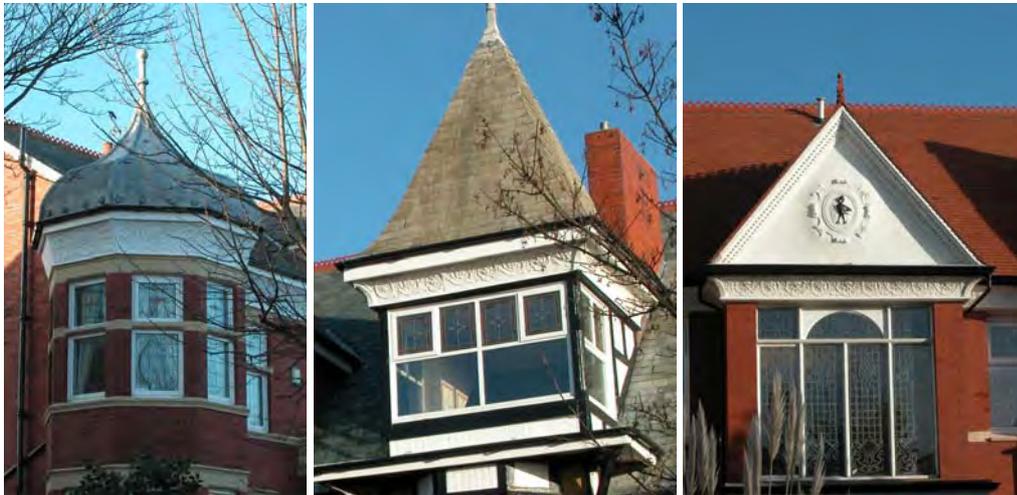
The same decorative plaster frieze is seen on 3 otherwise different buildings on Grosvenor Road, indicating that they were probably by the same developer.

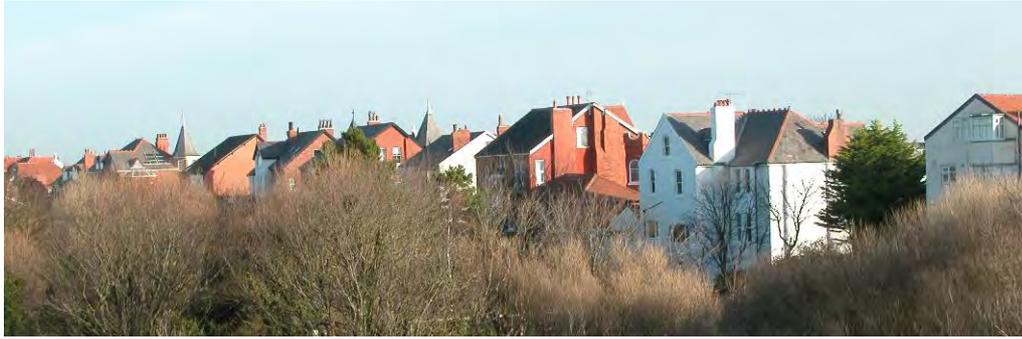
Houses on Westbourne Road, viewed from the sandhills along the coast.

Roofs of the buildings express the individual character and style of the buildings beneath and many use elaborate detailing around the eaves, verges and chimneys as part of their character. There are key factors such as pitch, materials and form, that generally link together the roofs of neighbouring buildings, creating an overall coherency.

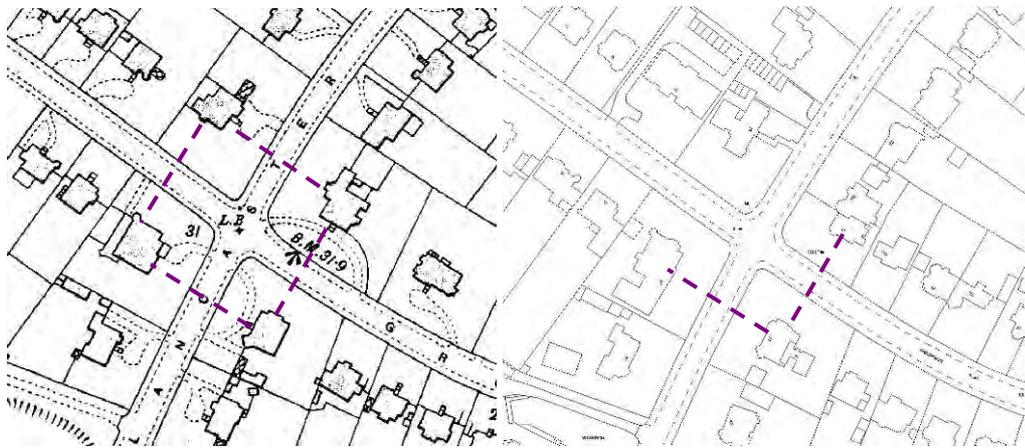
A building group on the junction between Grosvenor and Lancaster Roads. The two plans compare the relationship between 1908 and the present day, indicating the adverse effect of the modern development.

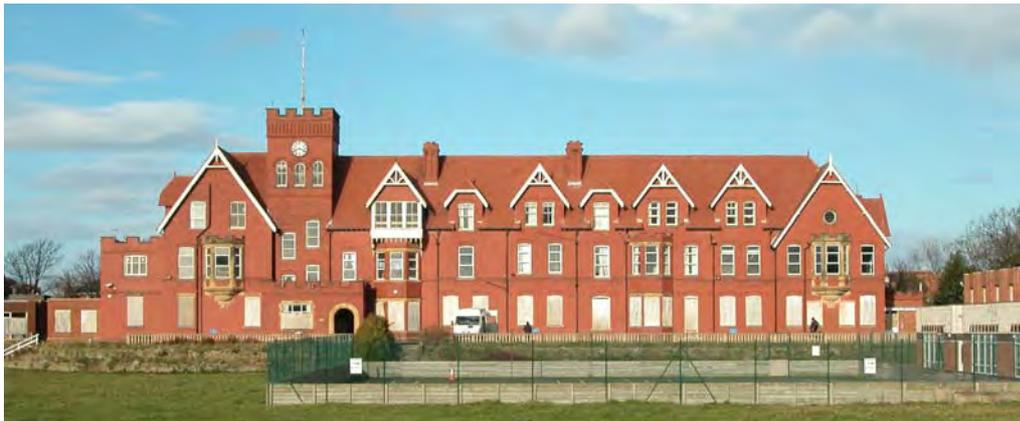
The only primary landmark in the area is the former Terra Nova school (annotated as '1' on the plan on the following page), as it of a considerable larger scale and orientated unusually at an angle to the road, giving it additional presence. Its spacious grounds set amongst an area of regularly spaced housing plots make it more of an unusual feature within the conservation area.

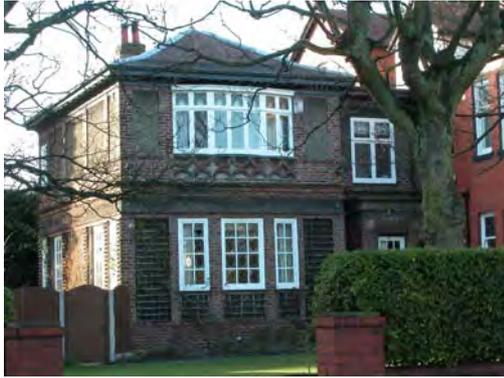
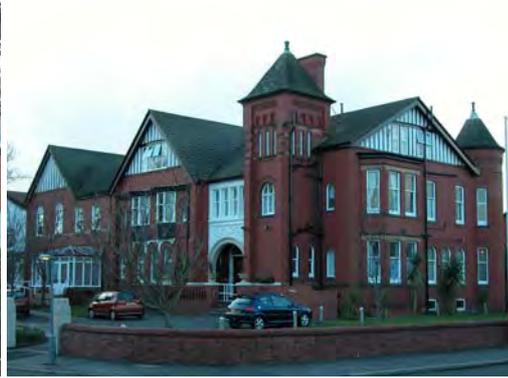
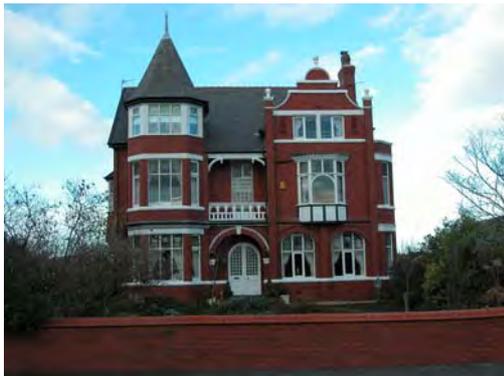
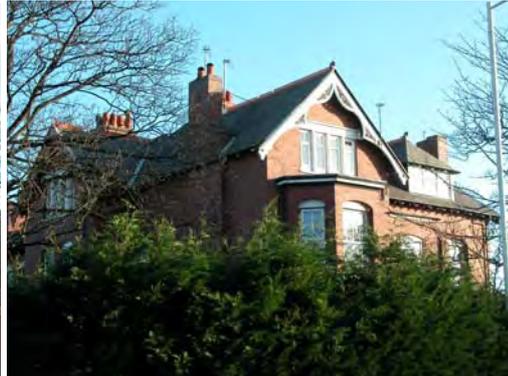
Secondary landmark buildings in the conservation area: (top left) 18 Grosvenor Road; (top right) 36 and 38 Lancaster Road; (bottom left) 50 Westbourne Road; (bottom right) 17 Grosvenor Road / 23a Lancaster Road

- Numbers 3 and 5 Grosvenor Road (2 & 3)
- Number 18 Grosvenor Road (interestingly because it is an oddity in terms of its scale) (4)
- Numbers 36 and 38 Lancaster Road (5)
- Number 50 Westbourne Road (6)
- Number 17 Grosvenor Road / 23a Lancaster Road (7)

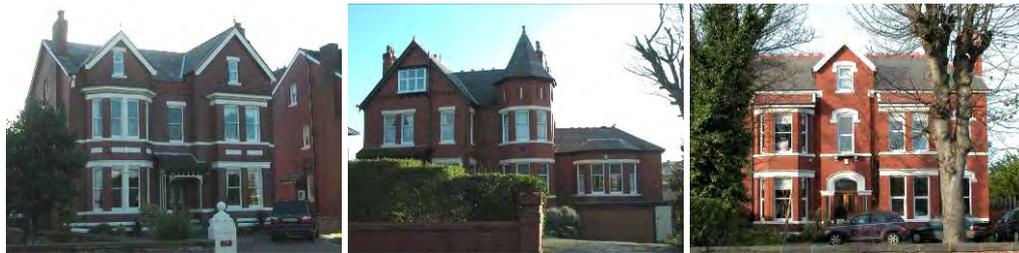
'Gothic' style houses within West Birkdale Conservation Area

Many of the earliest houses built within West Birkdale are of a Victorian gothic style. These houses were probably built within a relatively short period of between around 1880-1900, after Suburban Italianate had ceased to be popular and before the Arts and Crafts movement took hold. Typical features are ornate terracotta or stonework detailing (including hoodmoulds and door / window surrounds), steeply pitched roofs, pointed arch openings and dormer windows. Perhaps the most notably 'gothic' features seen regularly with West Birkdale are the towers and turrets. Bay windows are used extensively. This period and style saw a gradual move away from sash windows to casements often with leaded panes, although many houses unusually display leaded sash windows.

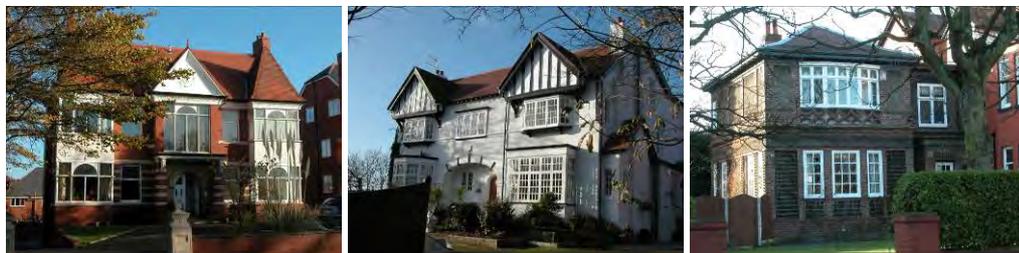
Buildings built using Arts and Crafts or Domestic Revival influences

Domestic revival / Arts and Crafts styles are also important to the character of the area and are used prolifically in buildings dating from around 1900-1935. At around the turn of the 20th century Arts and Crafts and gothic influences are often seen within the same buildings. A large palette of materials, including timber framing, brickwork, plain render and vertically hung tiling, are used. Arts and Crafts style houses display a high degree of craftsmanship, for instance in carved timber elements, and use traditional forms of decorative timber construction. Windows are generally leaded casements.

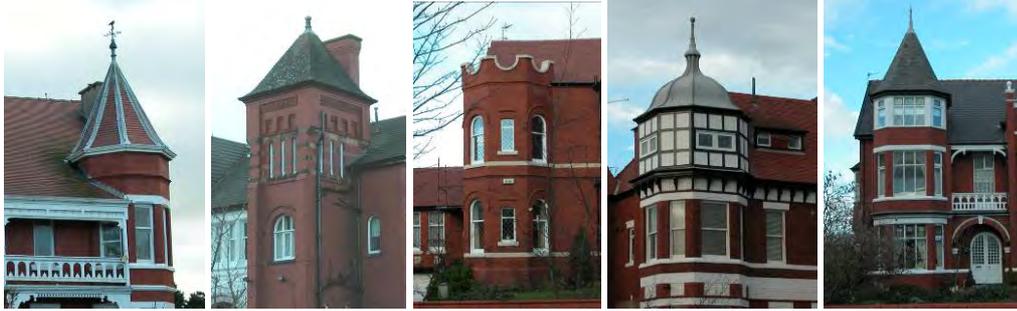
Turrets and towers

Towers and turrets: These architectural devices are used extensively throughout the conservation area, but mainly on buildings between around 1890 and 1900. Turrets are generally positioned on the south or west facing corners of building, with just a few exceptions (e.g. where the turret faces onto a junction). Turrets project above the eaves line of the buildings, often providing an additional 'half' storey of accommodation. The floor-plan shape of the turrets varies considerably with circular, octagonal and square plans all used. Similarly the shape and covering of their roofs also differs according to the exact styling of the feature. Spired roofs faceted to follow the shape of the tower are used with either slate or plain clay tile coverings. Most of these roofs kick out at the bottom. Crenellated and lead-clad bell shaped roofs are also used. Most spires on top of turrets are topped with a lead-clad or metal finial.

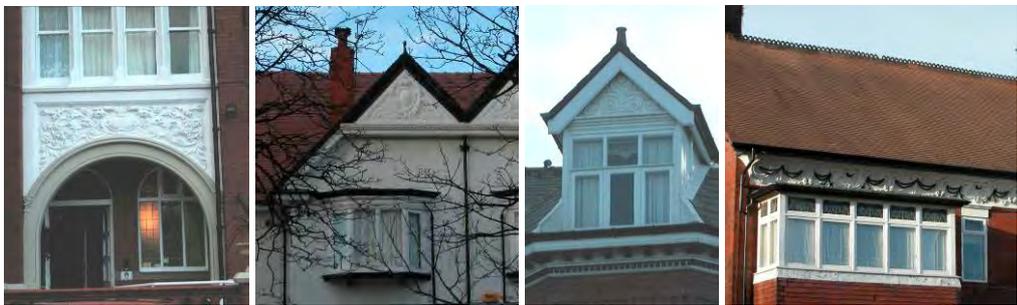
Decorative plasterwork

Decorative plasterwork: Decorative plaster panels are seen on many houses in the conservation area. They are used as a feature above doors, in gables, dormers and as an eaves cornice.

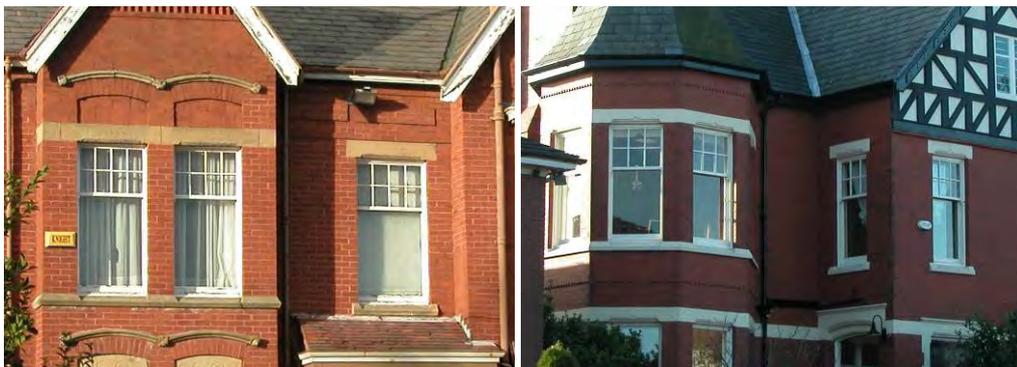
Sash windows within West Birkdale

Sliding sash windows: Vertically sliding sash windows are seen in the earlier buildings in the conservation area but rarely in buildings built after 1900. The most common configuration of glazing bars is the upper sash divided into 6 smaller panes, with the lower, larger sash glazed as one sheet. Horns are used regularly, but do not feature on all original windows. Sash windows are often grouped in twos or threes or used within bays. A particularly unusual and special feature of the conservation area is the use of lead comes and often stained glass within the upper sashes.

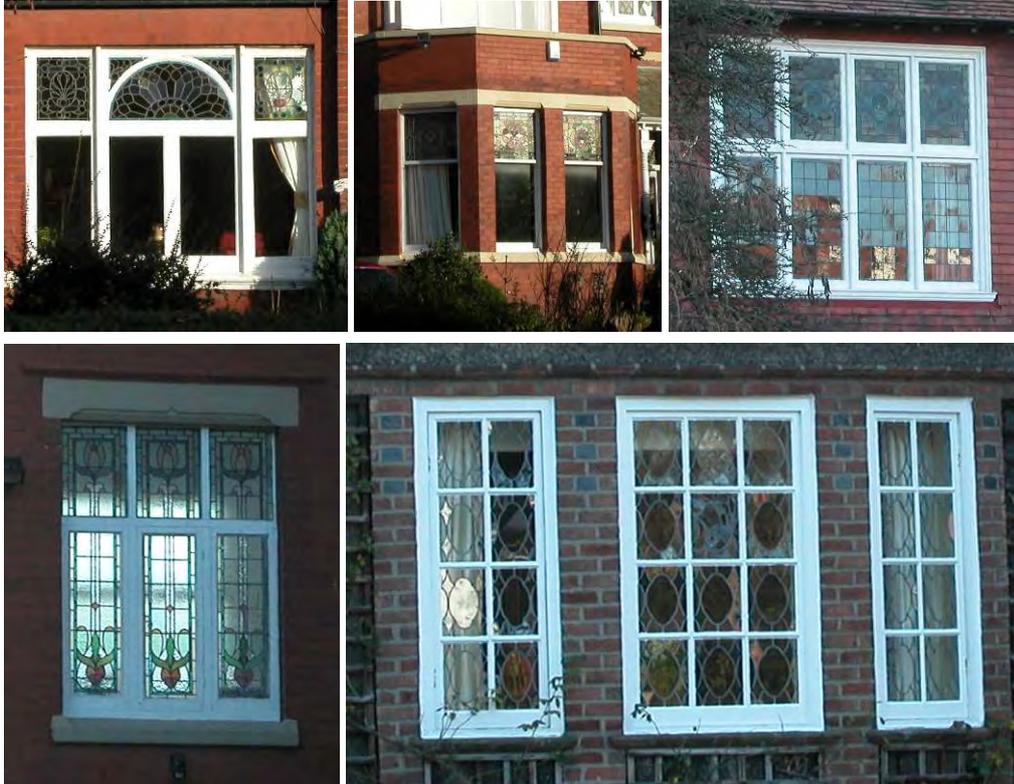
Decorative leaded windows: Leaded windows are seen extensively throughout the conservation area and are one of its most special, yet endangered features. Leaded windows would have been found in most buildings built between around 1890 and the 1920s in West Birkdale. Rarely are simple rectilinear or diamond patterns adopted throughout a building in West Birkdale. Most houses with original leaded

windows have some degree of decoration. This can be in the form of a geometric pattern, an arts and crafts inspired design and / or areas of stained glass. Typically the more decorative windows are in upper casements or sashes or to windows to hallways or above doors. Unfortunately, many very attractive original stained and leaded glass windows have been replaced in recent years with double glazing. Occasionally in these instances leading has been stuck onto the outer face of the window, but the overall effect is always crude in comparison to the originals.

Of particular importance to the character of the area are the leaded lights. These are generally examples of beautiful late Victorian or Edwardian craftsmanship and West Birkdale has an exceptional number of very good quality examples. However, these leaded panes are gradually being replaced double glazed units which cannot use the original panes. Where leading is simply adhered to a single pane of glass the effect is not the same, as the multi-faceted shimmering of light that the leaded panes give is lost.

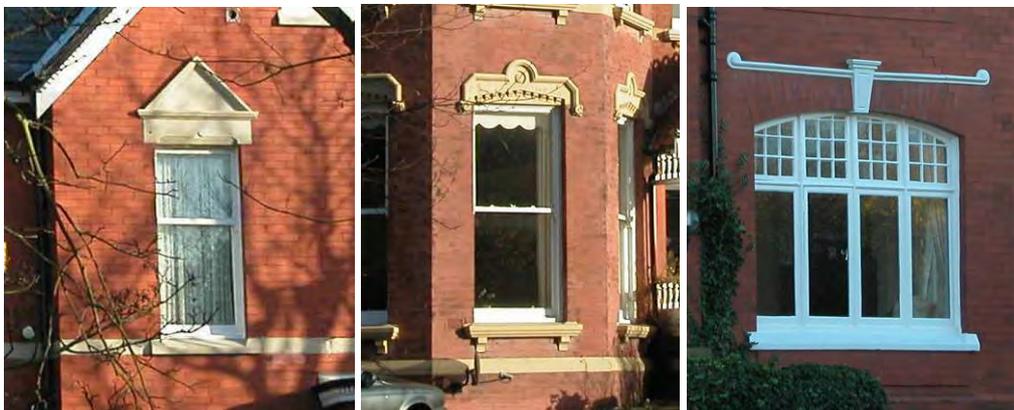
Window surrounds in West Birkdale.

Window surrounds: Ornate lintels are generally seen in the earlier houses that have plain sash windows. These lintels are of carved stone (painted) and are in a variety of forms. Often the style is varied between adjacent houses to express their individuality. Hood moulds are also seen regularly in the conservation area.

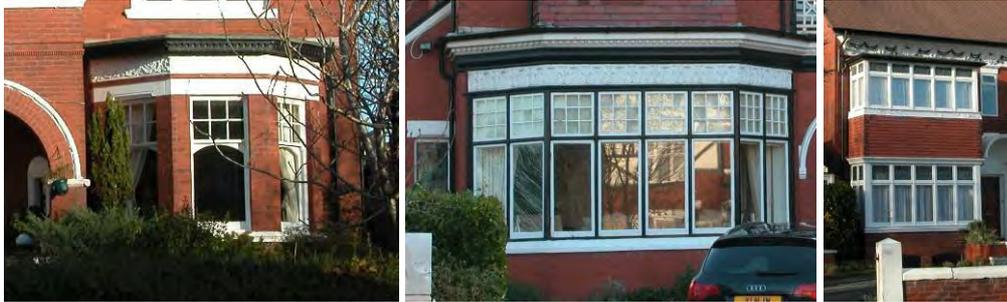
Bay windows: Bay windows are seen in the vast majority of buildings built up to the 1930s in West Birkdale. They are used both in the earlier ‘gothic’ buildings and the later Arts and Crafts inspired houses. These projecting windows create a hierarchy of rooms, denoting the principle living and bedrooms and engage the building with the streetscape. A variety of building materials are used – some are heavy and structural with thick masonry posts dividing the windows; others are lightweight, with simple timber mullions and transoms. The level of decoration to the bay windows is a particular special characteristic of the area with elaborate plaster cornices seen regularly.

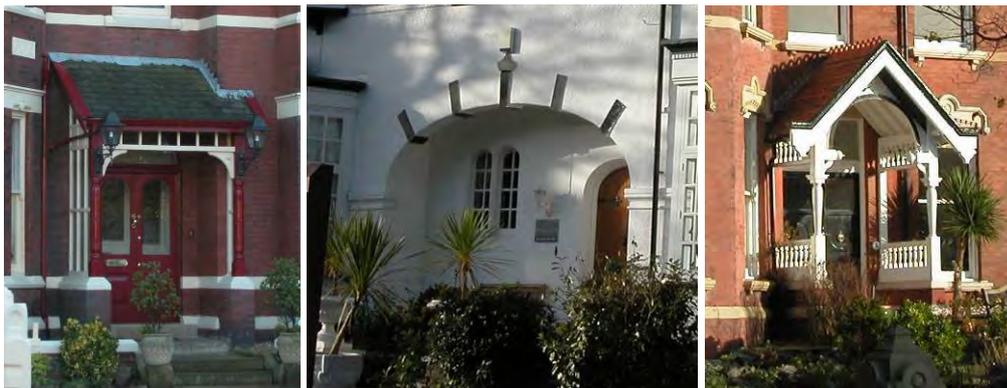
Doors, porches and canopies within the conservation areas

Doors, porches and canopies: A common door detail in West Birkdale is a simple timber and glass panelled door, set slightly back from the brickwork, which is sheltered by a timber canopy. The timber canopies express the architectural character of the building. Slated or plain clay tile roofs are supported on turned posts, which sit on low brick walls. Further timberwork is often used to decorative effect on the sides and ‘eaves’ of these canopies. Another common detail for entrances is where the door is set beneath a timber balcony to the first floor which spans between two bays or a tower. A detail seen in slightly later houses is a door behind a recessed archway. Porches are not seen commonly within West Birkdale, however, where they are seen they are an integral part of the visual character of the building, forming part of the front elevation ‘composition’.

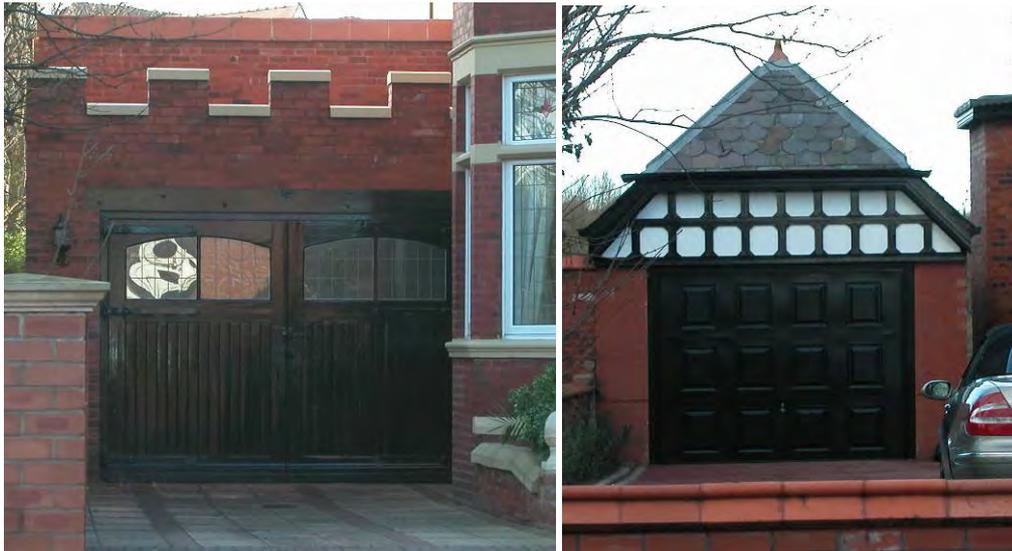
Garages

Coach Houses and Garages: Houses built from around the turn of the 20th century often have original or early garages or coach houses. These are often attractive buildings in their own right, with similar details and materials to their parent building. Most garages are built with a gable end facing the road. The gables have details such as timber framing. Where they still exist, the original or early doors are attractive, with large strap hinges and leaded glazed panes.

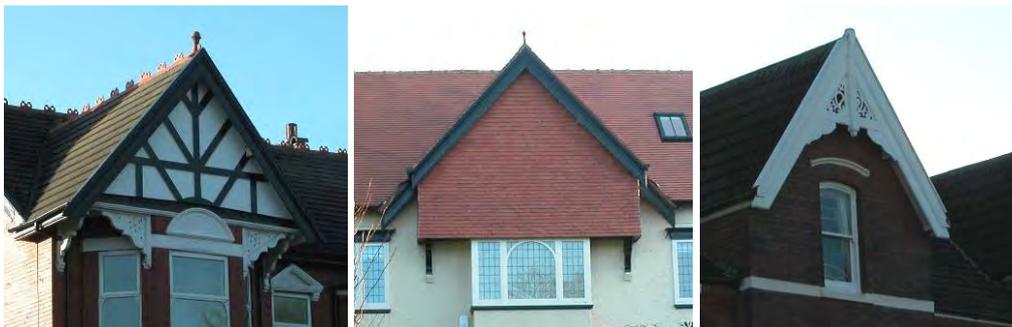
Gable details

Gable detailing: Gables feature some of the most distinctive detailing, with their treatment giving the buildings individuality, particularly where they are a variant of a repeated form. Timber framing and hung tiles are seen commonly, together with more occasional elaborately detailed timber exposed gable trusses.

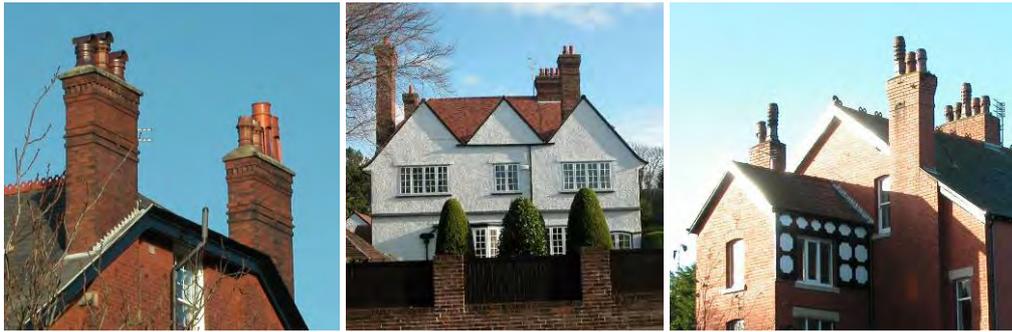
Chimneys within and adjacent to the conservation area

Chimneys: Chimneys are an important part of the architectural composition of buildings in West Birkdale. They are generally taller and more prominent than chimneys in neighbouring Birkdale Park. Earlier chimneys, from the 1880s and 1890s are generally rectilinear in plan with corbelling to the top courses and projecting bands often lower down. The later buildings, with a more Arts and Crafts influence, have squarer, more decorative chimneys. Almost all chimneys are of red brick. Most chimneys still have original or early pots. The tall height of the pots, together with the slender elegance of the chimneys adds to the interesting roofscape.

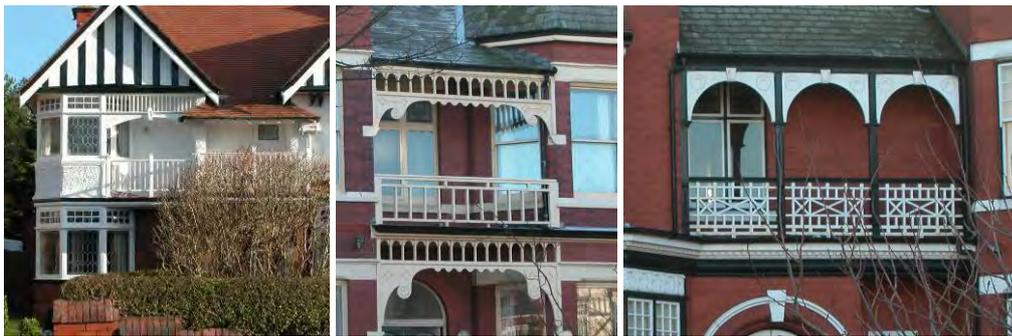
Timber balconies in West Birkdale

Balconies: The balconies on the fronts of buildings in West Birkdale are an unusual and particularly special feature in the areas character. Balconies generally span between bays and occasionally towers. All original balconies are painted timber. Balconies generally consist of a timber balustrade with vertical posts connecting it to an over-sailing section of the main roof. There are often timber brackets or further balustrading immediately under the roof line. Balconies are painted black, white or cream to match the colour of other timberwork. The level of decoration to the balcony depends on the design of the house. Timber scrolls, arched brackets and latticework often corresponds to detailing elsewhere on the building, such as to doorways or gable ends. Later buildings typically have simpler balconies.

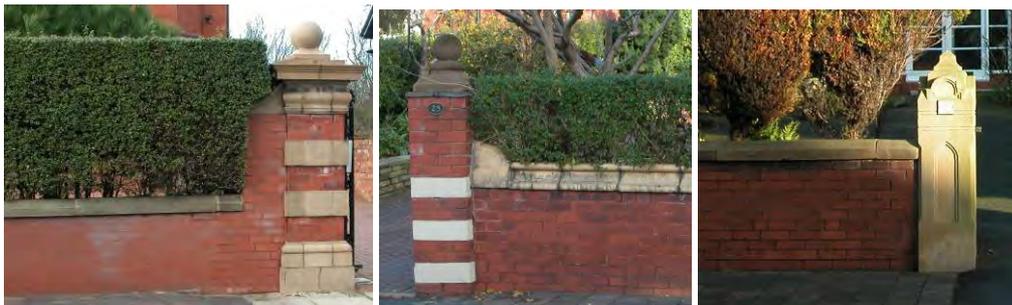
Gate piers within the conservation areas

Gate Piers: Sandstone or red brick gate piers are a typical feature throughout the Conservation Area. Their size and design vary to some extent with the grandeur and scale of the property to which they relate. Their contribution to the dynamic and character of the street scene is significant, even where the related property has been lost or replaced by new development. The majority of houses within the conservation areas have retained their original gate piers, although very few have original or appropriate gates between them.

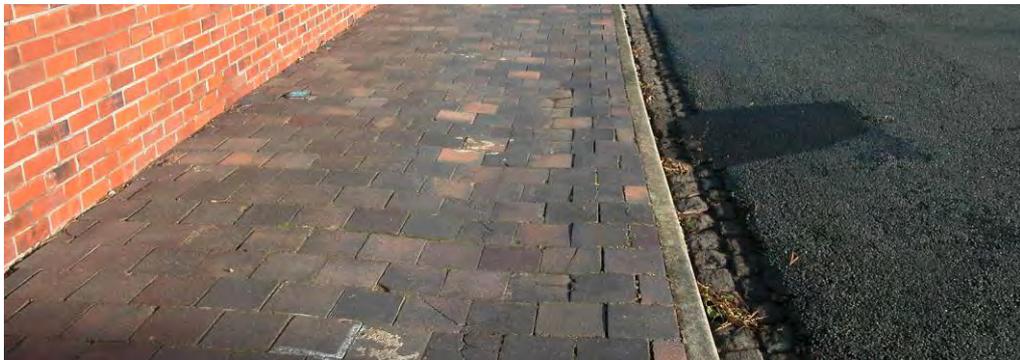
Typical surfaces within west Birkdale

Surfaces: The streets and pavements within West Birkdale are fairly consistent in terms of their materials. Almost all of the pavements have a surface of 9” clay paviours, which vary in colour from blues, greys and purples. It is possible that these are original to the construction of the roads. At driveways these paviours have generally been replaced with modern tarmac. There is a mixture of old limestone and modern concrete kerbstones through the conservation area. Adjacent to the kerb is often a drainage channel lined with granite setts. It is not known whether these historic setts extend under the modern tarmac surface.

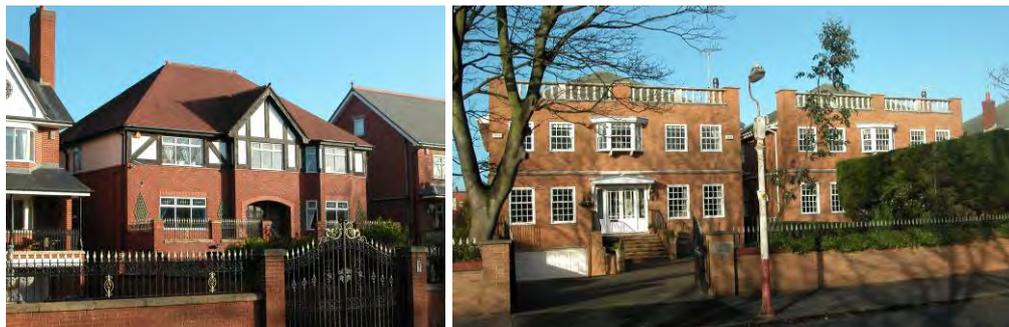
Small groups of detached houses built in the late 20th century.

Individual or small groups of houses built during the second half of the 20th century are generally large detached buildings of a fair standard of build quality and detailing, in comparison to other contemporary buildings elsewhere. Although these buildings have had some money put into the quality of their materials and a degree of effort into their design, they generally jar with the character of the conservation area in terms of their scale and spacing and their overall quality falls far short of their more historic counterparts. The storey heights of these buildings are without exception lower than their historical counterparts and they are spaced much closer together. Although some of their materials are appropriate and some effort is often made to use local detailing, the design quality of all details such as openings, windows, eaves and gable treatment is far inferior to that seen in the original buildings in West Birkdale. In addition to the above, many modern houses adopt a neo-classical style, with porticos and balustraded parapets. Although these particular buildings may share the same aspiration to quality and opulence that the original buildings may have had, their architectural style is entirely out of place in the area.

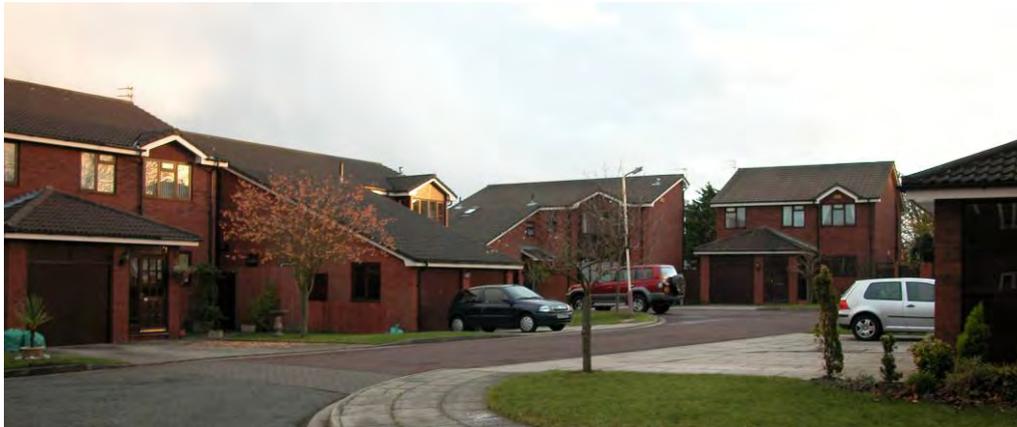
Modern cul-de-sac just outside, but affecting the setting of the conservation area.

In a few instances, a number of small houses have been fitted within the gardens or large plots of existing houses, often in the form of a cul-de-sac. The introduction of a new road access onto an existing street involves the demolition of one or two existing houses and changes its character often dramatically, breaking the otherwise continuous line formed by boundary walls and heavily disrupting the rhythm of the existing villas. Despite the small scale of their buildings, modern developments of houses have a significant effect on the streetscapes and this is shown in the creation of the modern cul-de-sac of housing off Westbourne Road, which would otherwise until recently have had a continuous, unbroken run of original villas on its north-eastern end on both sides of the street. The houses placed onto Westbourne Road as part of this development completely fail in their attempt to masquerade as original villas, particularly as they are of a much smaller scale.

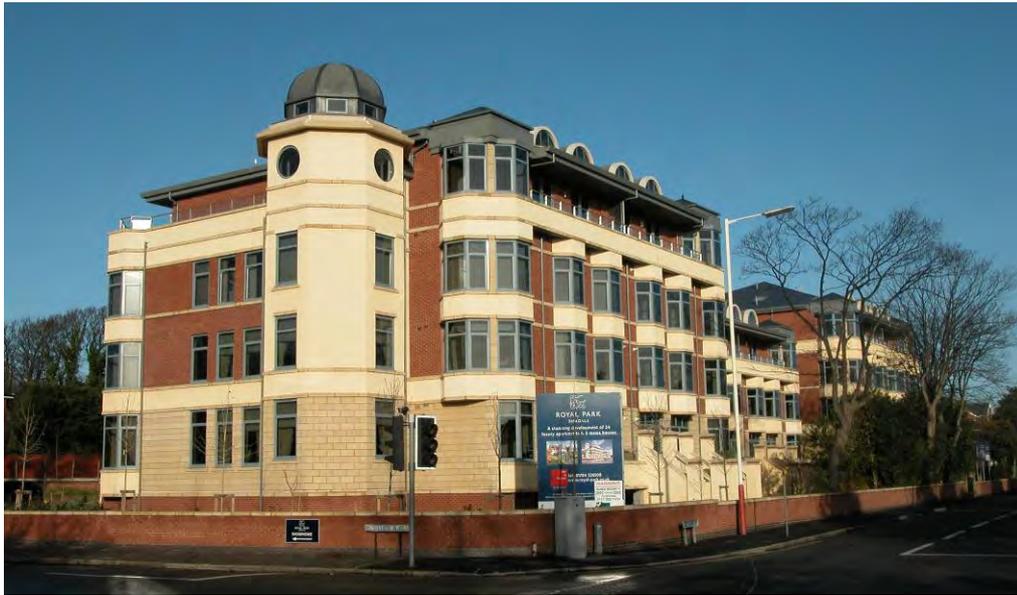
An example of a recent development of apartments. Although the building is sited just outside the conservation area, it greatly impacts on its setting. The scale of the building greatly dominates other surrounding buildings and it is built a long way in front of the existing building line, adding to its prominence. Whilst a building on this site should act as a gateway to the area beyond, this building bears almost no resemblance to the massing and quality of materials and detailing of West Birkdale Conservation Area.

Corner sites appear to be particularly under threat from applications for demolition of the existing building(s) and replacement with larger apartment blocks. Sadly this phenomenon is currently happening on the corner of Oxford Road and Westbourne Road which has seen the loss of one of West Birkdale's earlier houses, which had acted as a gateway to the conservational area. It replacement with a significantly larger apartment building is imminent at the time of writing.

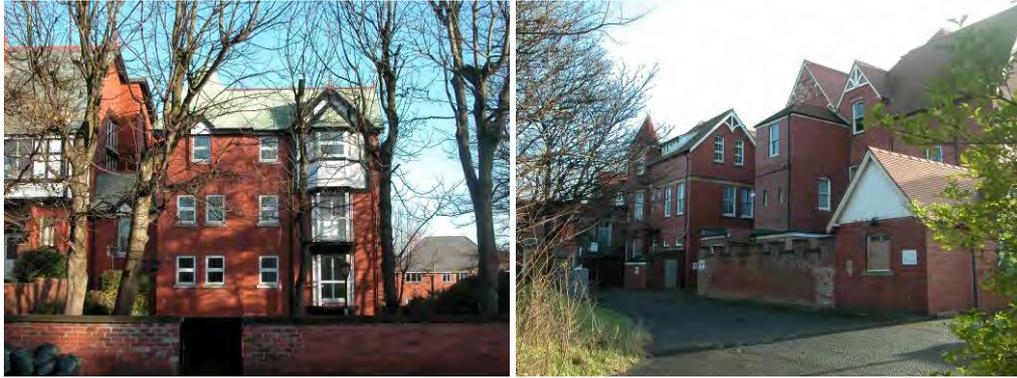
Significant extensions to 3 Grosvenor Road and to the rear of Terra Nova

Number 3 Grosvenor Road has a significant recent extension. The extension largely fills what was the building's grounds. The original building is one of the most architecturally interesting out of all the houses in the conservation area and has some of the finest detailing. The extension is comparatively crude, with ill-proportioned windows with thick frames and no detailing at their heads, a modern roofing material unconvincingly attempting to emulate slate and poor quality, plain timber bargeboards and fascias. The basic nature of this extension devalues the architectural quality of the original building.

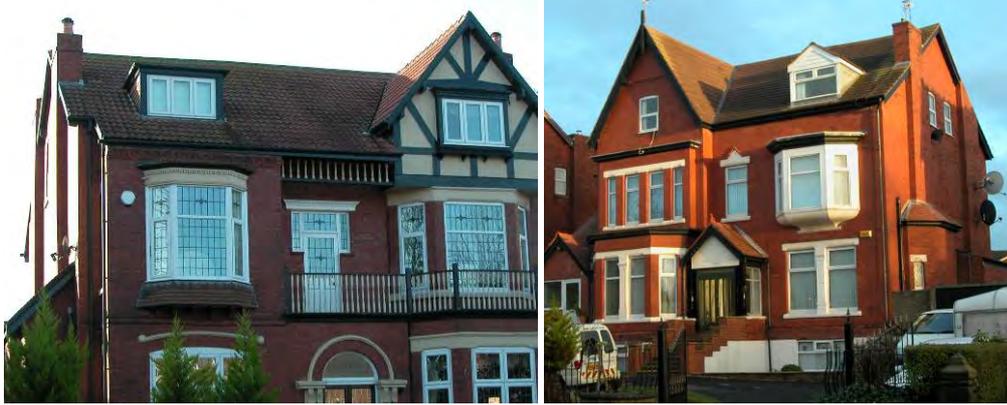
The negative effect that replacement pantile (left) and concrete tile (right) roof coverings have on the appearance of a building.

Roofs: In around six or seven instances original Welsh slate or plain clay tiled roofs have been replaced in concrete tiles or pantiles. Roofs play a critical role in the character of the conservation areas, particularly in the longer 'streetscape' views, visually linking similar building types. Although both plain clay tiles and Welsh slate roofs are seen in the conservation area, building owners should be dissuaded from replacing their roofs in anything but a like-for-like replacement as the type of roof covering is directly linked to the buildings architectural character.

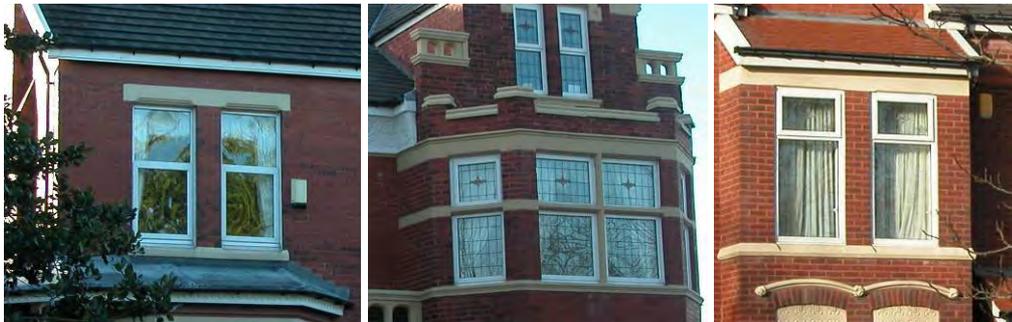
Replaced windows in the conservation area

Windows and doors: Around half of the original houses within the conservation areas have had at least some of their windows replaced either with uPVC or inferior quality timber windows. This is particularly damaging to the character of not only the individual properties but also to the streetscene. The introduction of thicker framing members (almost always necessary with uPVC), the removal of glazing bars, the reconfiguration of the window, etc. all have a detrimental effect on the appearance of the property and the overall visual quality of the area.

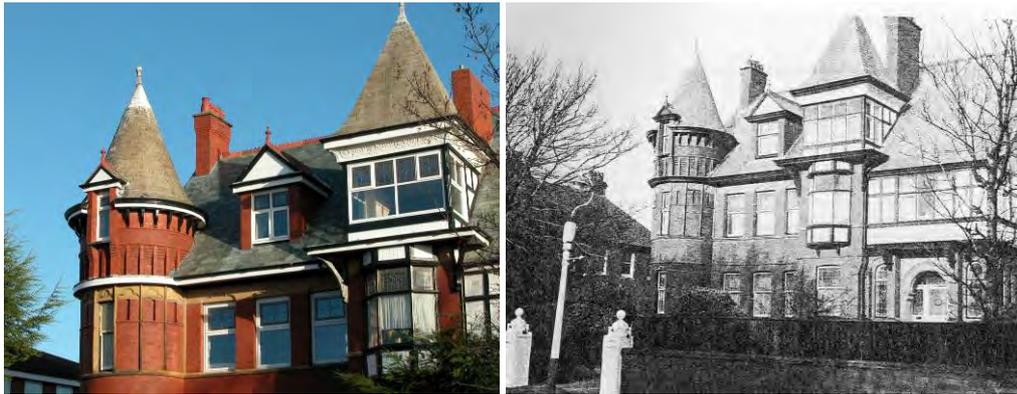
These photographs illustrate the negative impact of changes to windows, timberwork, chimneys and panelling within the past 20 years. In this time the front boundary wall and gateposts have also been removed. The trees and shrubs to the front garden have also been lost.

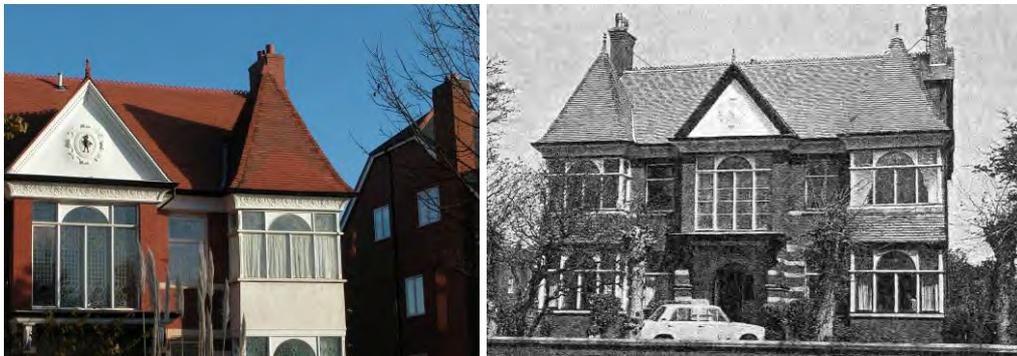
The above photographs illustrate the changes to no. 5 Grosvenor Road. The leaded windows have been double glazed, leaving one smooth plate of glass on the outside. Although the leaded comes have been retained, or replicated on the inside one of the essential characteristics of the glazing, namely the shimmering faceted nature of the windows in the sunlight, has been lost. The hung tiles to the square bays have also been replaced by comparatively crude render and the tops of the chimneys removed.
