West Birksdale
Conservation Area Appraisal
Adopted March 2008

This conservation area appraisal was prepared by Donald Insall Associates in August 2007, amended following public consultation in November 2007 and fully adopted including the suggested boundary changes shown below in March 2008. For more reasoning on boundary changes please see Section 8.0

WEST BIRKDALE CONSERVATION AREA APPRAISAL

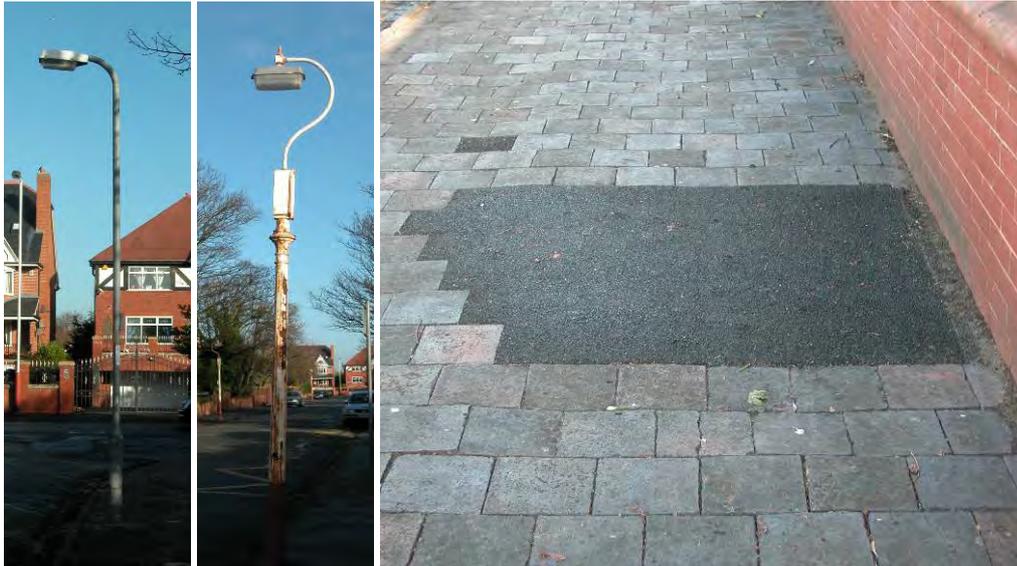
(Left) An example of a poor quality, modern lamppost; (middle) an example of an older cast-iron lampposts, with a modern alteration – the original part of this lamppost could be used as a model for any replicas in the conservation area; (right) a crude repair to the attractive clay pavings.

Many of the lampposts within the conservation area are of a very basic quality, with no design merit. A long-term programme should consider the replacement of modern, poor quality lampposts and other street furniture, such as street signs. Traditional designs should be used, based on the evidence of early photographs where they are available. Although the quality of the paving is generally good, in some instances it has been crudely repaired with tarmac. A programme should be undertaken to repair these defects and reintroduce historic materials where missing.

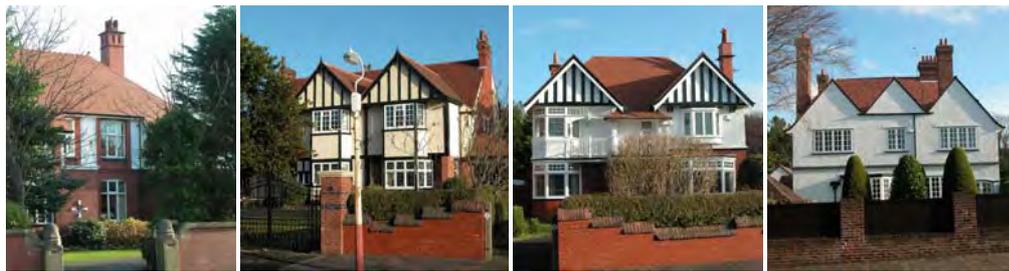
Some of the buildings on Sandringham Road, which are proposed for inclusion within the conservation area boundary.

It is recommended that the conservation area boundary is extended to include the above houses as they have most of the characteristics that are special to the conservation area. They are of a similar scale and relate to each other and their boundaries in a similar way as buildings, for instance, on Westbourne Road. Materials seen within the existing conservation area boundary, such as red brick, timber framing and plain clay tiled roofs are seen within this group of buildings. The quality of detailing is very high with some ornate details such as leaded glass and timber balconies. Many of these buildings have attractive, tall chimneys. The overall architectural composition of many of the buildings is particularly good; most notable are numbers 5 and 9 which are of particularly good Arts and Crafts designs.
