Flood Investigation Report

Fouracres (Maghull), Sefton Lane (Maghull),
Hawksworth Drive (Formby), Water, Street (Thornton)
and Moss Lane (Lydiate)

Date of flooding: 24/09/2012

Version 1.2
November 2012

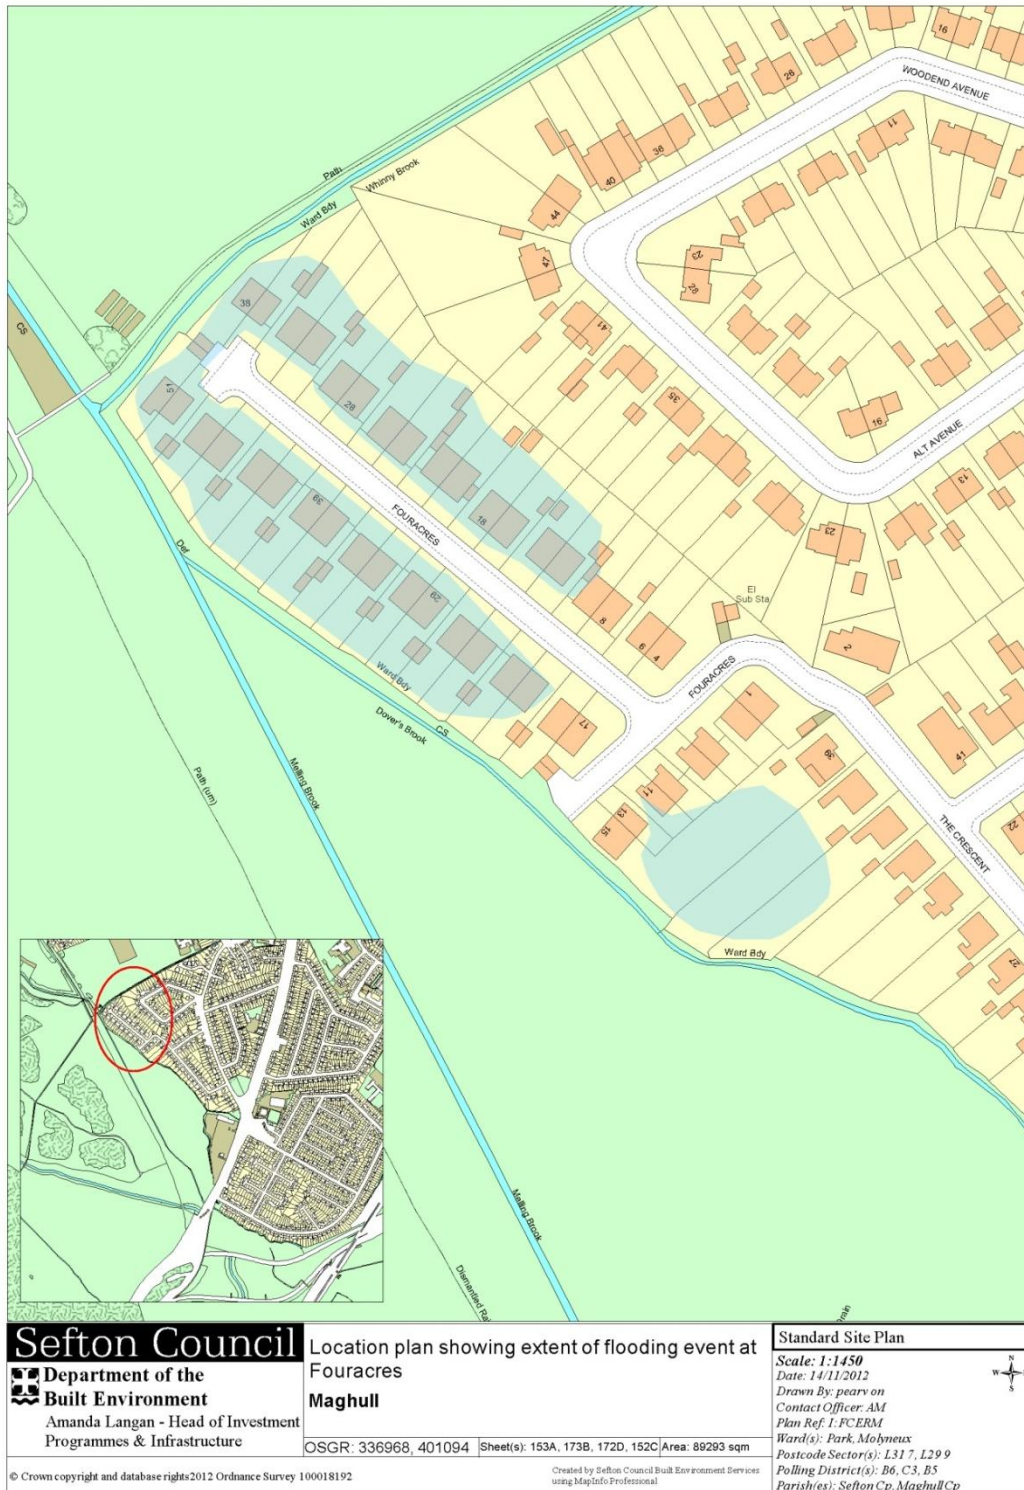
Figure 1: Site location and flood extent

Fouracres is a small residential cul-de-sac situated at the confluence of Whinny Brook and Dover's Brook on the western side of Maghull. The estate was built circa 1964.

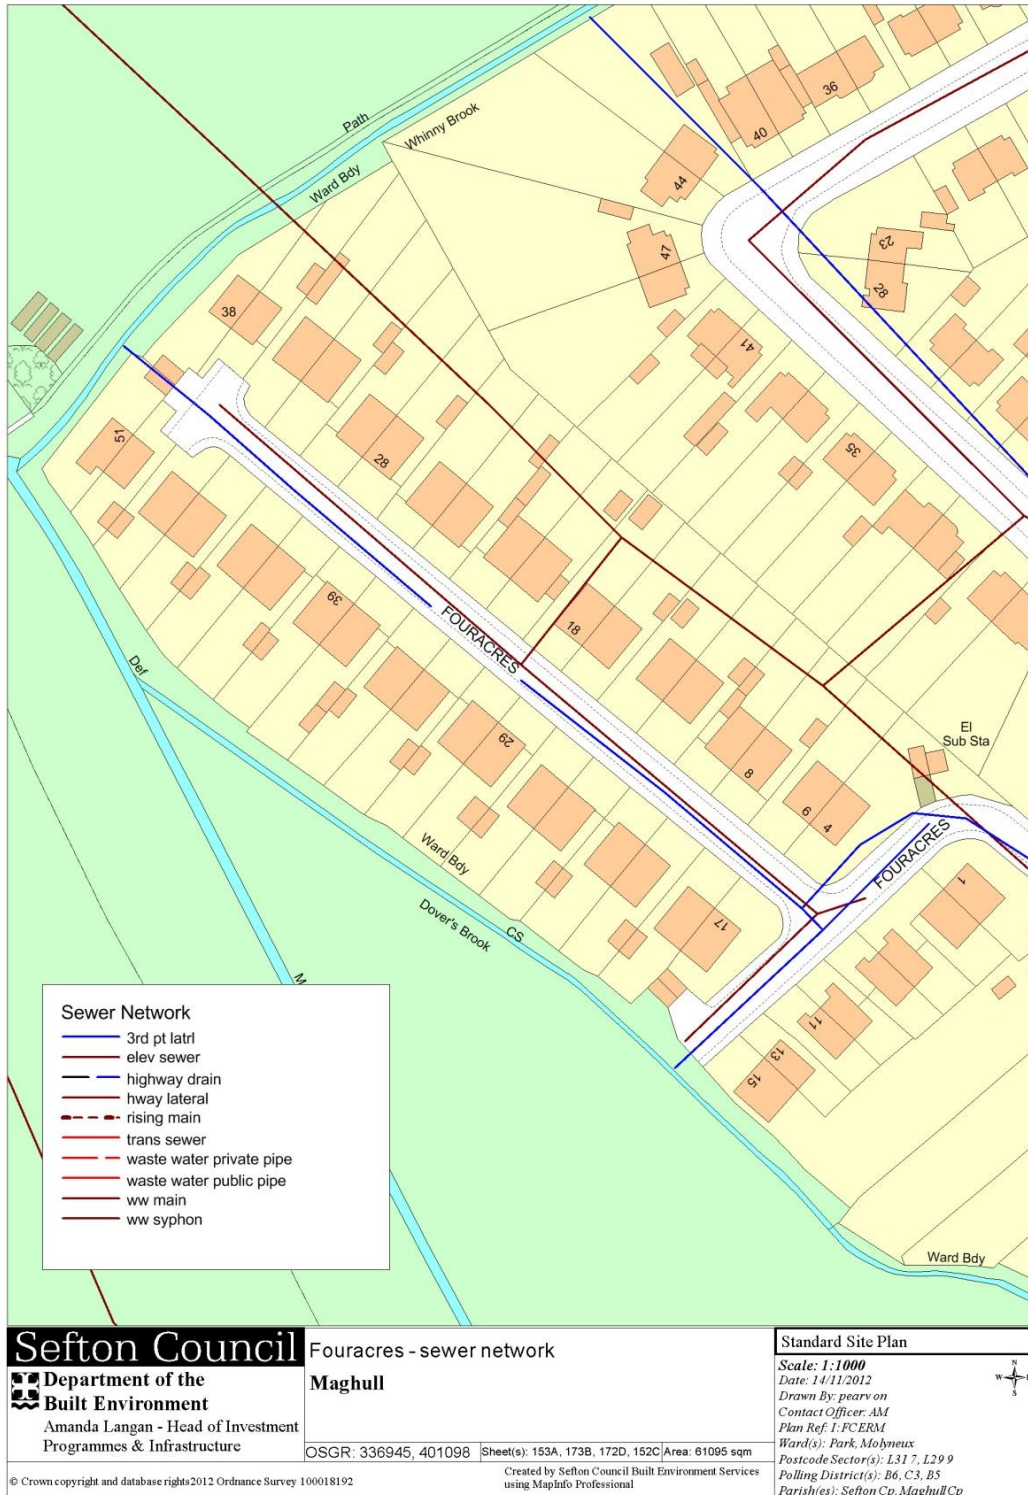
Figure 2: The sewer network

The area is drained by normal surface water methods, within the property boundaries drainpipes discharge to gullies which connect to the surface water sewer which, depending on location within Fouracres, either discharges into Dover's Brook or Whinny Brook via an outfall. Similarly highway drainage is collected by gullies and discharges via the same mechanisms.

United Utilities did not find a blockage on the surface water sewer system either. However, it was found that neither of the 2 outfalls which discharged into Dover's and Whinny Brook had a flap/non return valve on them. They have undertaken to carry out further investigations on the system to better understand it and check for cross-connections.

Number	Recommendation	Lead Risk Management Authority
1	Investigate the merit of installing flap valves/non return systems on the outfalls into Whinny Brook and Dover's Brook.	United Utilities
2	Co-ordination of maintenance priorities and works between the Risk Management Authorities	Environment Agency

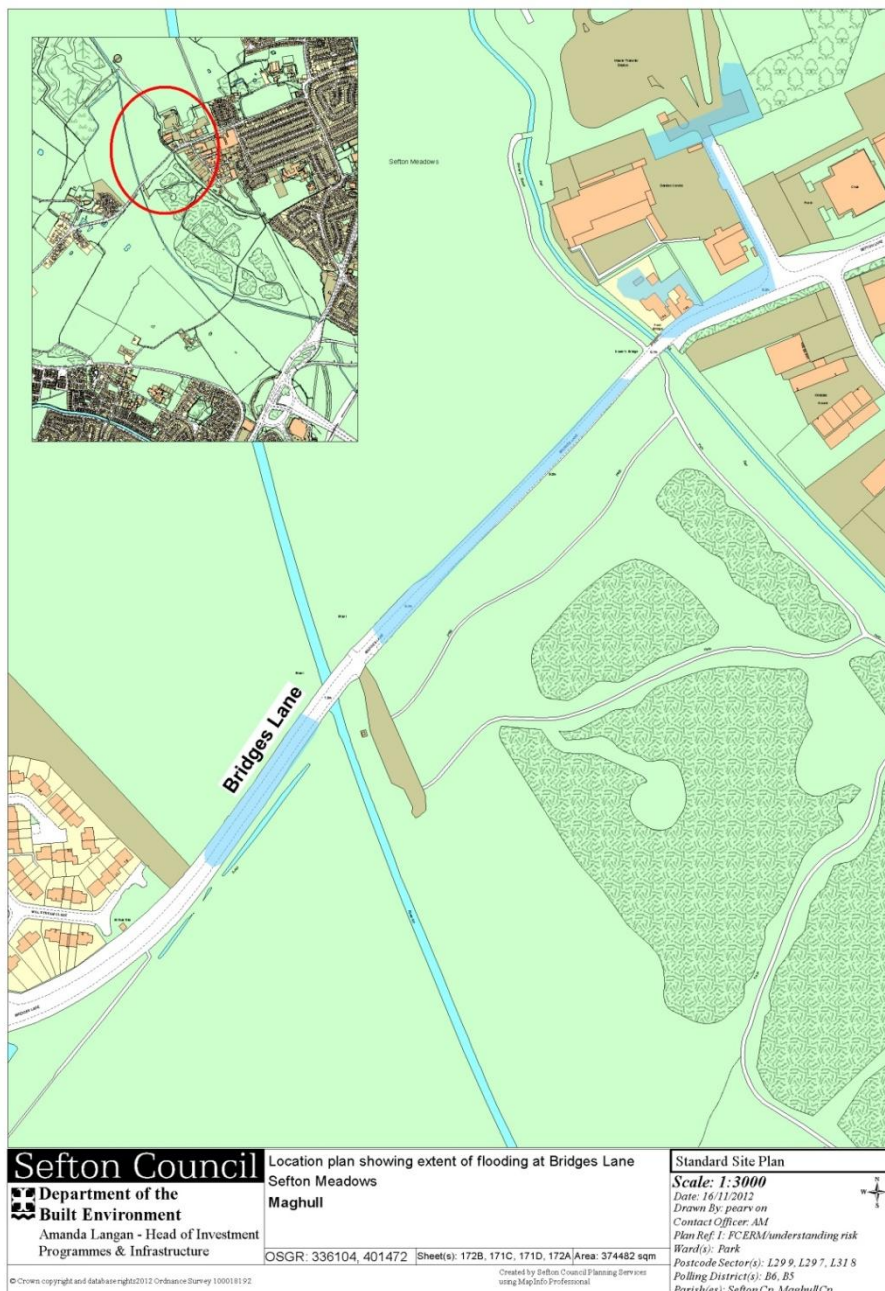
Figure 9: Site location and flood extent

Sefton Lane is on the western side of Maghull linking it with Sefton village via Bridges Lane. The road is a busy commuter route which also serves the industrial estate and the waste recycling centre at Sefton Meadows. The road name changes at the bridge over Dover's Brook to Bridges Lane.

Number	Recommendation	Lead Risk Management Authority
1	Environment Agency should engage in further discussions with the riparian owner at Dover's Bridge about raising the embankment, to raise the low point in the defence.	Environment Agency
2	Council to discuss with the local farmer any more suitable measures to stop surface water flowing from the field into the highway.	Sefton MBC

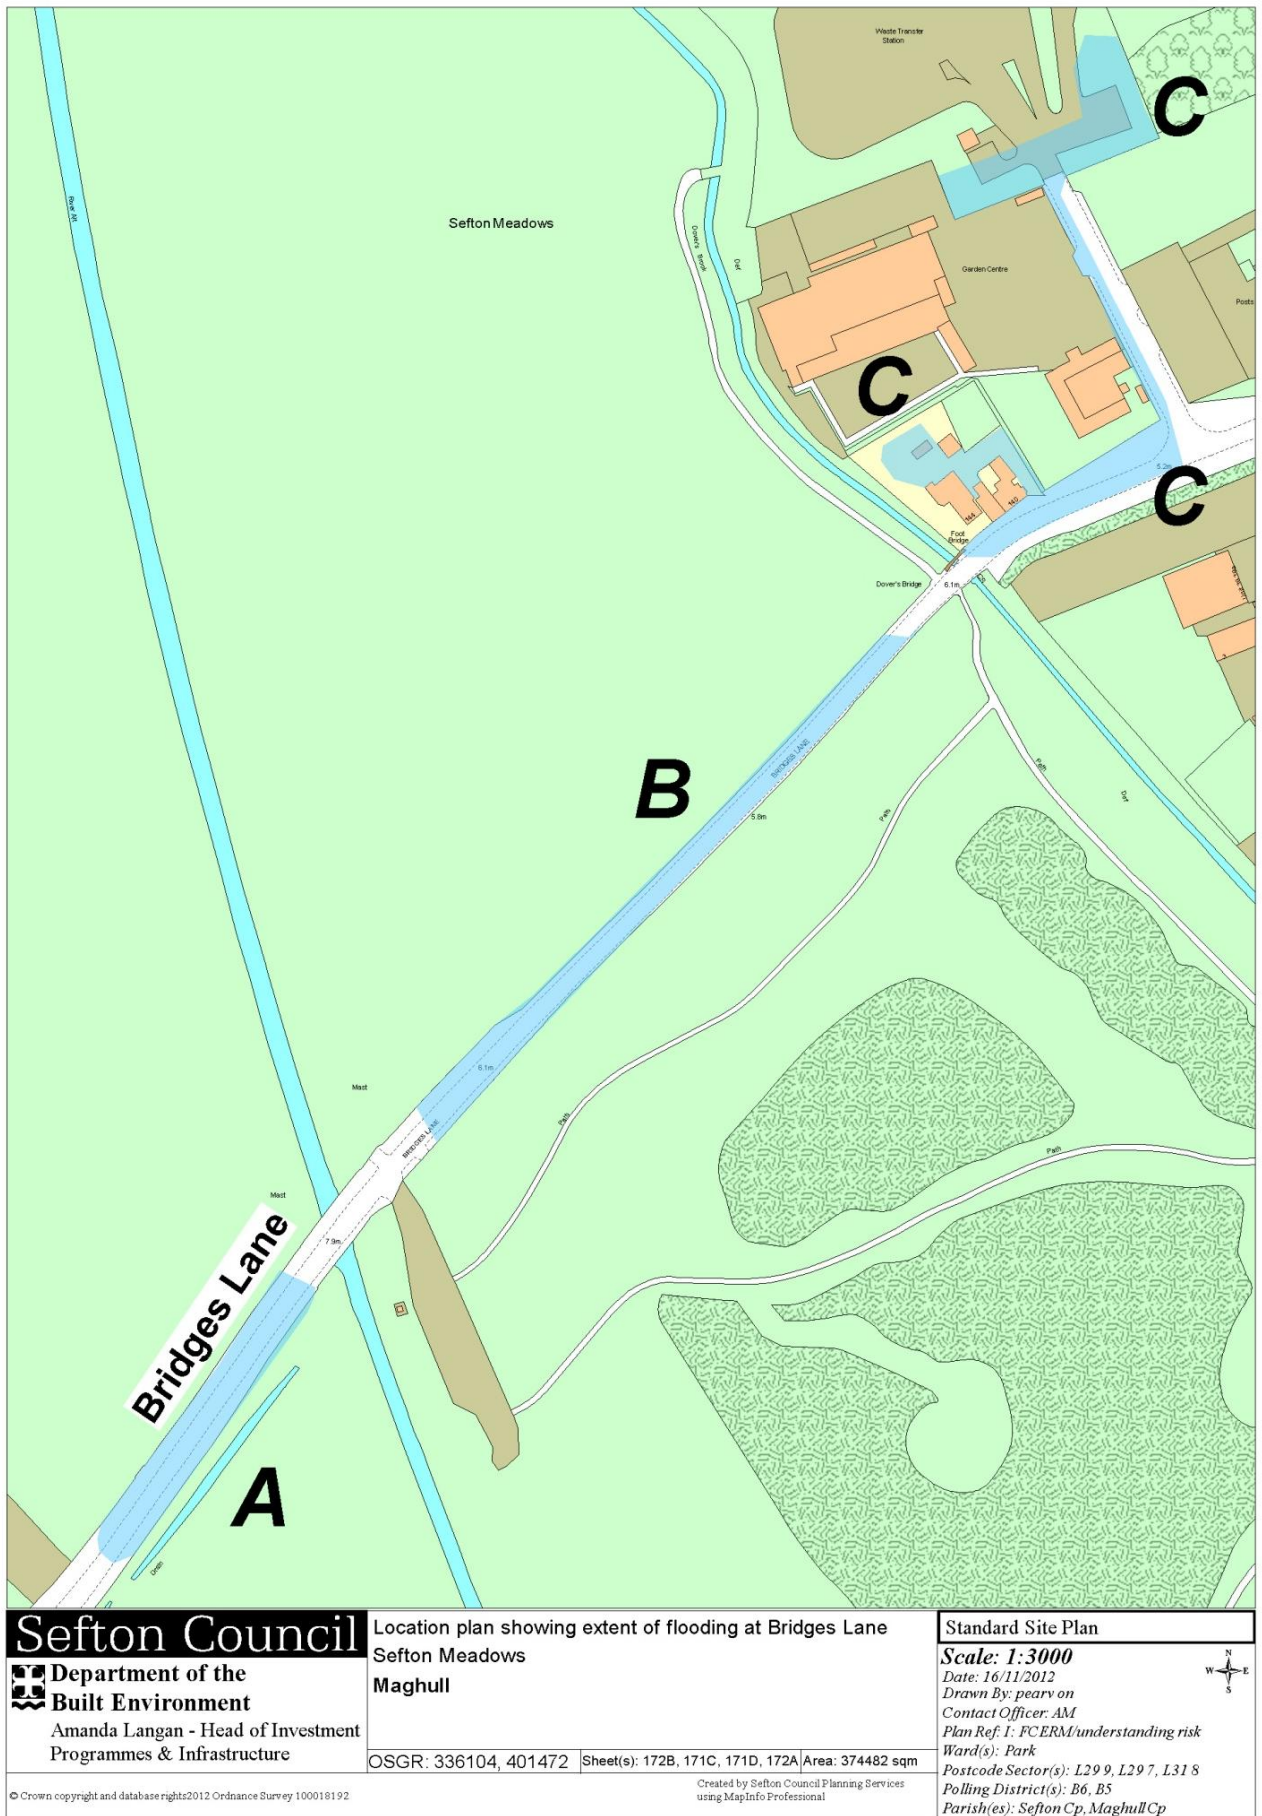
Figure 12: Separate flooding sources at Bridges Lane, Sefton Meadows, Maghull

The first source (*A, figure 11*), was from the surface water system not being able to discharge into Dover's Brook or the River Alt due to high river levels.

The second stretch (B, Figure 13 and figure 14), of highway flooding was between the bridges over the River Alt and Dover's Brook to a depth of approximately 15 cms.

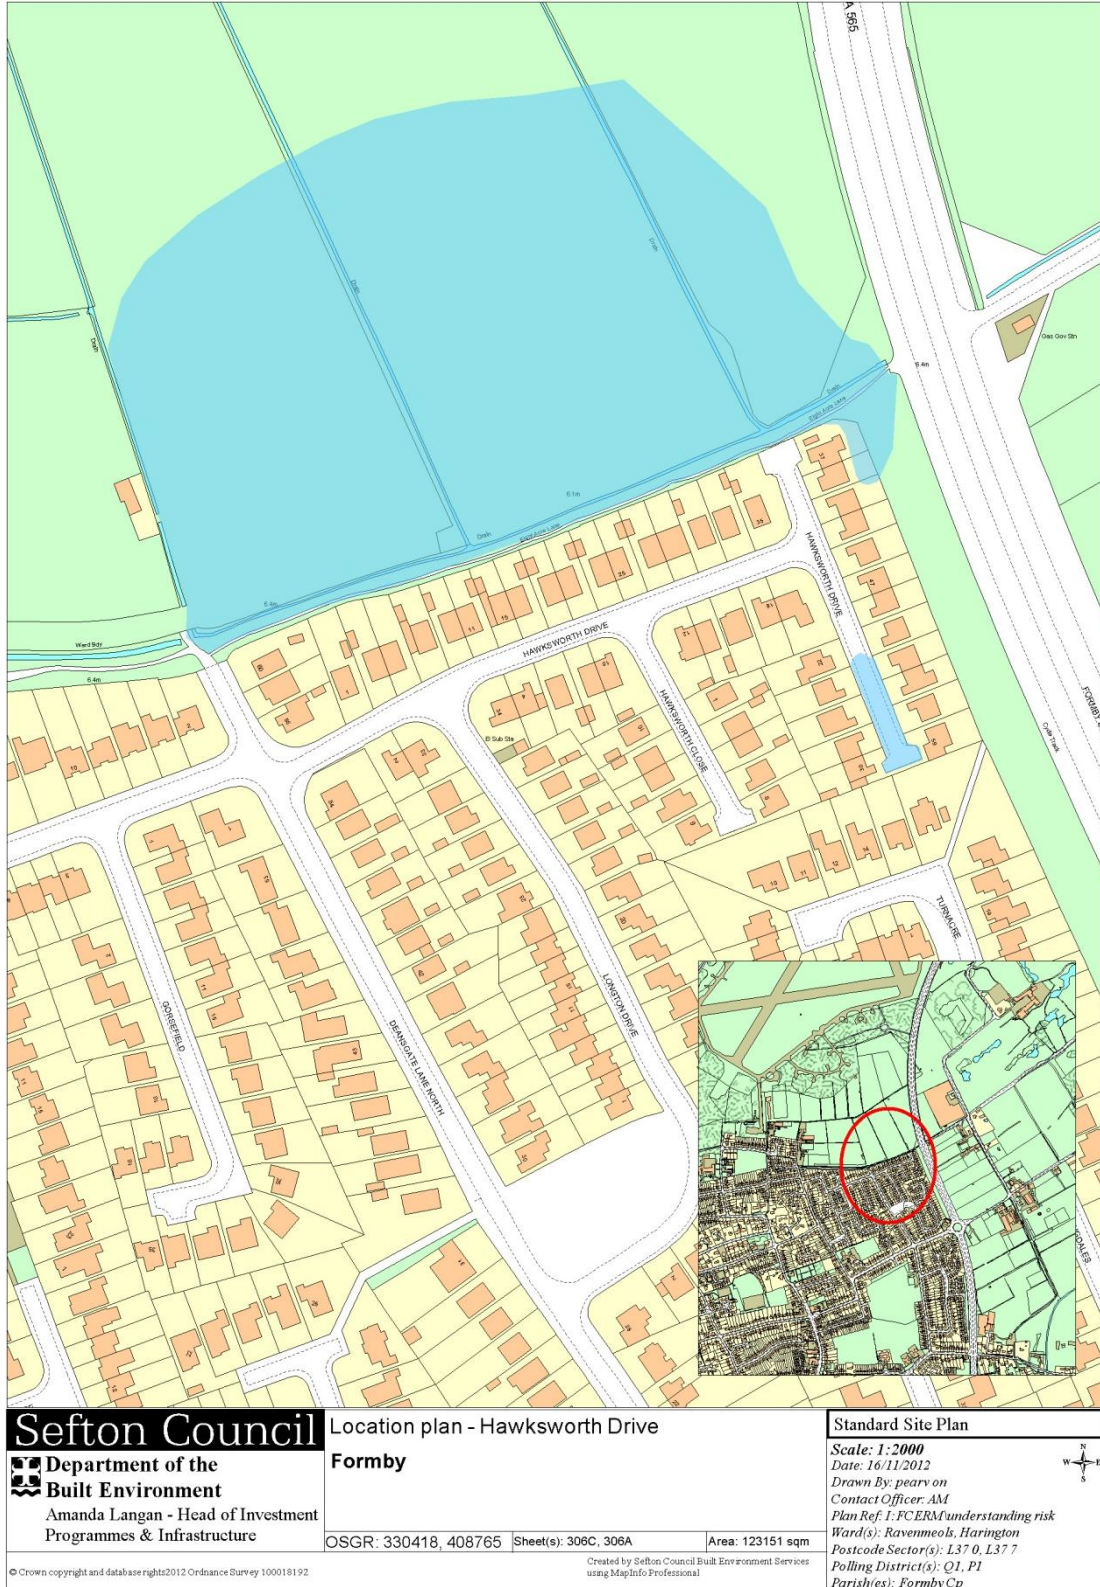
Figure 16: Site location and flooding extent

Hawksworth Drive is a small residential cul-de-sac adjacent to Eight Acre Brook on the northern side of Formby bordering Woodvale.

Number	Recommendation	Lead Risk Management Authority
1	The level of the low spot in the embankment should be raised to the same level as the rest of the embankment.	Environment Agency
2	Investigate if there are flap valves/none return systems on the outfalls into Eight Acre Brook. And if not, consider the merit of installing them.	United Utilities

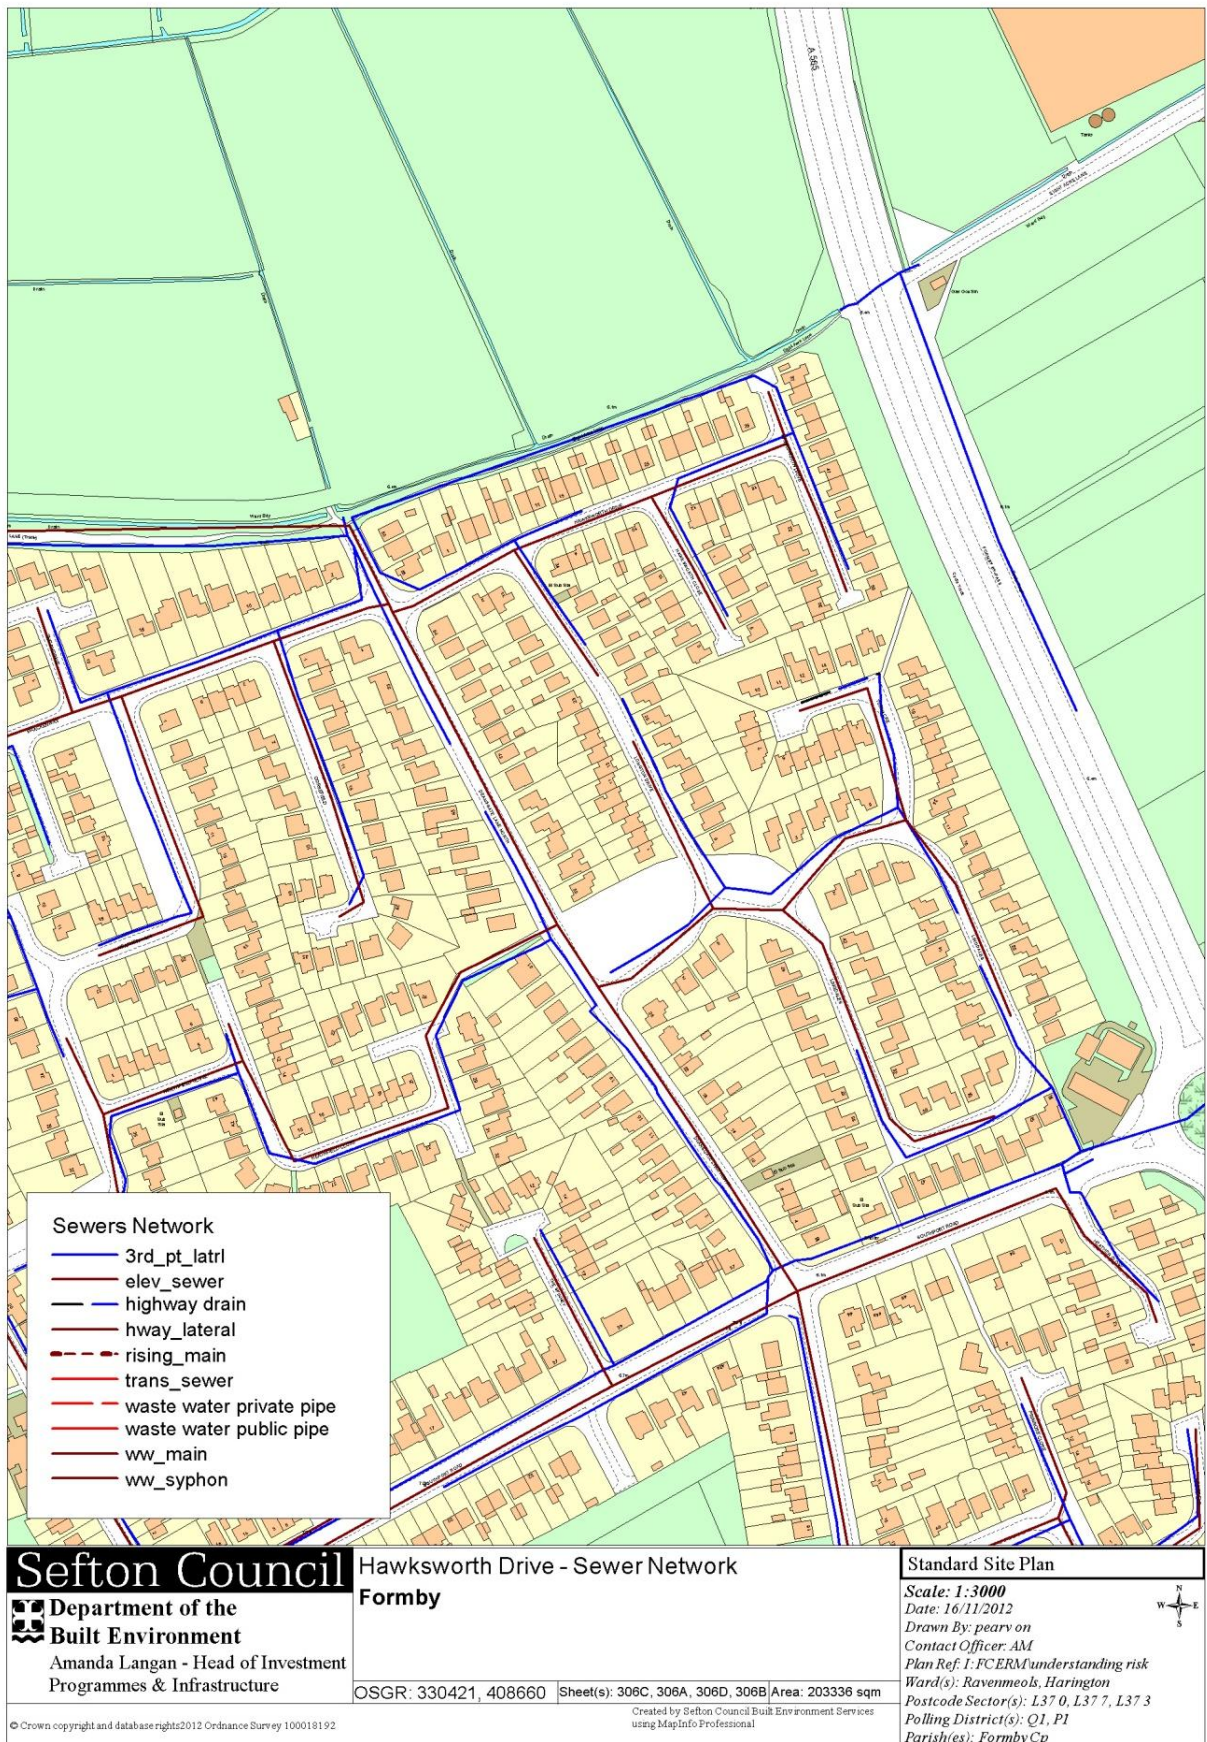
Figure 17: Hawksworth Drive Sewer Network

Surface water from the area is discharged via the public sewer (shown as the blue line on the Figure 17) into Eight Acre Brook, which is a main river and as such the Environment Agency exercise permissive powers to inspect and maintain it.

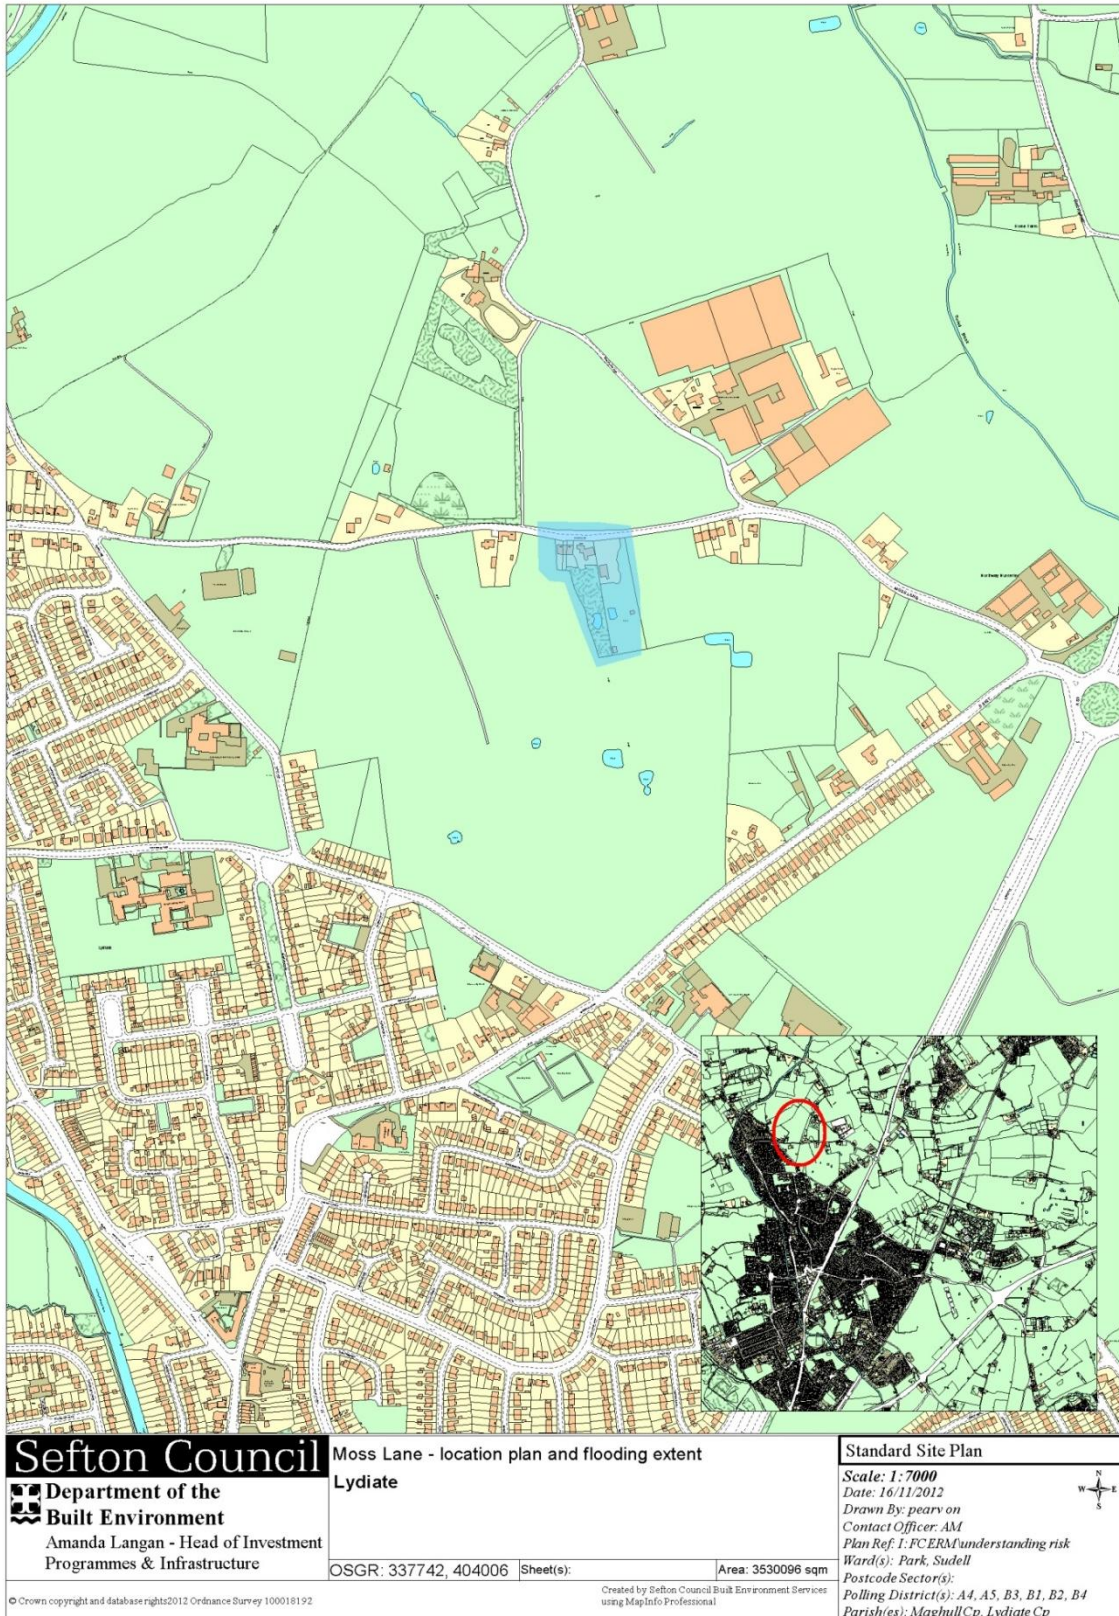
Figure 23: Site location and flooding extent

The capacity of the culvert which the watercourse flows into was not sufficient to handle the flow during this event. The watercourse serving the agricultural land at the rear of the even numbered properties in Moss lane connects to this culvert near to 68 Moss Lane. This culvert is inadequate for flows of this magnitude and this leads to flooding as storm water backs up and overflows the banks of the open ditch affecting the farmed fields, residential properties and the highway.

Number	Recommendation	Lead Risk Management Authority
1	Discuss the issues with the riparian land owners and seek to negotiate a solution	Sefton MBC

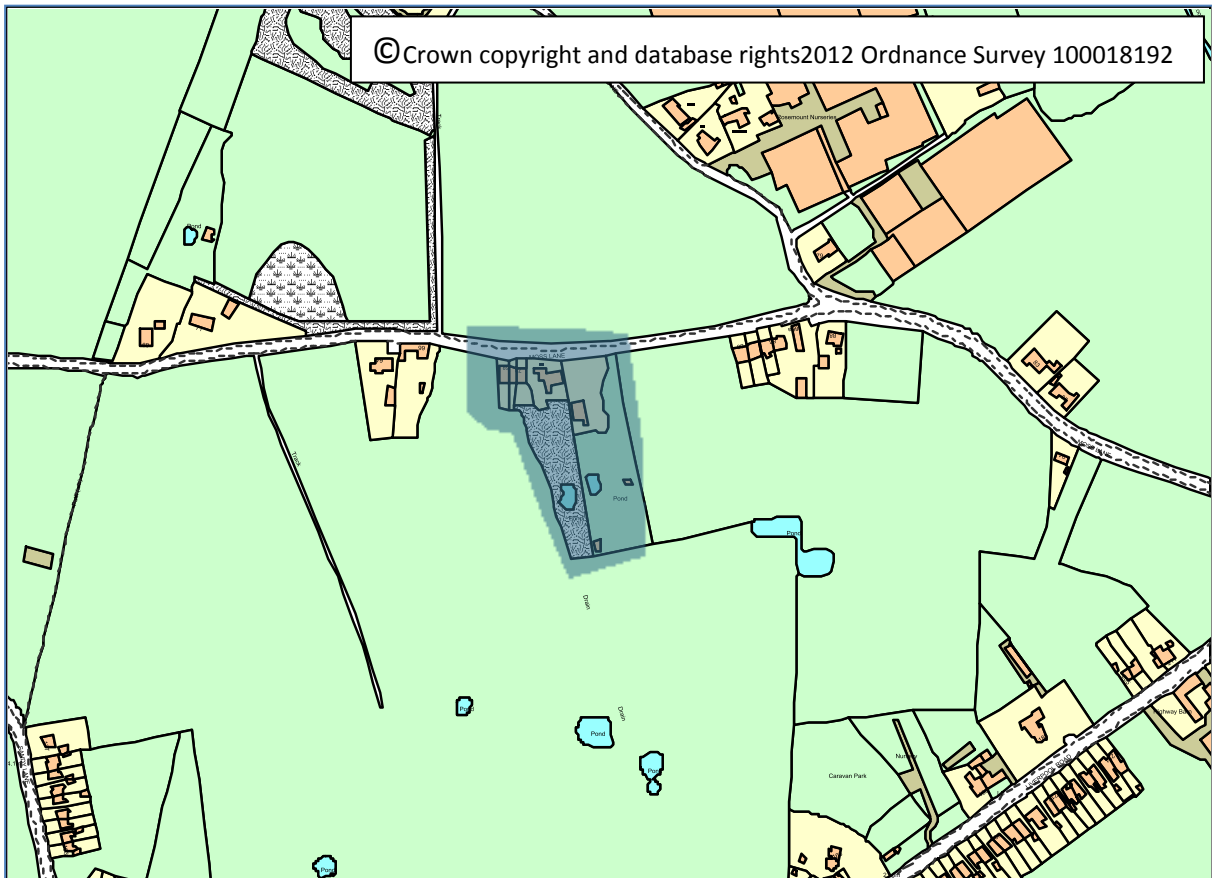
Figure 24: map showing the approximate flood envelope

Moss Lane is served by a 150mm and a 225mm culvert that connects into the 450mm diameter pipe at the junction with the A59-North Road. It is not known if the culvert capacity was ever sufficient for these types of flows or whether something has changed upstream to affect the rate of discharge from the land.

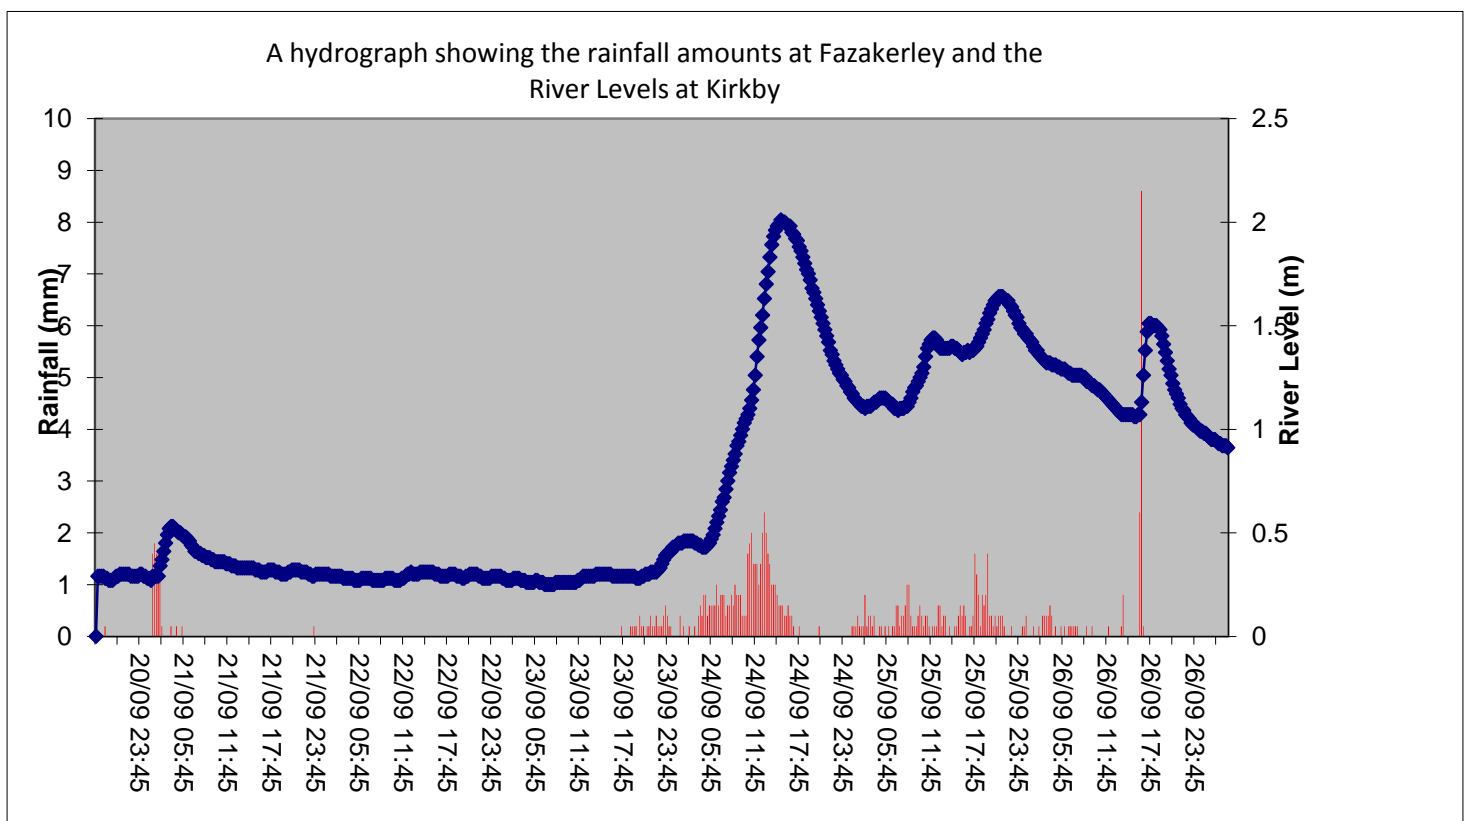
In response to the heavy rainfall the River Alts levels, measured at the Environment Agency's Kirkby gauging station, rose from 0.285m at 21.00 on the 23rd and peaked at 2.01m at 15.45 on the 24th September, as shown in the graph below.
