# Flood Investigation Report

Fouracres (Maghull), Sefton Lane (Maghull),  
Hawksworth Drive (Formby), Water, Street (Thornton)  
and Moss Lane (Lydiate)

Date of flooding: 24/09/2012

Version 1.2  
November 2012

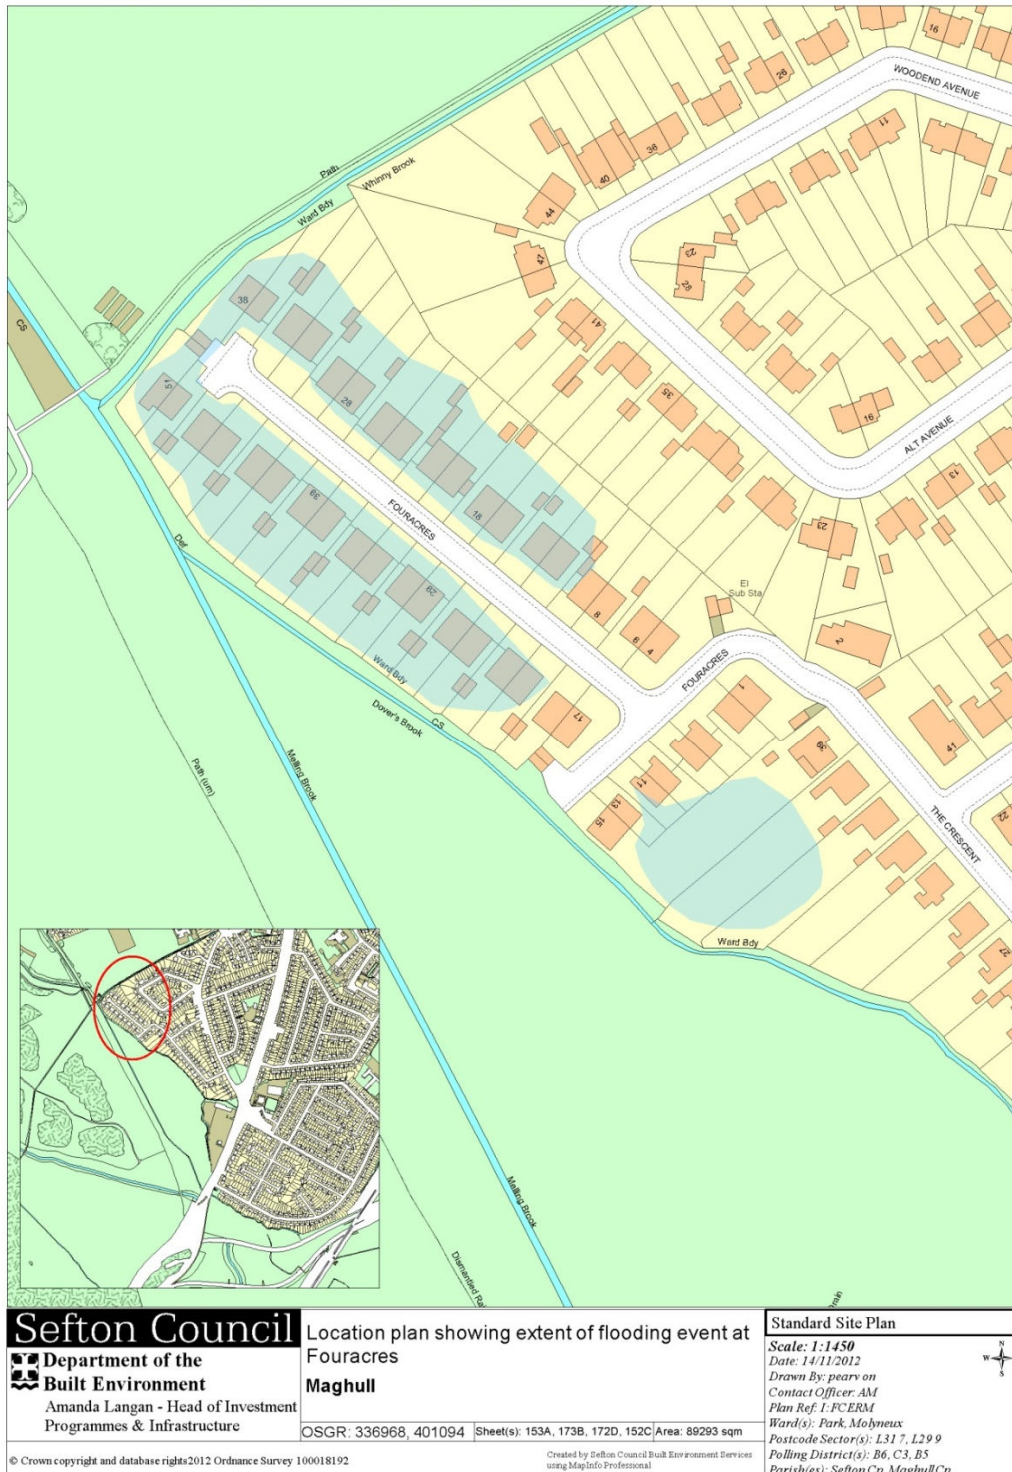
Figure 1: Site location and flood extent

Fouracres is a small residential cul-de-sac situated at the confluence of Whinny Brook and Dover's Brook on the western side of Maghull. The estate was built circa 1964.

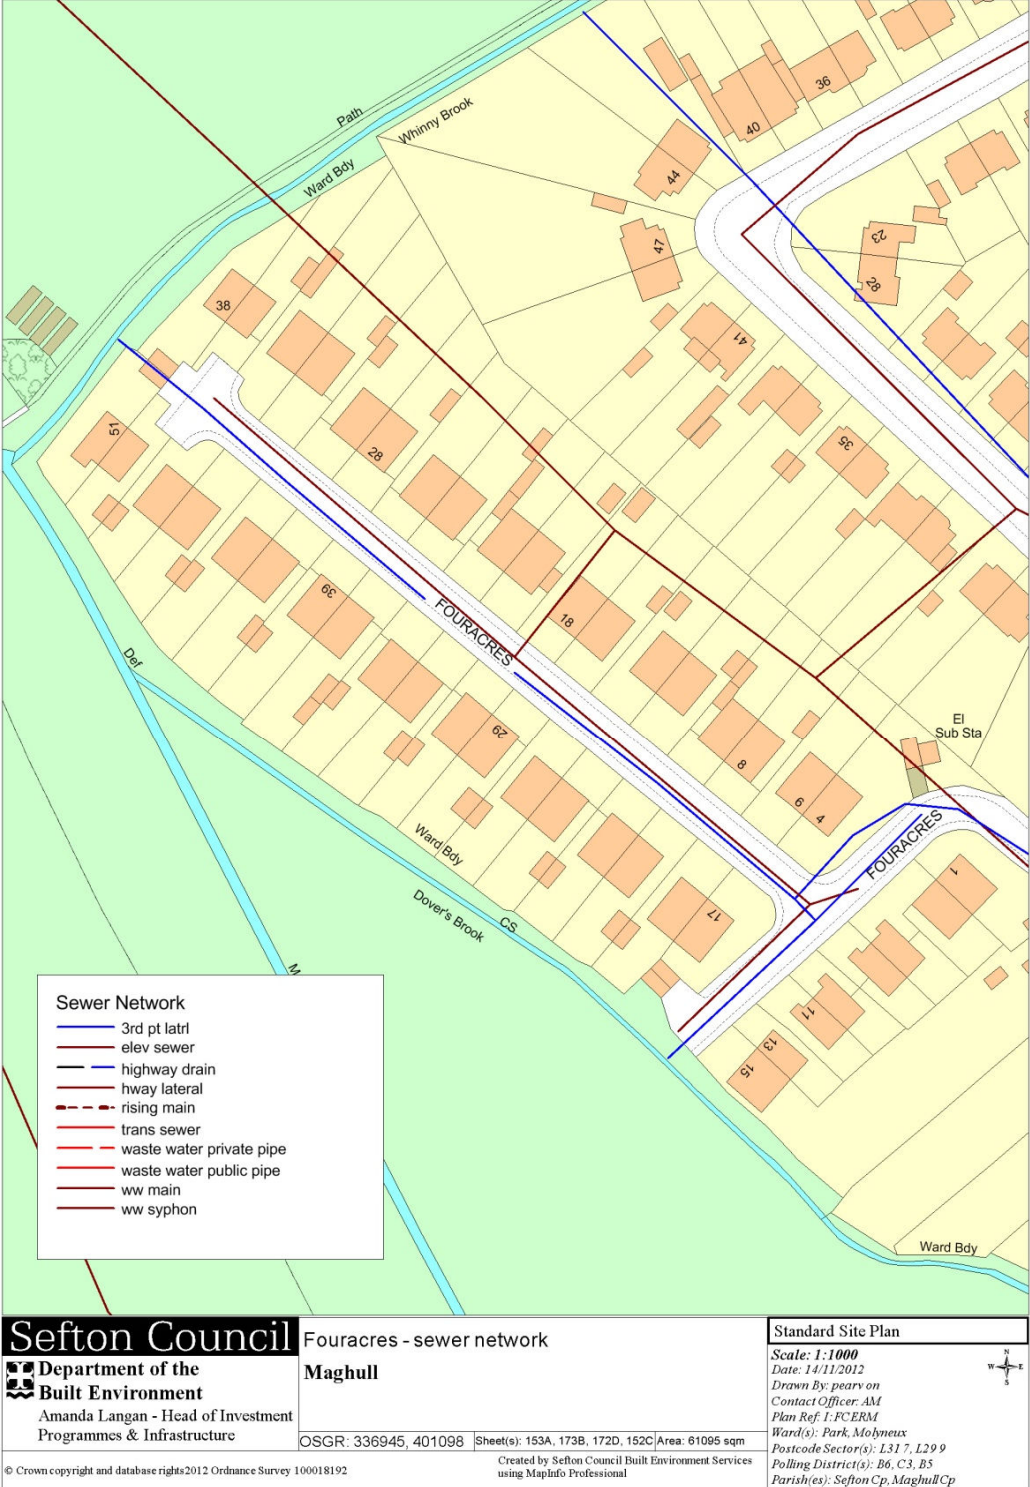
Figure 2: The sewer network

The area is drained by normal surface water methods, within the property boundaries drainpipes discharge to gullies which connect to the surface water sewer which, depending on location within Fouracres, either discharges into Dover's Brook or Whinny Brook via an outfall. Similarly highway drainage is collected by gullies and discharges via the same mechanisms.

United Utilities did not find a blockage on the surface water sewer system either. However, it was found that neither of the 2 outfalls which discharged into Dover's and Whinny Brook had a flap/non return valve on them. They have undertaken to carry out further investigations on the system to better understand it and check for cross-connections.

<b>Number</b>	<b>Recommendation</b>	<b>Lead Risk Management Authority</b>
1	Investigate the merit of installing flap valves/non return systems on the outfalls into Whinny Brook and Dover's Brook.	United Utilities
2	Co-ordination of maintenance priorities and works between the Risk Management Authorities	Environment Agency

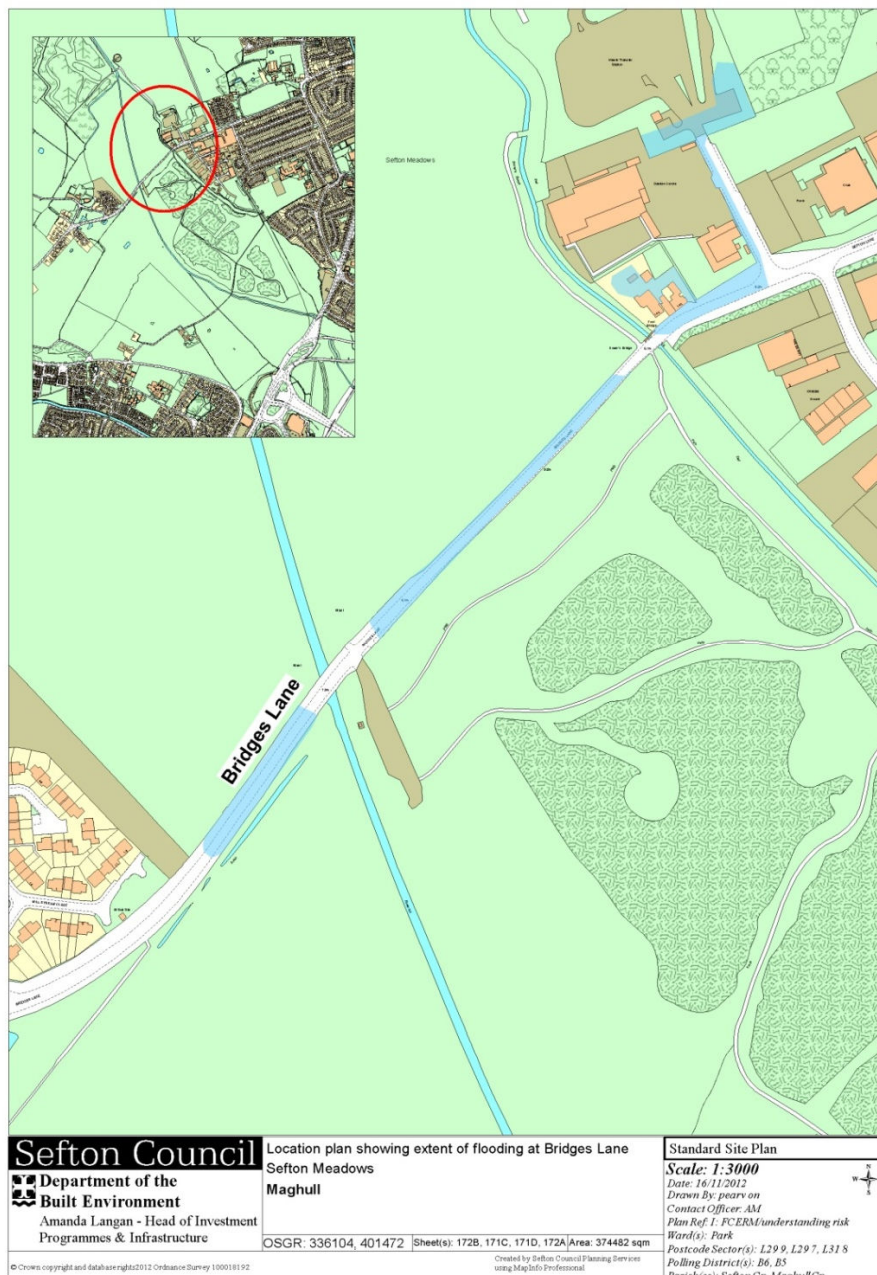
Figure 9: Site location and flood extent

Sefton Lane is on the western side of Maghull linking it with Sefton village via Bridges Lane. The road is a busy commuter route which also serves the industrial estate and the waste recycling centre at Sefton Meadows. The road name changes at the bridge over Dover's Brook to Bridges Lane.

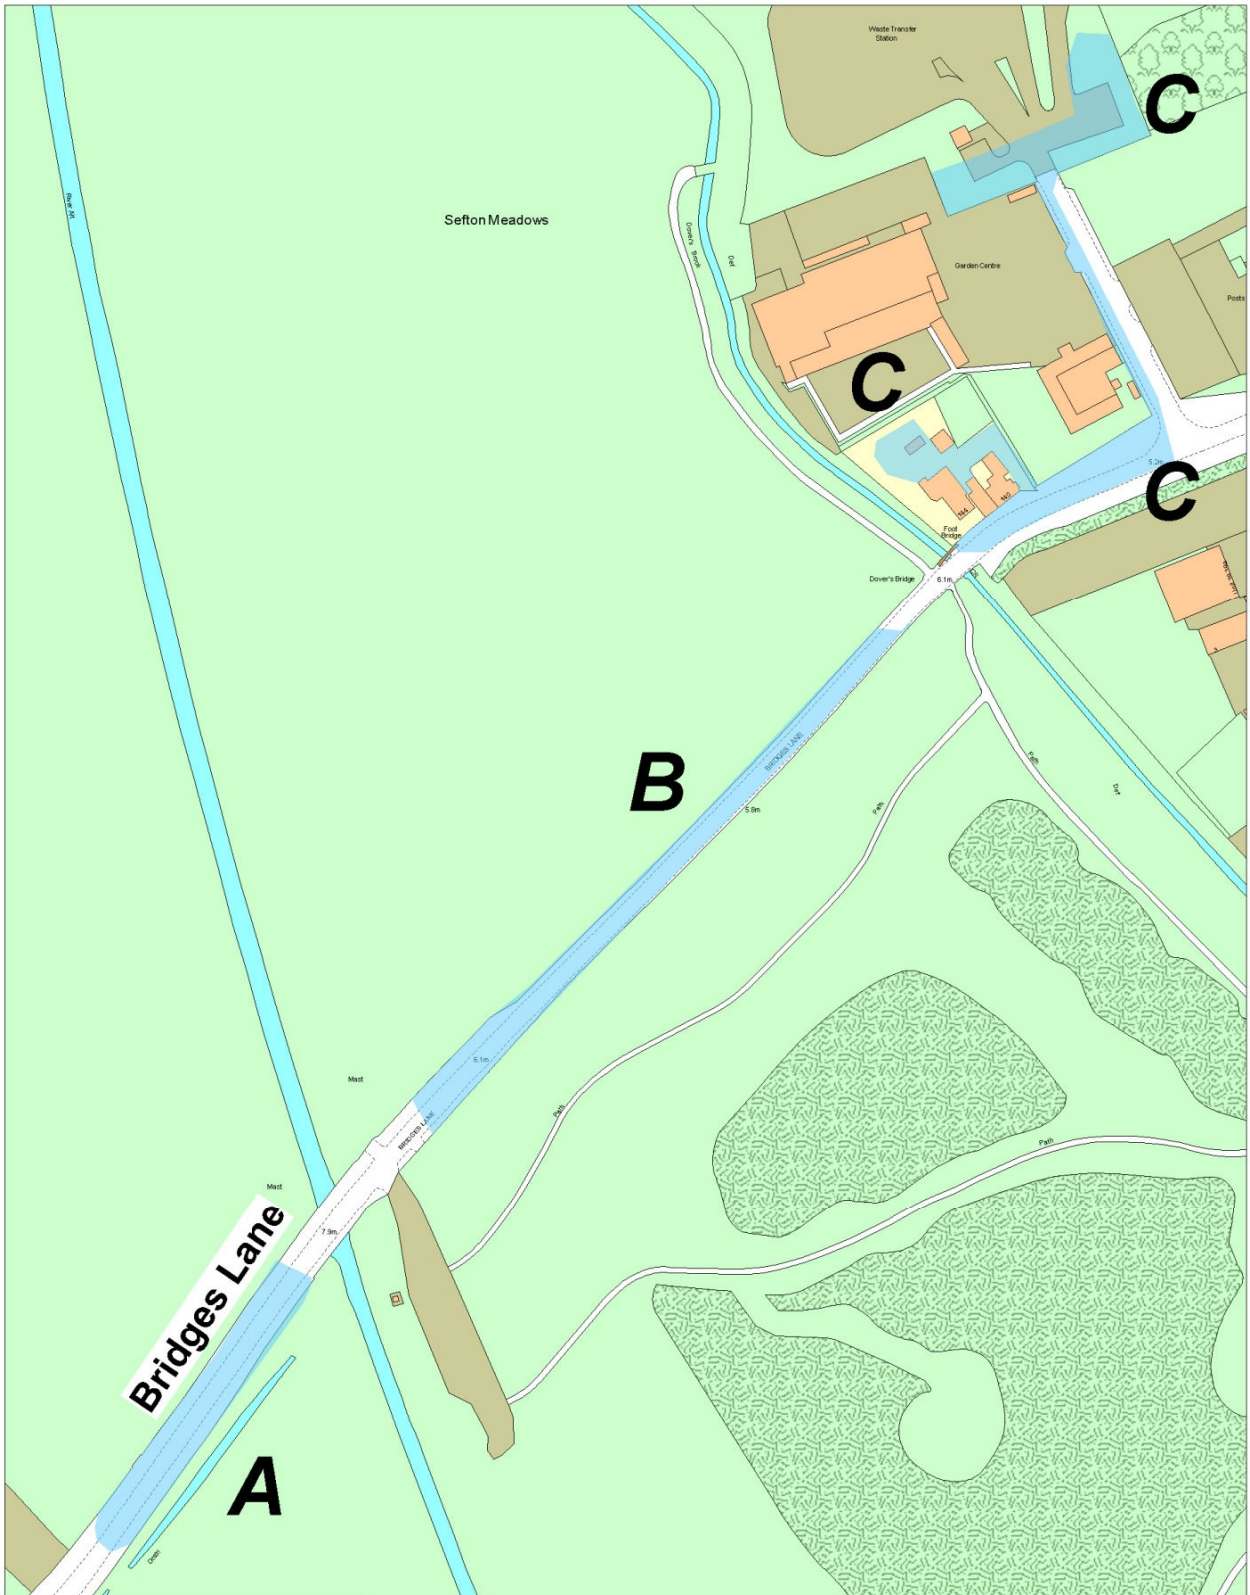
Figure 12: Separate flooding sources at Bridges Lane, Sefton Meadows, Maghull

The first source (*A, figure 11*), was from the surface water system not being able to discharge into Dover's Brook or the River Alt due to high river levels.

<b>Number</b>	<b>Recommendation</b>	<b>Lead Risk Management Authority</b>
1	Environment Agency should engage in further discussions with the riparian owner at Dover's Bridge about raising the embankment, to raise the low point in the defence.	Environment Agency
2	Council to discuss with the local farmer any more suitable measures to stop surface water flowing from the field into the highway.	Sefton MBC

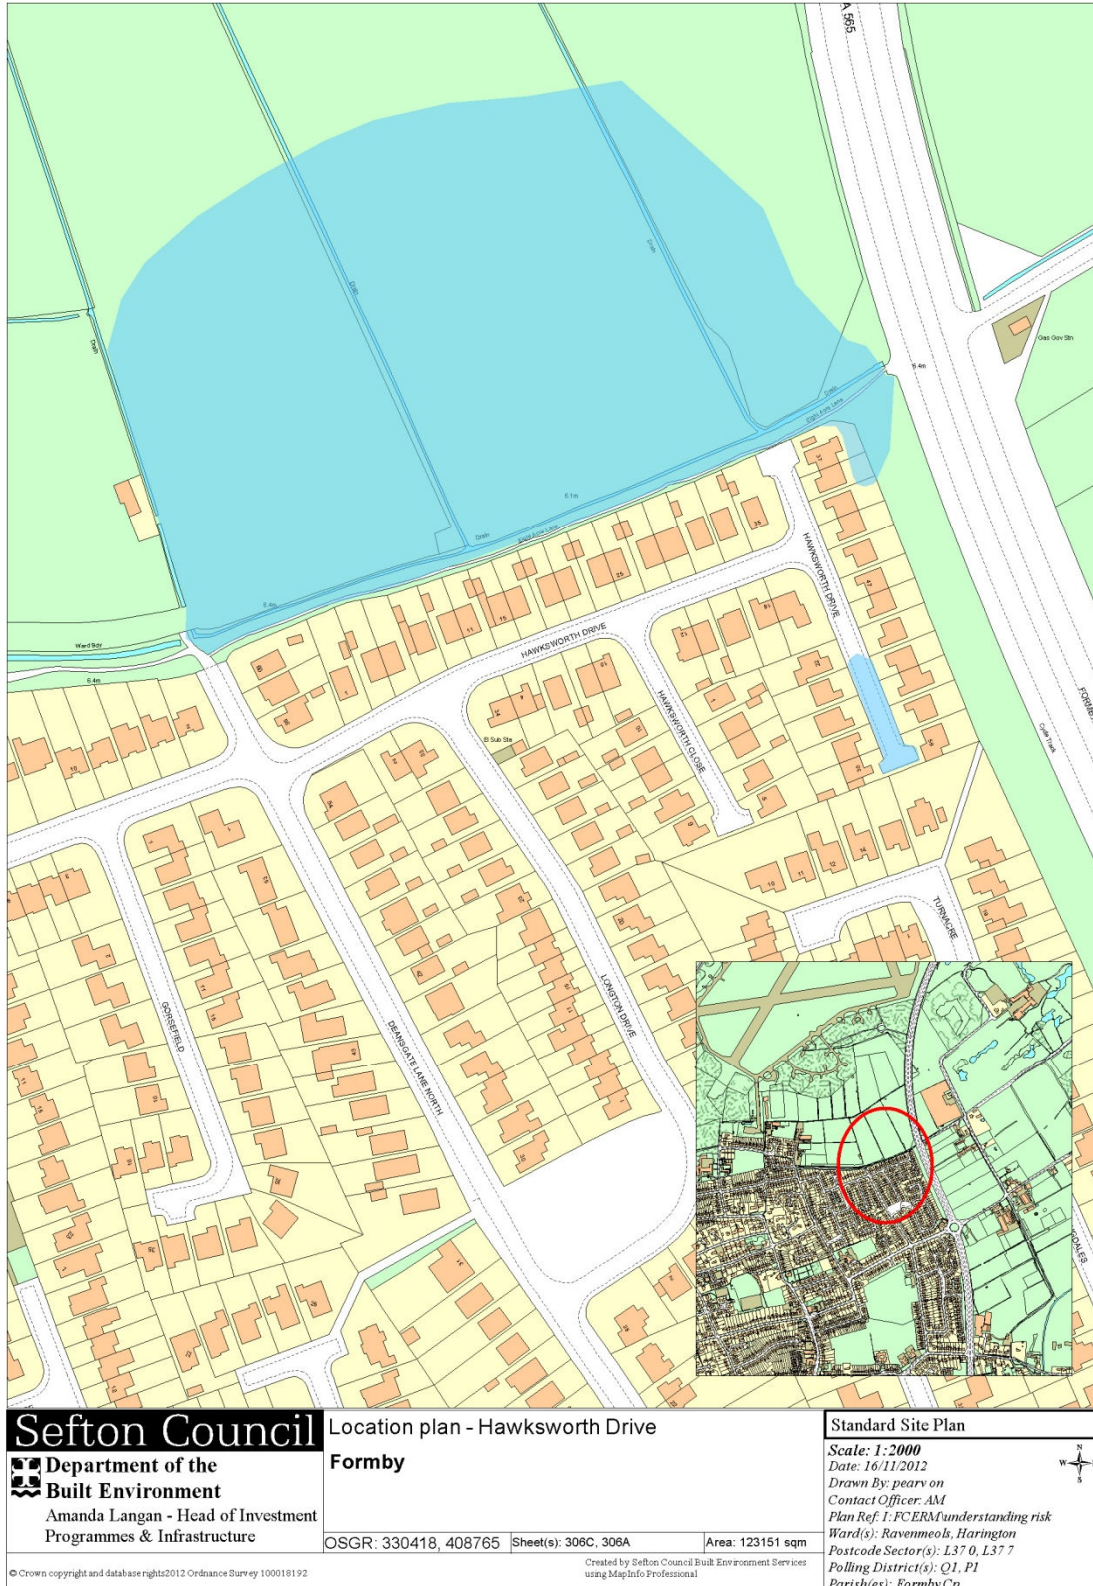
Figure 16: Site location and flooding extent

Hawksworth Drive is a small residential cul-de-sac adjacent to Eight Acre Brook on the northern side of Formby bordering Woodvale.

<b>Number</b>	<b>Recommendation</b>	<b>Lead Risk Management Authority</b>
1	The level of the low spot in the embankment should be raised to the same level as the rest of the embankment.	Environment Agency
2	Investigate if there are flap valves/none return systems on the outfalls into Eight Acre Brook. And if not, consider the merit of installing them.	United Utilities

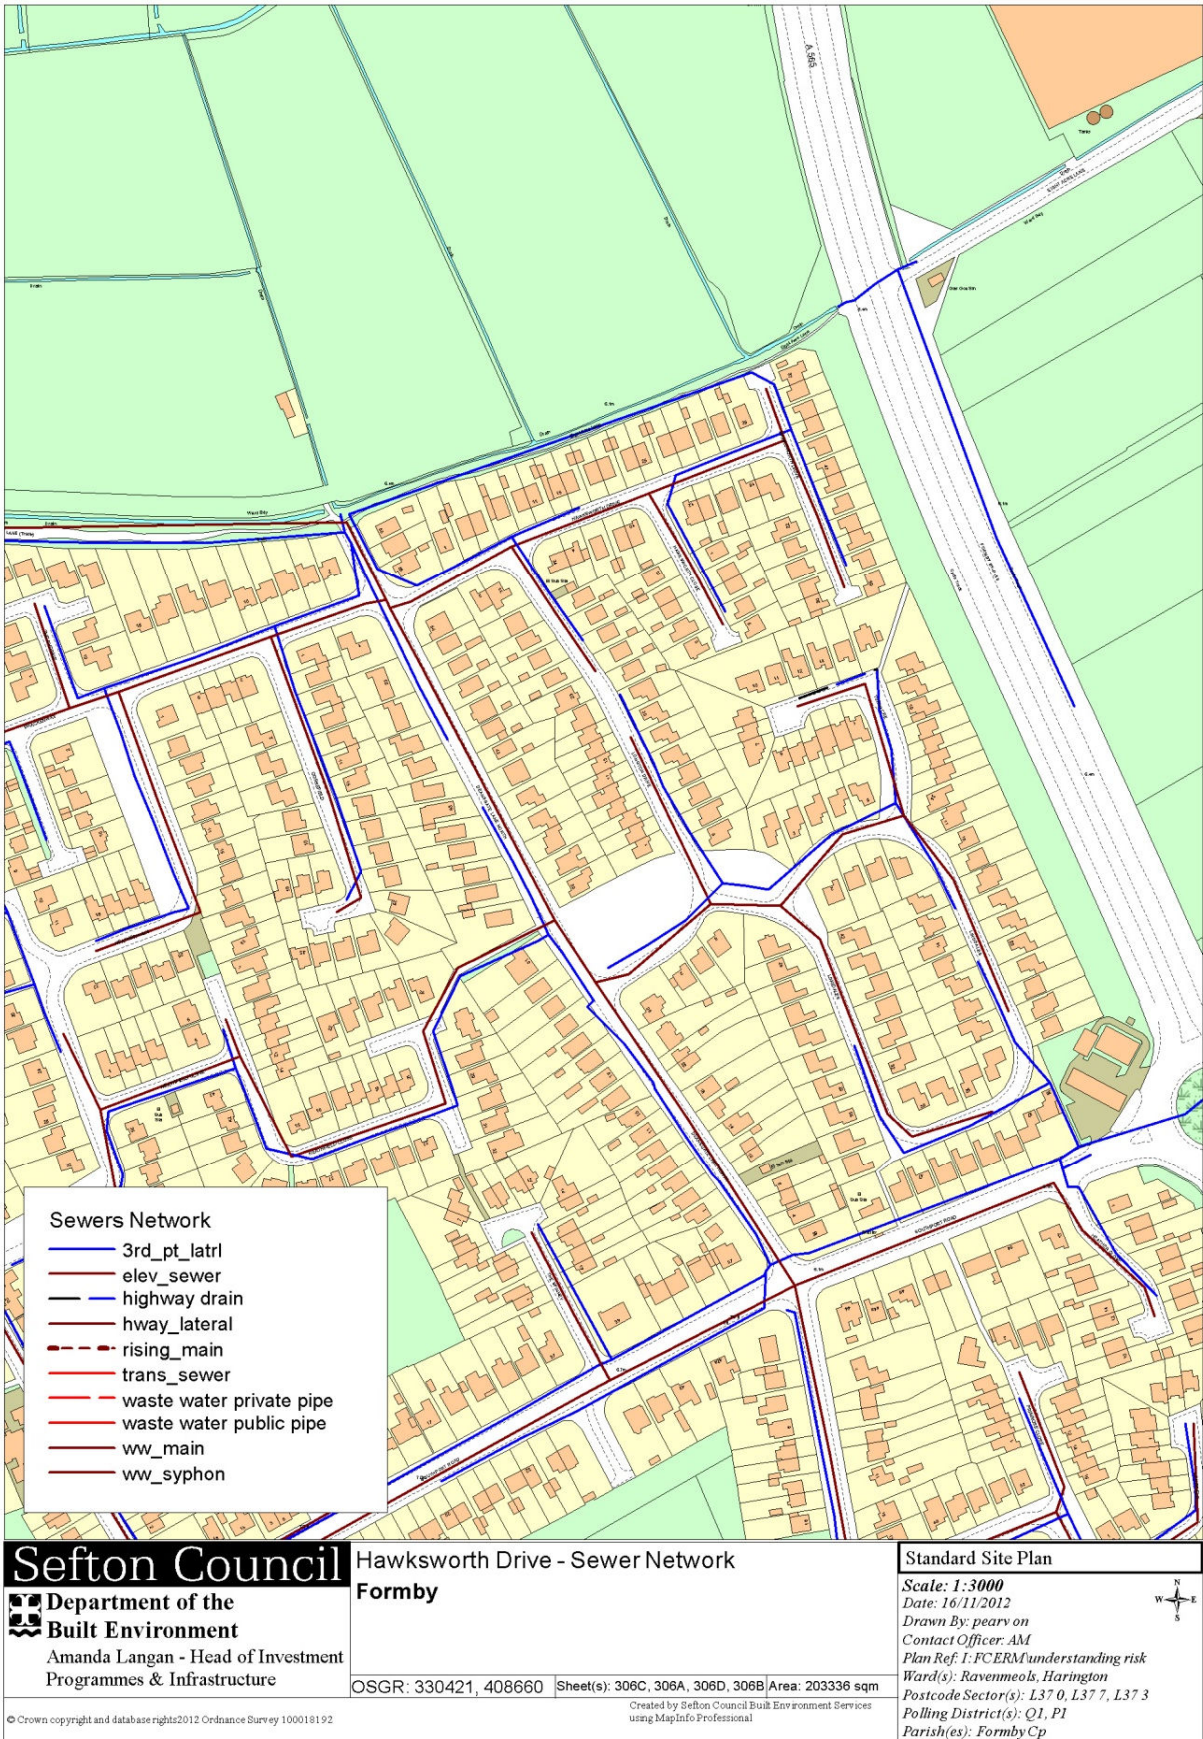
Figure 17: Hawksworth Drive Sewer Network

Surface water from the area is discharged via the public sewer (shown as the blue line on the Figure 17) into Eight Acre Brook, which is a main river and as such the Environment Agency exercise permissive powers to inspect and maintain it.

<p>Investigate if there are flap valves/none return systems on the outfalls into Eight Acre Brook. And if not, consider the merit of installing them.</p>	<p><b>This will be considered when conditions allow inspection of the outfall arrangement.</b></p>	<p><b>Will be inspected when conditions allow and mitigation measures if appropriate will be considered.</b></p>	<p><b>Outfall arrangement will be inspected and mitigation measures will be assessed and prioritised.</b></p>

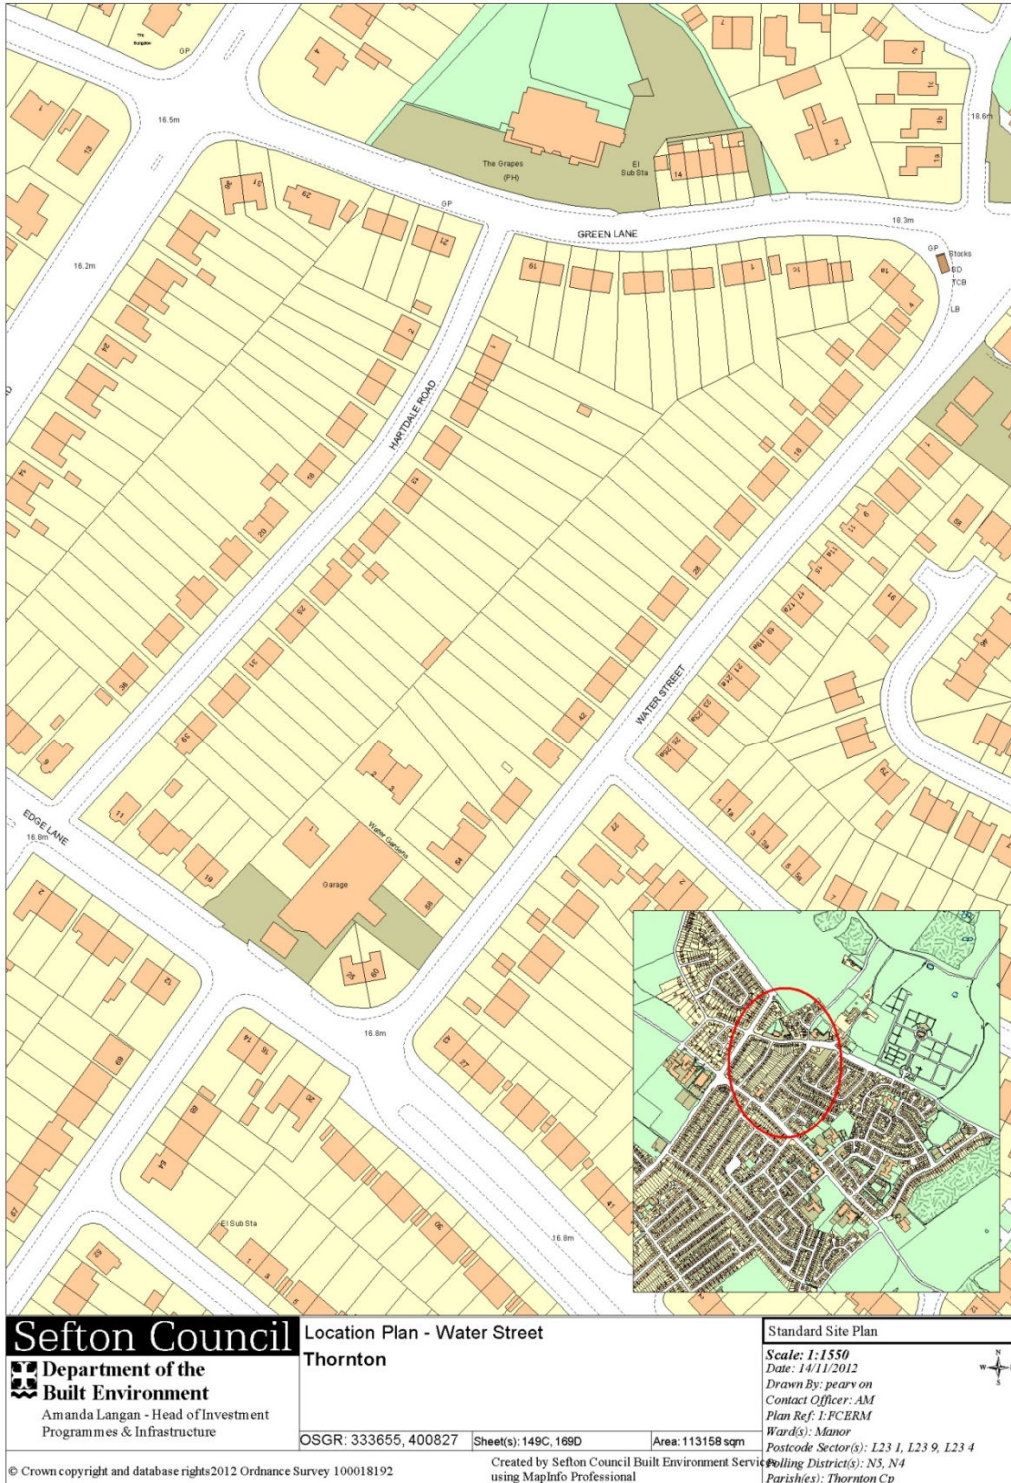
Figure 20: Water Street, Thornton - location plan

Water Street is a residential road in the middle of Thornton, close to the greenbelt.

<b>Number</b>	<b>Recommendation</b>	<b>Lead Risk Management Authority</b>
1	The Council will continue to work towards a solution that remedies defects and increases capacity for this area within financial constraints.	Sefton MBC

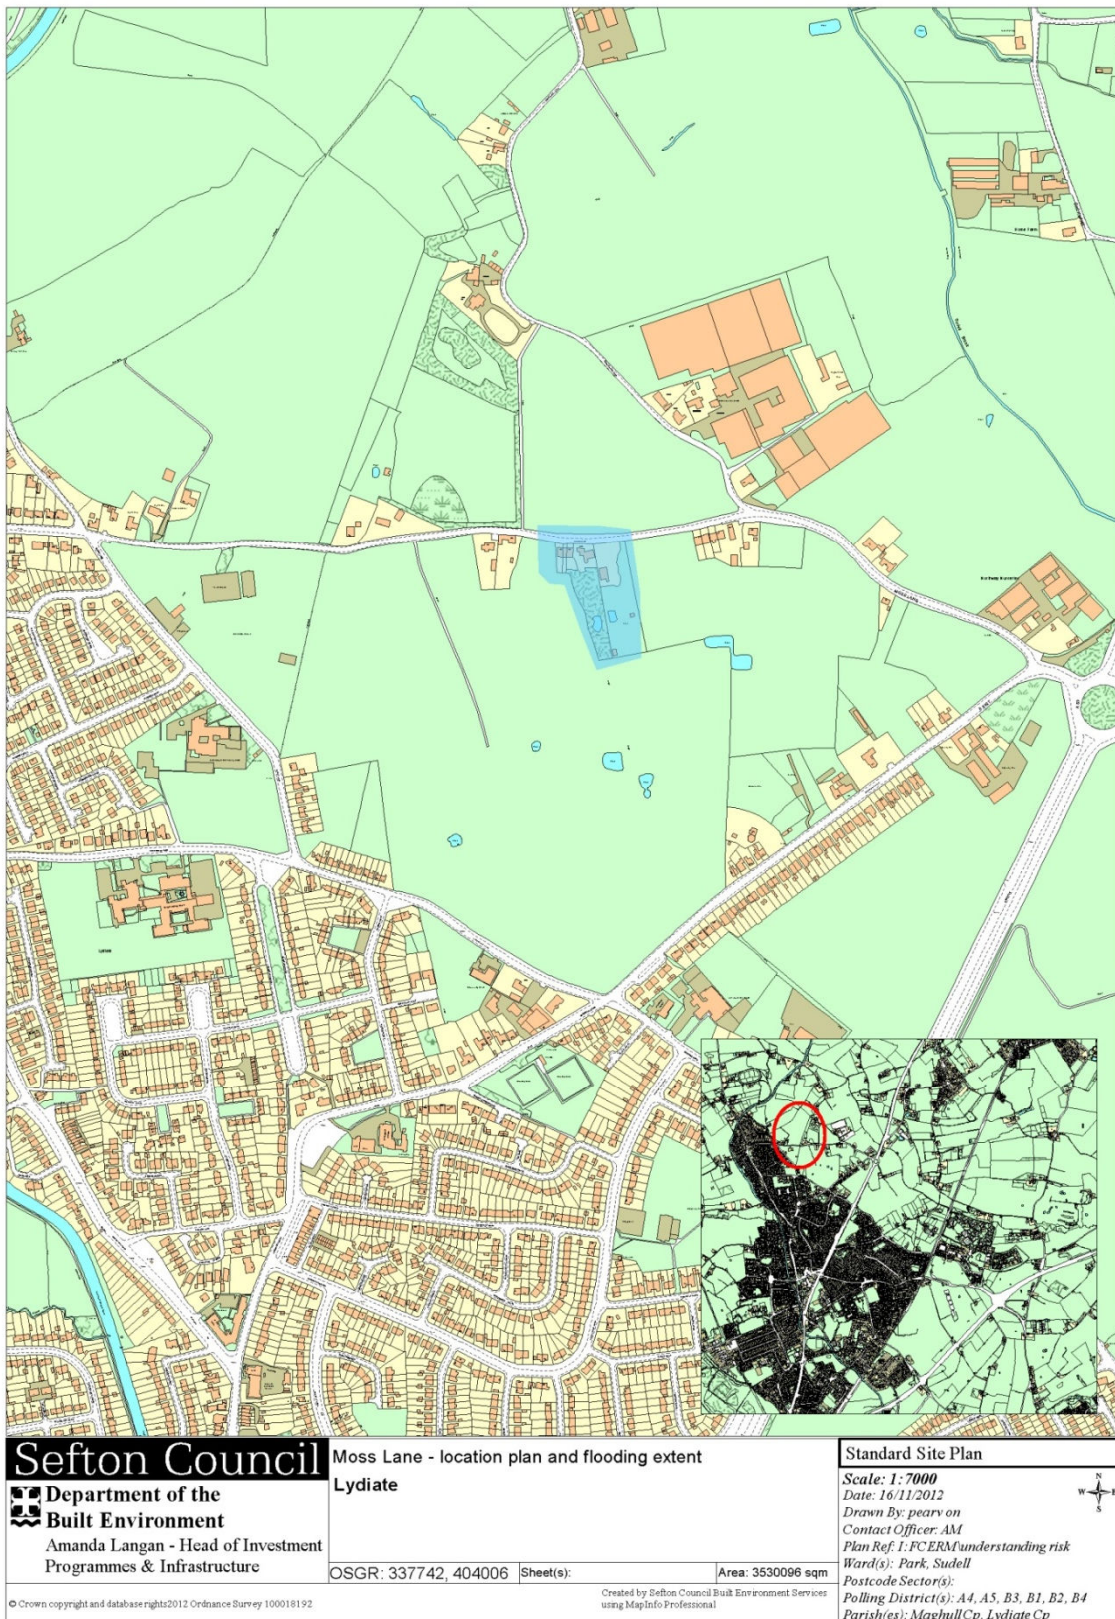
Figure 23: Site location and flooding extent

Moss Lane is situated on the rural outskirts of Lydiate, close to the boundary with West Lancashire District Council.

<b>Number</b>	<b>Recommendation</b>	<b>Lead Risk Management Authority</b>
1	Discuss the issues with the riparian land owners and seek to negotiate a solution	Sefton MBC

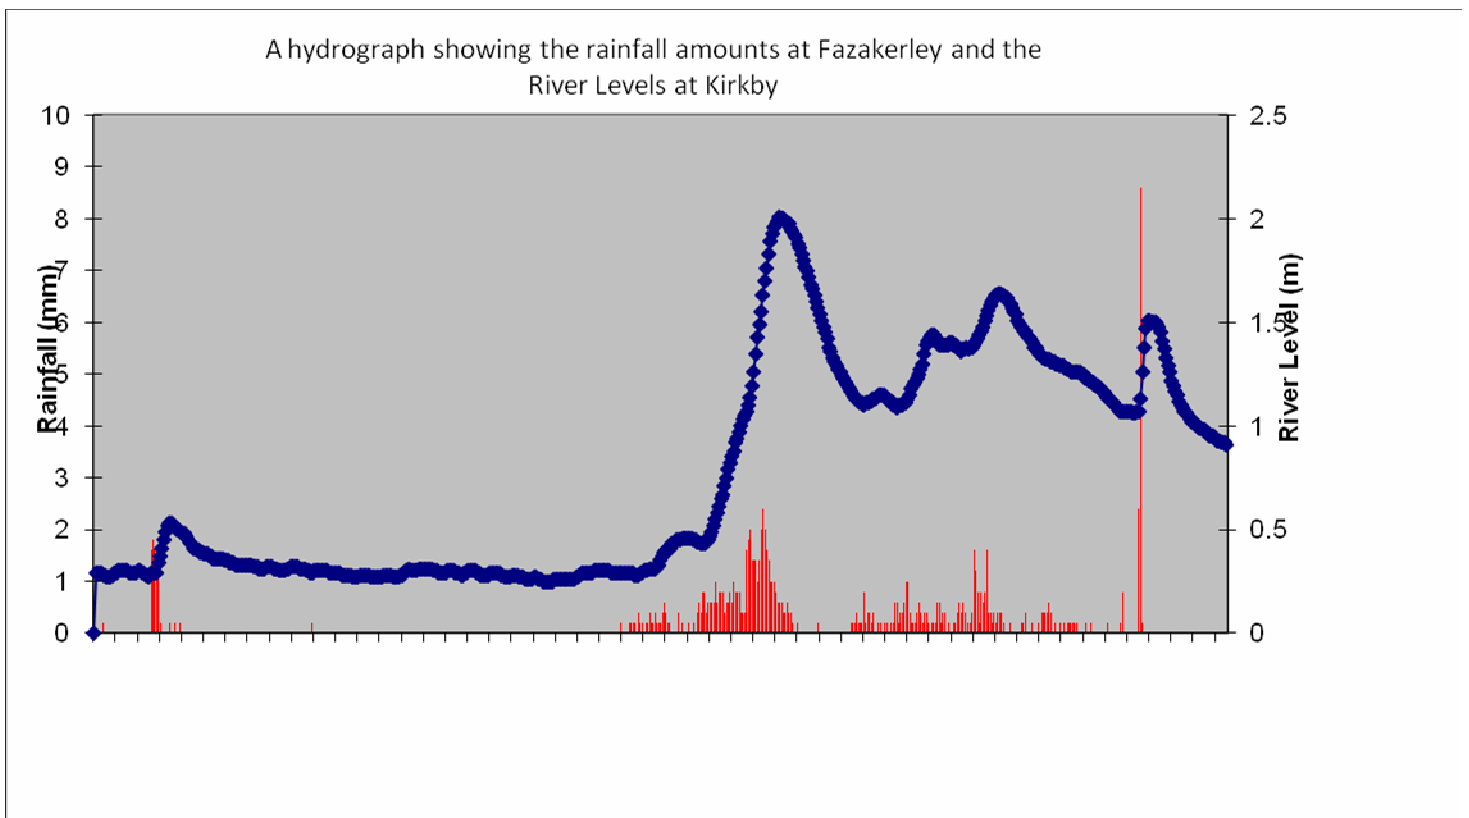
In response to the heavy rainfall the River Alts levels, measured at the Environment Agency's Kirkby gauging station, rose from 0.285m at 21.00 on the 23<sup>rd</sup> and peaked at 2.01m at 15.45 on the 24<sup>th</sup> September, as shown in the graph below.
