# Area 4 - Freshfield to Ainsdale Summary

This report summarises the coastal process monitoring and coastal defence work carried out by Sefton Council 2000-2004 and provides relevant background and historic information for Area 4 – Freshfield to Ainsdale.

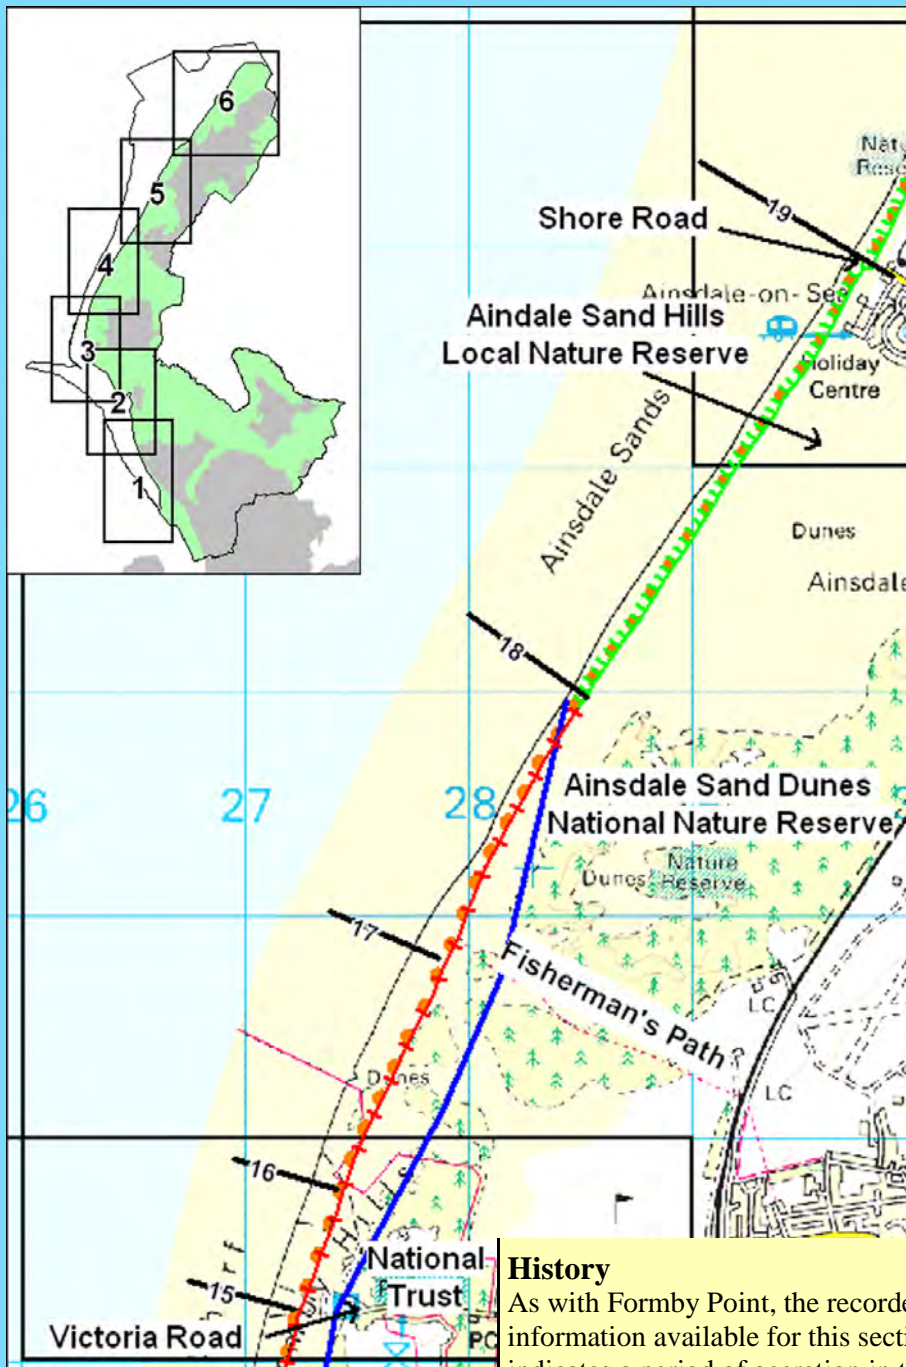
- ◆◆◆◆ Informal Rubble
- ▲▲▲▲ Rock Armour
- Sand dunes
- Accreting Sand dunes
- Eroding Sand dunes
- Saltmarsh
- Saltmarsh/embryo dune
- ■ ■ ■ Sea Wall
- Training Wall
- Profile Line
- Prediction of coastline location (2050)

**Length of coastline**  
 6.3km Total  
 6.3km sand dunes

**Coordinates**  
 Top right 330000 414000  
 Bottom Left 326000 408000

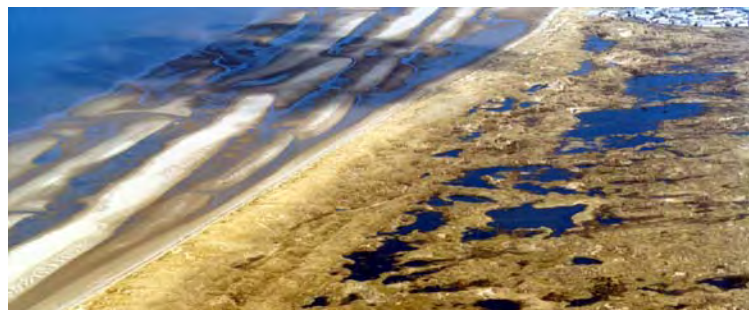
Beach and dune system at Ainsdale
