Moor Lane / Formby Bypass 100m radius 24/11/2012 to  
23/11/2015

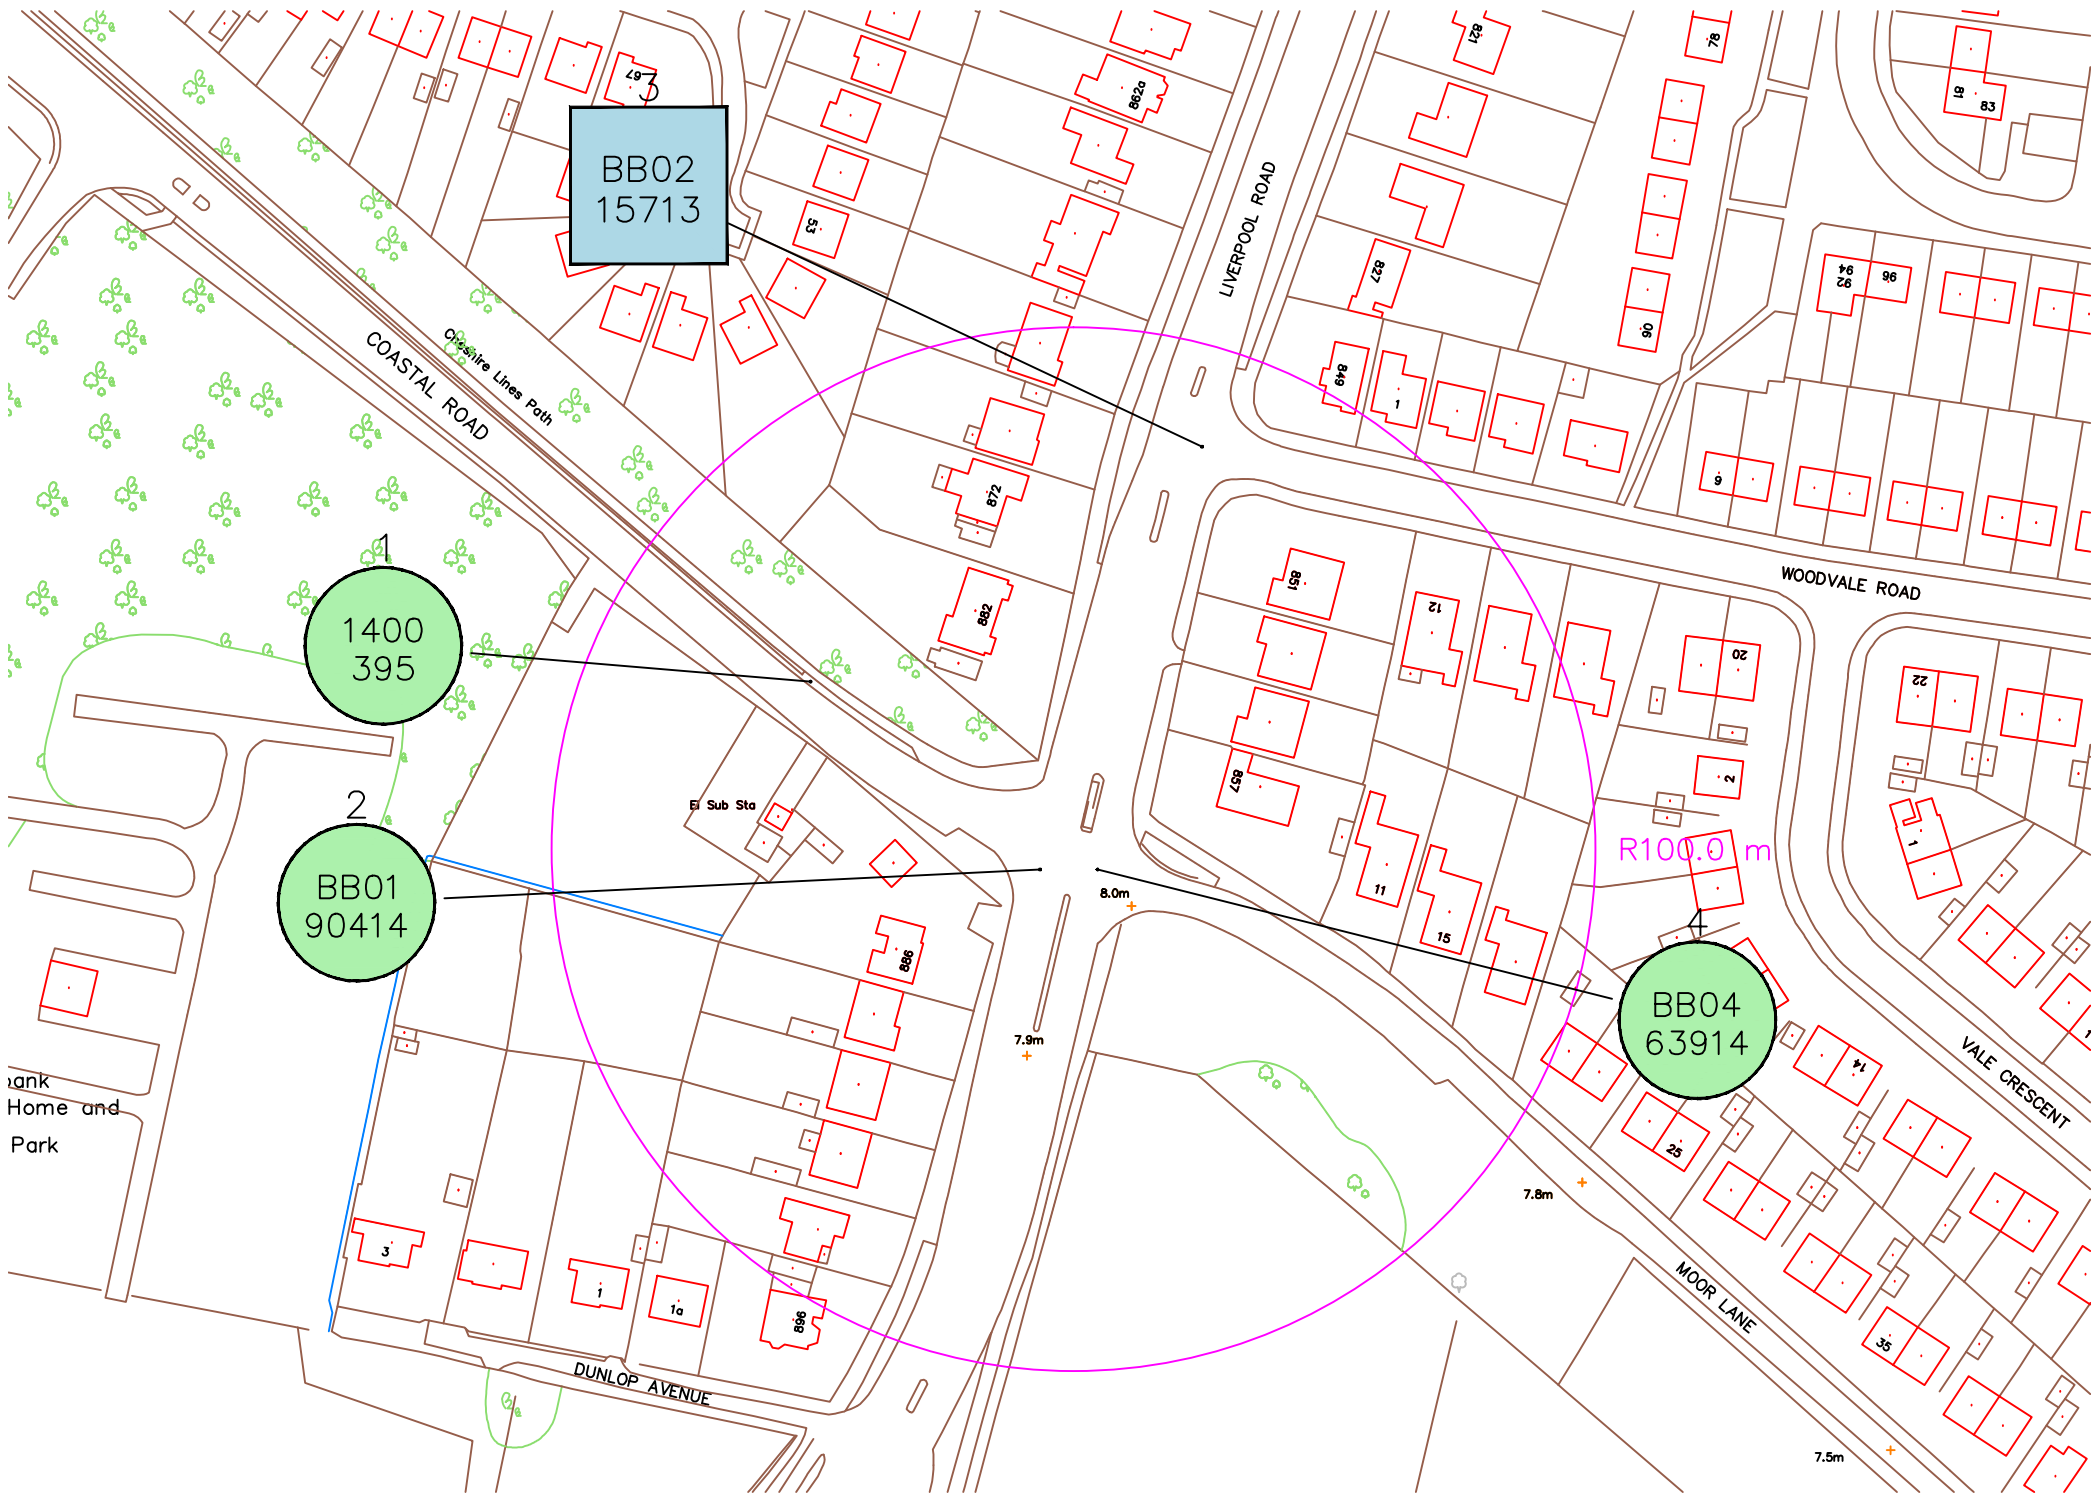
No.	Area	L/A	Reference	Severity	Day	Date	Time	Grid Coords	Link/Node	Street			
1	E08000014		1400395	Slight	Saturday	22/11/2014	16:38	331172/410710					
Location: 3311720410710 1st Rd: U 2nd Rd: A565													
Speed	C'Way	Jct Det/Ctrl	Lighting	Weather	Rd Surf	PedX - Human	- Phy Fac	Special	Hazard				
40MPH	Single c'way	X-Rds ATS	Dark/lights lit	Fine Wind	Wet	None	None	None	None				
Veh	Vehicle type	Towing	Manoeuvr	Dir	Veh loc	Junct. loc	Skidding	Hit obj in	Left cway	Hit obj off	Sex	Age	B/T
1	Car	No	Stop	E W	On main	Junt appr	Yes	None		None	Female	31	-ve
2	Car	No	Waiting	E W	On main	Junt appr	No	None		None	Male	36	-ve
3	Car	No	Waiting	E W	On main	Junt appr	No	None		None	Female	79	-ve
Cas No	Veh ref	Cas Class	Sex	Age	Severity	Car Pass	Ped Direction	Ped Movement	Ped location	School Pupil			
1	2	Drv/Rider	Male	36	Slight	No	Not ped	Not ped	Not ped	Other			
Description: DRIVER OF V1 HAS FAILED TO SEE V2 COME TO A HALT AND HAS COLLIDED WITH THE REAR OF IT, PUSHING V2 INTO V3.

User Information:													
2	E08000014		BB0190414	Slight	Thursday	06/03/2014	08:20	331216/410674					
Location: A565 LIVERPOOL ROAD, at its Junction with Unclassified Road COASTAL ROAD, SOUTHPORT, MERSEYSIDE 1st Rd: A565 2nd Rd: U													
Speed	C'Way	Jct Det/Ctrl	Lighting	Weather	Rd Surf	PedX - Human	- Phy Fac	Special	Hazard				
30MPH	Dual c'way	X-Rds ATS	Daylight	Fine	Dry	None	Ped Phase	None	None				
Veh	Vehicle type	Towing	Manoeuvr	Dir	Veh loc	Junct. loc	Skidding	Hit obj in	Left cway	Hit obj off	Sex	Age	B/T
1	Car	No	Stop	SW NE	On main	Junt appr	No	None		None	Male	-1	N/C
2	M/cycle 50 - 1	No	Stop	SW NE	On main	Junt appr	No	None		None	Male	20	N/C
Cas No	Veh ref	Cas Class	Sex	Age	Severity	Car Pass	Ped Direction	Ped Movement	Ped location	School Pupil			
1	2	Drv/Rider	Male	20	Slight	No	Not ped	Not ped	Not ped	Other			
Description: V2 STATIONARY AT RED ATS, V1 COLLIDES WITH THE REAR OF V2, V1 F.T.S.

User Information:													
3	B312 E08000014		BB0215713	Serious	Wednesday	03/04/2013	20:09	331247/410755					
Location: A565 LIVERPOOL ROAD, at its Junction with Unclassified Road WOODVALE ROAD, AINSDALE, SEFTON, S15200/S15415 1st Rd: A565 2nd Rd: U													
Speed	C'Way	Jct Det/Ctrl	Lighting	Weather	Rd Surf	PedX - Human	- Phy Fac	Special	Hazard				
30MPH	Single c'way	T/Stag Give	Dark/lights lit	Fine	Dry	None	None	None	None				
Veh	Vehicle type	Towing	Manoeuvr	Dir	Veh loc	Junct. loc	Skidding	Hit obj in	Left cway	Hit obj off	Sex	Age	B/T
1	Car	No	Right turn	S E	On main	Mid junction	No	None		None	Female	31	-ve
2	M/cycle > 500c	No	Going ahead	N S	On main	Mid junction	OT	None		None	Male	43	-ve
Cas No	Veh ref	Cas Class	Sex	Age	Severity	Car Pass	Ped Direction	Ped Movement	Ped location	School Pupil			
1	2	Drv/Rider	Male	43	Serious	No	Not ped	Not ped	Not ped	Other			
Description: V1 HAS TURNED RIGHT OFF LIVERPOOL ROAD, INTENDING TO TURN INTO WOODVALE ROAD AND HAS TURNED DIRECTLY INTO THE PATH OF V2.

User Information:													
4	E08000014		BB0463914	Slight	Friday	19/09/2014	19:50	331227/410674					
Location: A565 LIVERPOOL ROAD, at its Junction with Unclassified Road MOOR LANE, AINSDALE, MERSEYSIDE 1st Rd: A565 2nd Rd: U													
Speed	C'Way	Jct Det/Ctrl	Lighting	Weather	Rd Surf	PedX - Human	- Phy Fac	Special	Hazard				
30MPH	Single c'way	T/Stag ATS	Daylight	Fine	Dry	None	None	None	None				
Veh	Vehicle type	Towing	Manoeuvr	Dir	Veh loc	Junct. loc	Skidding	Hit obj in	Left cway	Hit obj off	Sex	Age	B/T
1	Car	No	O/T mov veh	N S	On main	Junt appr	No	None		None	Untra.	-1	N/C
2	Pedal Cycle	No	Going ahead	N S	On main	Junt appr	No	None		None	Male	32	N/A
Cas No	Veh ref	Cas Class	Sex	Age	Severity	Car Pass	Ped Direction	Ped Movement	Ped location	School Pupil			
1	2	Drv/Rider	Male	32	Slight	No	Not ped	Not ped	Not ped	Other			
Description: V1 HAS BEEN TOO CLOSE TO V2 (P/CYCLE), V1 COLLIDES WITH THE REAR WHEEL OF V2 CAUSING RIDER TO FALL, V1 F.T.S.
