Appendix 5

Selective & Additional HMO Licensing Case Studies

Case Study 1

Selective Licensing

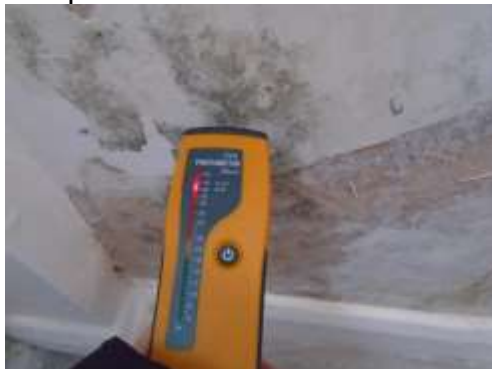
Damp & Mould Hazard

There were rising damp issues to the hallway and through lounge and penetrating damp to the front bedroom.

- A Damp Report was undertaken and provided to the Council and remedial works were carried out to the property followed by plastering of effected walls.

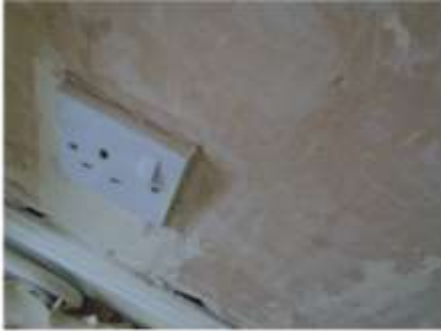
There was an electrical socket that remained in situ in the bathroom that had failed to be isolated.

Socket identified in bathroom

- All Electrical issues were resolved and an EICR Electrical Installation Condition Report was received confirming the electrical safety standard of the property was satisfactory including installation of a cooker switch and providing additional sockets. The bathroom socket was isolated, and a blanking plate installed.

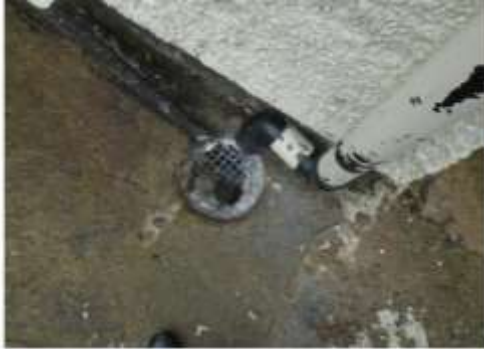
Rainwater gullies were not fit for purpose and were susceptible to obstruction.

- The downpipe and rainwater gullies were repaired to ensure there was no obstruction and water could safely discharge to the drainage system.

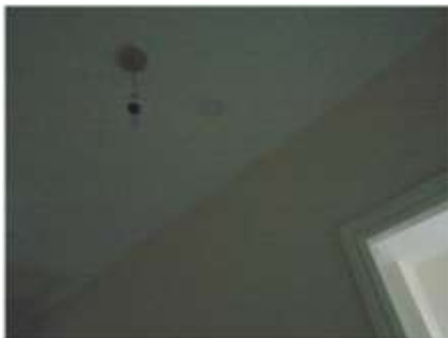
The property only had one working smoke detector in place reducing the early warning for the occupants. However, the complex layout of the property also meant the occupants had to pass through a high-risk room in the event of a fire. We had requested for an upgrade from battery smoke to mains operated smoke detection, FD30's in all bedrooms and escape windows to provide early warning and escape route. As an emergency battery smoke detection was requested.

Missing smoke detector

- Due to the cost implications of upgrading the fire precautions we provided the landlord with an alternative solution which involved reinstating the protected route and removing the “inner room” scenario with Building Regulations approval where necessary. The alternative solution then only necessitated battery smoke detection which was acceptable.

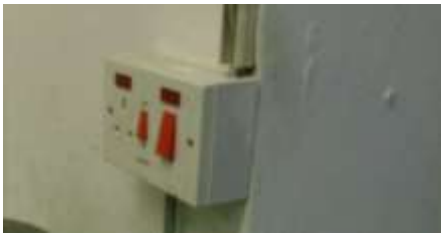
Cooker switch installed

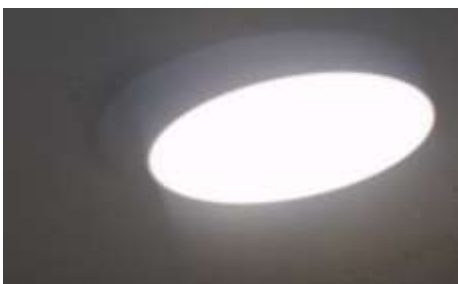
- The bathroom light was changed for one which has a 'Ingress Protection rating of IPX4".

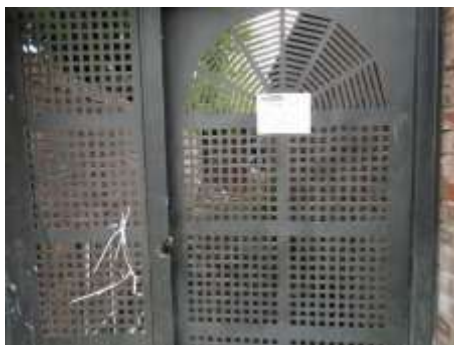
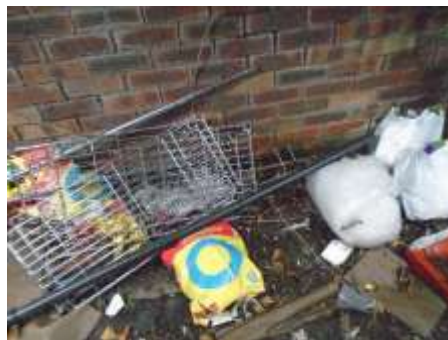
Entrance to Alley /Access to Annex

The tenant of this annex could not access the electrics to top up their supply as it was located in the main building. The property also lacked a constant supply of hot water. The only access to the property was via the rear entry, unlit and full of refuse. There were no opening windows to the property. The property was totally uninhabitable. The landlord and tenant were immediately informed that the property should not be used as accommodation.

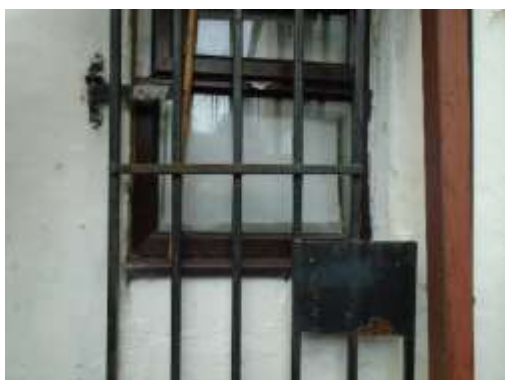
Only Window (Unusable)

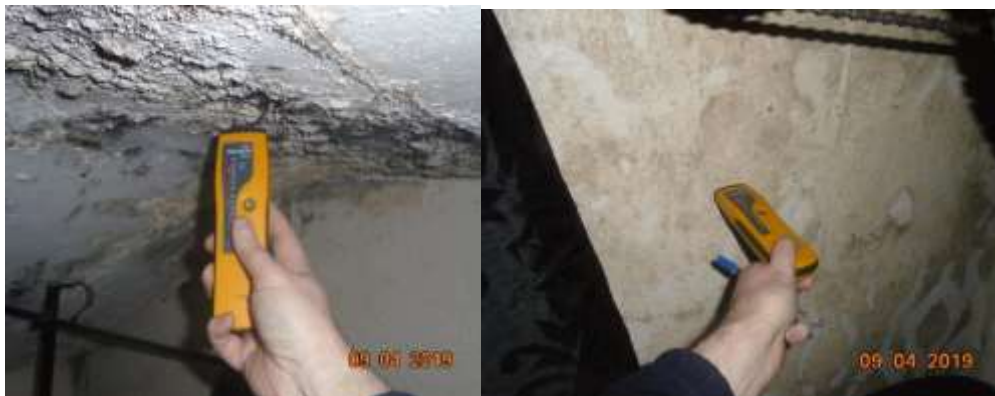
There was excessive dampness and excessive mould growth within the top Flat (Flat C) which was a direct result of the defective roof.

- Extensive work has been carried out to Flat C internally and the roof has been overhauled and made watertight.
- Insulation has been provided internally in Flat C and the owners took advantage of a Government Scheme to help with the cost.
- The required handrail to the external steps has been provided and the pipework to Flat B has been boxed in.
- The Fire Doors (FD30S) have all been installed as requested with combined intumescent strips, cold smoke seals and self-closers.

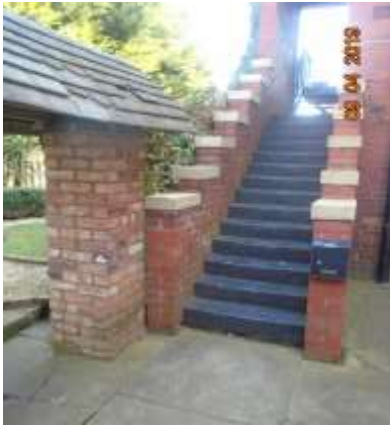
The staircase within flat C and to the rear of the premises leading up to flat A and Flat C represented a fall on stairs hazard and both required a handrail.

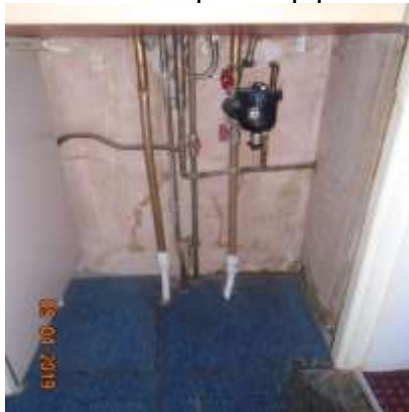
There was exposed pipework within flat B which should be covered or boxed in.
